| Facility Name & Address: Newgen Agro Processors Pvt Ltd, Krishnagiri | Audited On: 01/06/2023 |

### FACILITY SURROUNDING

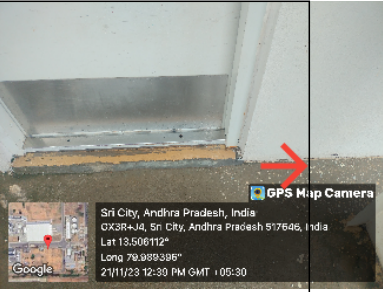
| Internal Premises | | | REVIEW DATE | COMPLETION DATE | |
|---|---|---|---|---|--|
| | | Structural Issue (Pest harbourages) | Door frame to floor and door frame to doors gaps observed | | |
| | | Access Issues | RM Emergency doors regularly using man movement, so it was not closed properly. | | |
| | | Description of Pest Infestation | It is Serious Threat for Ants,millipede and other crawling insects. | | |

| Internal Premises | | | REVIEW DATE | COMPLETION DATE | |
|---|---|---|---|---|--|
| | | Preventive Action suggested to customer | Gap should be closed with rubber breading or silicone sealant. | | |

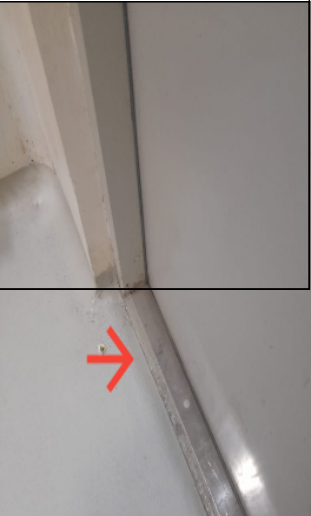
<table><tr> <td>Location</td> <td>We are instructed to Technician for Regular Monitoring.</td> </tr><tr> <td>Structural Issue (Pest harbourages)</td> <td>Gap observed between the doors to doors frame.</td> </tr><tr> <td>Description of Pest Infestation</td> <td>We observed live millipede out side of the building.</td> </tr><tr> <td>Any other observations</td> <td>Due to rain all crawling insects come and hide some places like cracks and gaps area</td> </tr></table>

<table><tr> <td>Location</td> <td>We are instructed to Technician for Regular Monitoring.</td> </tr><tr> <td>Preventive Action suggested to customer</td> <td>In this area where ever cracks and gaps identified that area should be closed with cement concrete.</td> </tr><tr> <td></td> <td>We are instructed to Technician for Regular Monitoring.</td> </tr></table>
