PEST CONTROL EXPERTS

Facility Name & Address: LCN Industries , Chittoor	Audited On: 09-09-2025
Audited By: SURESH KUMAR.V	
Client Contact Person Name: Mr. Chanukya Naidu	PC Experts Contact Person Name: SURESH KUMAR.V
Client Contact Person No: 9440274003	PC Experts Contact Person No: 8248672110

FACILITY SURROUNDING

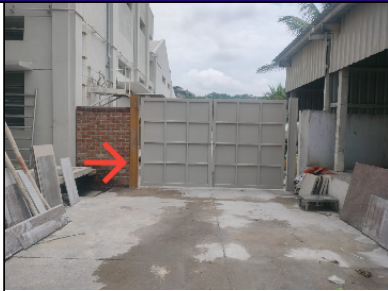
1

Location	Factory backside gate		
	Cleaning / sanitation & Housekeeping Issues	Nil		
	Structural Issue (Pest harbourages)	Gate bottom and gate sides gaps observed		
	Access Issues	Nil		
	Description of Pest Infestation	It is Serious Threat for Ants, Rodents, lizards, snakes and other crawling insects		
	Any other observations	Nil		
	Preventive Action suggested to customer	Gap should be closed with metal sheets or mesh or rubber beading.		
	Curative action from	We are instructed to Technician for Regular Monitoring.

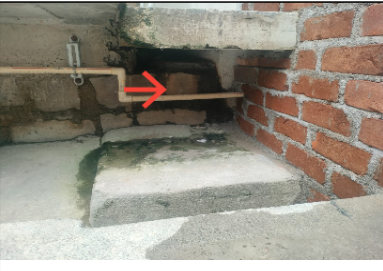
Location	Backside gate near (left side slab bottom Gap area)		
		Cleaning / sanitation & Housekeeping Issues	Nil		
		Structural Issue (Pest harbourages)	Slab bottom Gap observed		
		Access Issues	Nil		
		Description of Pest Infestation	It is Serious Threat for Beetles, Rodents, lizards, snakes flying insects and other crawling insects		
		Any other observations	Nil		
		Preventive Action suggested to customer	Gap should be closed with cement		
		Curative action from	We are instructed to Technician for Regular Monitoring.		
2

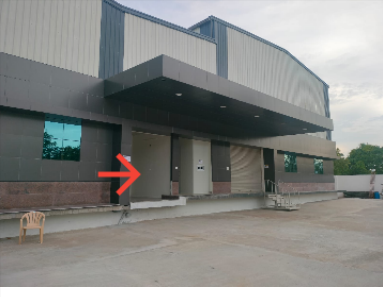
Location	Main building all hygiene and materials receiving area.		
		Cleaning / sanitation & Housekeeping Issues	Nil		
		Structural Issue (Pest harbourages)	All entry points PVC strips and Aircutains not fixed		
		Access Issues	Nil		
		Description of Pest Infestation	It is Serious Threat for Ants, lizards, cockroaches, Rodents, flying insects and other crawling insects

Any other observations	Nil		
		Preventive Action suggested to customer	All entry points should be placed PVC strips and Aircutains without any gaps.		
		Curative action from	We are instructed to Technician for Regular Monitoring.		
3

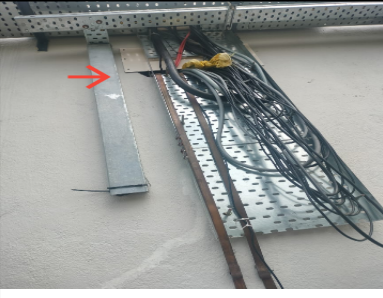
4

Location	Main building cable trench area (Salt and sugar).		
		Cleaning / sanitation & Housekeeping Issues	Nil		
		Structural Issue (Pest harbourages)	Wall to Cable trench surroundings Gap observed		
		Access Issues	Nil		
		Description of Pest Infestation	It is Serious Threat for Ants, beetles, lizards, flying insects and other crawling insects		
		Any other observations	Nil		
		Preventive Action suggested to customer	Gap should be closed with form sealent without any gaps		
		Curative action from	We are instructed to Technician for Regular Monitoring.

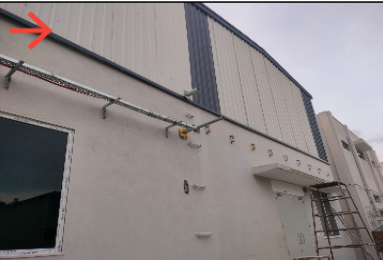
Location	Main building outer area		
		Cleaning / sanitation & Housekeeping Issues	Nil		
		Structural Issue (Pest harbourages)	Wall to wall metal sheets between gaps noticed.		
		Access Issues	Nil		
		Description of Pest Infestation	It is Serious Threat for Ants, beetles, lizards, flying insects and other crawling insects.		
		Any other observations	Nil		
		Preventive Action suggested to customer	Gap should be closed with cement or form sealent.		
		Curative action from	We are instructed to Technician for Regular Monitoring.		
5

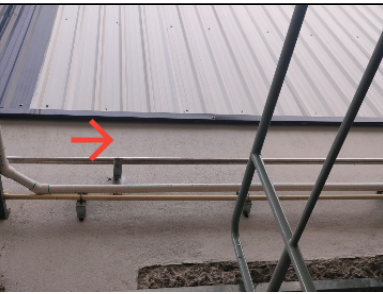
Curative action from	We are instructed to Technician for Regular Monitoring.		
6

Location	Main building outer area		
		Cleaning / sanitation & Housekeeping Issues	Nil		
		Structural Issue (Pest harbourages)	Wall to wall metal sheets between gaps noticed		
		Access Issues	Nil		
		Description of Pest Infestation	It is Serious Threat for Beetles, lizards, flying insects and other crawling insects		
		Any other observations	Nil		
		Preventive Action suggested to customer	Gap should be closed with cement or form sealent without any gaps

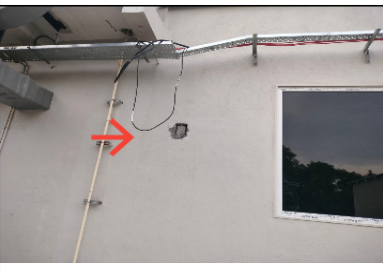
7

Location	Main building backside area		
		Cleaning / sanitation & Housekeeping Issues	Nil		
		Structural Issue (Pest harbourages)	Gap noticed between the wall to wall brick		
		Access Issues	Nil		
		Description of Pest Infestation	It is Serious Threat for Ants, lizards, other crawling insects		
		Any other observations	Nil		
		Preventive Action suggested to customer	Gap should be closed with cement.		
		Curative action from	We are instructed to Technician for Regular Monitoring.

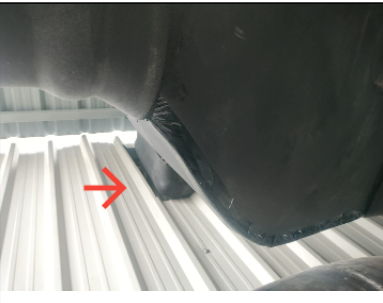
Location	Main building outer AHU line area		
		Cleaning / sanitation & Housekeeping Issues	Nil		
		Structural Issue (Pest harbourages)	AHU surroundings to wall metal sheets gap noticed		
		Access Issues	Nil		
		Description of Pest Infestation	It is Serious Threat for Ants, beetles, lizards, flying insects and other crawling insects.		
		Any other observations	Nil		
		Preventive Action suggested to customer	Gap should be closed with form sealent without any gaps		
		Curative action from	We are instructed to Technician for Regular Monitoring.		
8

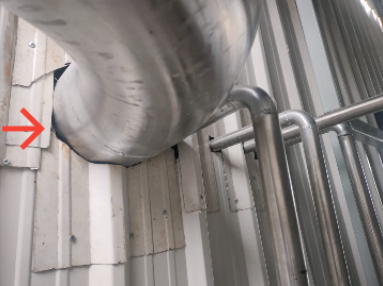
Location	Main building outer area (ss pipes line area)		
		Cleaning / sanitation & Housekeeping Issues	Nil		
		Structural Issue (Pest harbourages)	SS pipe to Wall metal sheet gaps observed		
		Access Issues	Nil		
		Description of Pest Infestation	It is Serious Threat for Ants, beetles lizards flying insects and other crawling insects		
		Any other observations	Nil

Preventive Action suggested to customer	Gap should be closed with proper material like form sealent,		
		Curative action from	We are instructed to Technician for Regular Monitoring.		
9

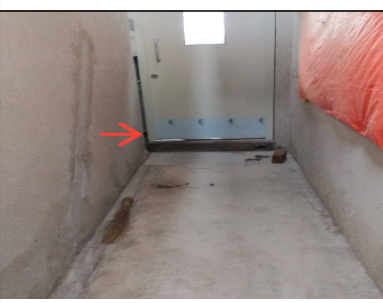
10

Location	Main emergency door exit area.		
		Cleaning / sanitation & Housekeeping Issues	Nil		
		Structural Issue (Pest harbourages)	Door frame to Wall gap noticed and door bottom Gap observed		
		Access Issues	Nil		
		Description of Pest Infestation	It is Serious Threat for Ants, beetles, lizards flying insects and other crawling insects		
		Any other observations	Nil		
		Preventive Action suggested to customer	Gap should be closed rubber beading and cement		
		Curative action from	We are instructed to Technician for Regular Monitoring.

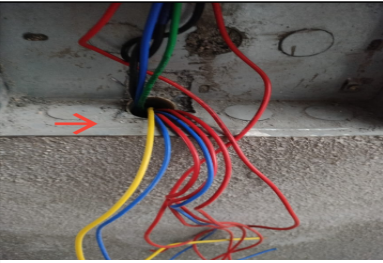
Location	Emergency door backside (cable switch box area)		
		Cleaning / sanitation & Housekeeping Issues	Nil		
		Structural Issue (Pest harbourages)	Switch box wire line pipe gaps noticed		
		Access Issues	Nil		
		Description of Pest Infestation	It is Serious Threat for Ants, lizards, other crawling insects		
		Any other observations	Nil		
		Preventive Action suggested to customer	Switch box should be placed with top switch box frame		
		Curative action from	We are instructed to Technician for Regular Monitoring.		
11

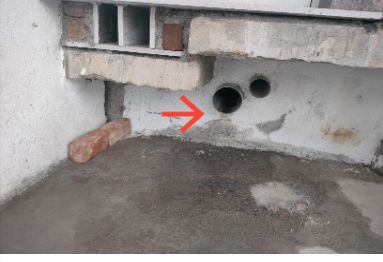
Curative action from	We are instructed to Technician for Regular Monitoring.		
12

Location	Main building (water outlet pipe line)		
		Cleaning / sanitation & Housekeeping Issues	Nil		
		Structural Issue (Pest harbourages)	Pipe lid not placed		
		Access Issues	Nil		
		Description of Pest Infestation	It is Serious Threat for Ants, mosquito, beetles lizards flying insects and other crawling insects.		
		Any other observations	Nil		
		Preventive Action suggested to customer	Mesh type lid should be placed

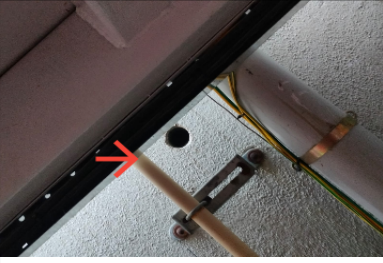
13

Location	Main building outer area (vessels back side)		
		Cleaning / sanitation & Housekeeping Issues	Nil		
		Structural Issue (Pest harbourages)	Hole observed on the Wall		
		Access Issues	Nil		
		Description of Pest Infestation	It is Serious Threat for Ants, lizards and other crawling insects.		
		Any other observations	Nil		
		Preventive Action suggested to customer	Hole should be closed with cement		
		Curative action from	Nil

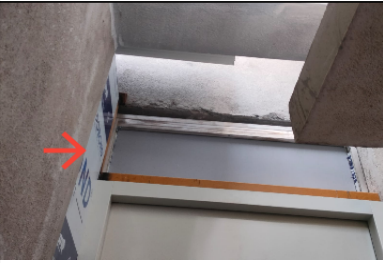
Curative action from	We are instructed to Technician for Regular Monitoring.		
15

Location	Main building (outer emergency area)		
		Cleaning / sanitation & Housekeeping Issues	Nil		
		Structural Issue (Pest harbourages)	Door top side corner Gap observed		
		Access Issues	Nil		
		Description of Pest Infestation	It is Serious Threat for Beetles. Lizard, flying insects and other crawling insects		
		Any other observations	Nil		
		Preventive Action suggested to customer	Gap should be closed with form sealent

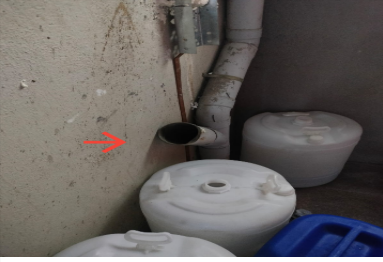
Location	Main building backside (vessels backside area)		
		Cleaning / sanitation & Housekeeping Issues	Nil		
		Structural Issue (Pest harbourages)	pipe hole not closed.		
		Access Issues	Nil		
		Description of Pest Infestation	It is Serious Threat for Ants, flying insects, mosquito and other crawling insects		
		Any other observations	Nil		
		Preventive Action suggested to customer	Hole should be closed with pipe lid		
		Curative action from	We are instructed to Technician for Regular Monitoring.		
16

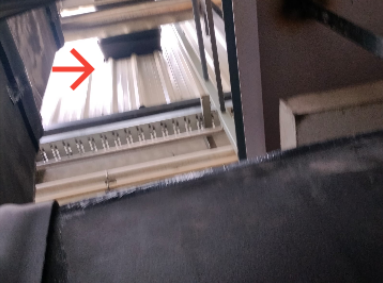
17

Location	Main building outer area (AHU line area)		
		Cleaning / sanitation & Housekeeping Issues	Nil		
		Structural Issue (Pest harbourages)	AHU line surroundings gaps noticed		
		Access Issues	Nil		
		Description of Pest Infestation	It is Serious Threat for Beetles,ants, lizards, flying insects and other crawling insects

Any other observations	Nil		
		Preventive Action suggested to customer	Gap should be closed with form sealent without any gaps		
		Curative action from	We are instructed to Technician for Regular Monitoring.

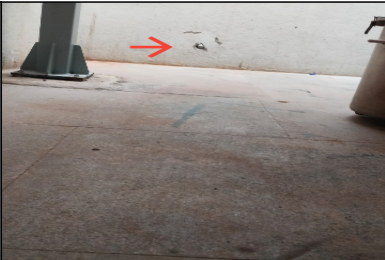
Location	Main building backside area (vessels area backside)		
		Cleaning / sanitation & Housekeeping Issues	Nil		
		Structural Issue (Pest harbourages)	Hole observed in Wall		
		Access Issues	Nil		
		Description of Pest Infestation	It is Serious Threat for Ants., lizards, Rodents, snakes and other crawling insects		
		Any other observations	Nil		
		Preventive Action suggested to customer	Hole should be closed with cement		
		Curative action from	We are instructed to Technician for Regular Monitoring.		
18

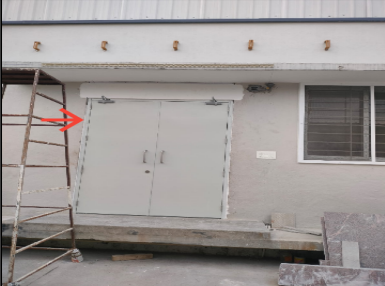
Curative action from	We are instructed to Technician for Regular Monitoring.		
19

Location	Main building backside (FG outer area)		
		Cleaning / sanitation & Housekeeping Issues	Nil		
		Structural Issue (Pest harbourages)	PVC strips and Aircutains not fixed.		
		Access Issues	Nil		
		Description of Pest Infestation	It is Serious Threat for Beetles, lizards, ant, flying insects cockroaches and other crawling insects		
		Any other observations	Nil		
		Preventive Action suggested to customer	All entry points should be placed PVC strips and Aircutains without any gaps

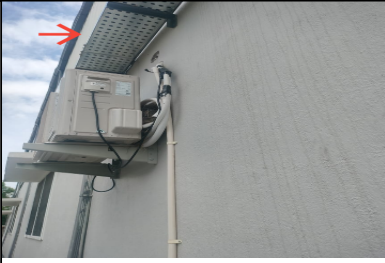
Location	Main building (cable trench line area)		
		Cleaning / sanitation & Housekeeping Issues	Nil		
		Structural Issue (Pest harbourages)	Cable trench line to wall between gaps noticed		
		Access Issues	Nil		
		Description of Pest Infestation	It is Serious Threat for Ants, Rodents, lizards and other crawling insects		
		Any other observations	Nil		
		Preventive Action suggested to customer	Hole should be closed from sealent or cement		
		Curative action from	We are instructed to Technician for Regular Monitoring.
