## PEST CONTROL EXPERTS

Facility Name & Address: LCN INDUSTRIES , Chittoor	Audited On: 09-09-2025
Audited By: SURESH KUMAR.V	
Client Contact Person Name: mr.chanukya Naidu	PC Experts Contact Person Name: SURESH KUMAR.V
Client Contact Person No: 9440274003	PC Experts Contact Person No: 8248672110

### FACILITY SURROUNDING

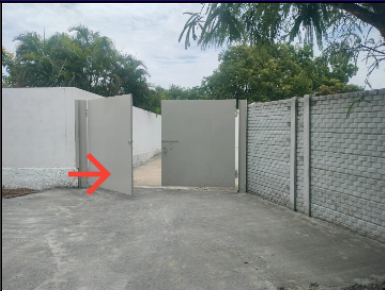
Location	Factory main gate		
		Cleaning / sanitation & Housekeeping Issues	Nil		
		Structural Issue (Pest harbourages)	Main bottom and surroundings gaps observed		
		Access Issues	Nil		
		Description of Pest Infestation	It is Serious Threat for Ants, snakes, dogs, Rodents and other crawling insects		
		Any other observations	Nil		
		Preventive Action suggested to customer	Gap should be with metal sheets or mesh or rubber beading		
		Curative action from	We are instructed to Technician for Regular Monitoring.

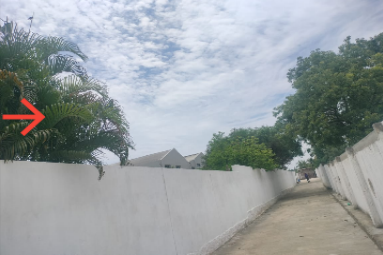
2

Location	COMPOUND WALL IN SIDE		
		Cleaning / sanitation & Housekeeping Issues	Tree branches fall down on the Wall		
		Structural Issue (Pest harbourages)	Nil		
		Access Issues	Nil		
		Description of Pest Infestation	It is Serious Threat for Ants, Rodents, lizards and other crawling insects		
		Any other observations	Nil		
		Preventive Action suggested to customer	Tree branches should be trimmed on regular basis		
		Curative action from	We are instructed to Technician for Regular Monitoring.		
3

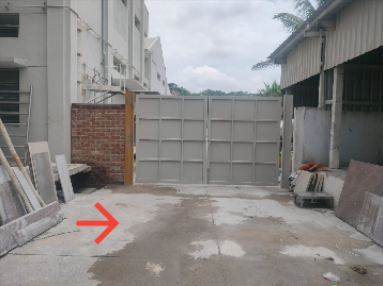
Location	Backside gate		
		Cleaning / sanitation & Housekeeping Issues	Nil		
		Structural Issue (Pest harbourages)	Gate bottom and surroundings gaps observed		
		Access Issues	Nil		
		Description of Pest Infestation	It is Serious Threat for Ants, Rodents, lizards, dogs, snakes		
		Any other observations	Nil		
		Preventive Action suggested to customer	Gap should be closed with metal sheets or mesh or rubber beading

Curative action from	We are instructed to Technician for Regular Monitoring.		
4

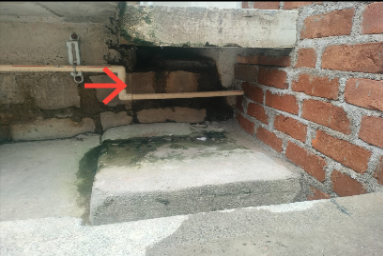
Location	Main building backside ( near backside gate)		
		Cleaning / sanitation & Housekeeping Issues	Nil		
		Structural Issue (Pest harbourages)	Slap bottom gaps observed		
		Access Issues	Nil		
		Description of Pest Infestation	It is Serious Threat for Ants, cockroaches, lizards, Rodents, mosquito and other crawling insects		
		Any other observations	Nil		
		Preventive Action suggested to customer	Gap should be closed with cement		
		Curative action from	We are instructed to Technician for Regular Monitoring.

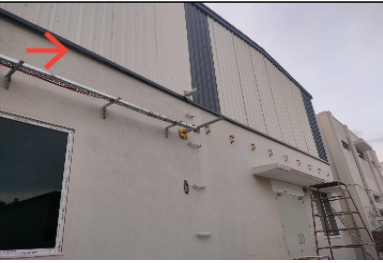
5

Location	Main building outer area		
		Cleaning / sanitation & Housekeeping Issues	Nil		
		Structural Issue (Pest harbourages)	Wall to Wall metal sheets joint we observed the gaps.		
		Access Issues	Nil		
		Description of Pest Infestation	It is Serious Threat for Beetles, ants, lizards, flying insects and other crawling insects		
		Any other observations	Nil		
		Preventive Action suggested to customer	Gap should be closed with form sealent or cement		
		Curative action from	We are instructed to Technician for Regular Monitoring.		
6

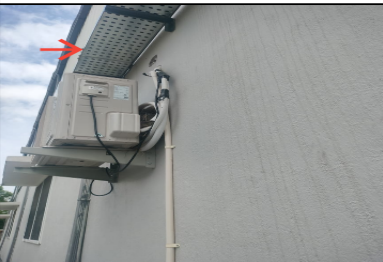
Location	Main building outer area ( cable trench line)		
		Cleaning / sanitation & Housekeeping Issues	Nil		
		Structural Issue (Pest harbourages)	Cable trench line to wall having a hole gaps		
		Access Issues	Nil		
		Description of Pest Infestation	It is Serious Threat for Ants, Rodents, snakes, lizards and other crawling insects		
		Any other observations	Nil		
		Preventive Action suggested to customer	Cable Trenches hole will be Properly Closed.

Curative action from	We are instructed to Technician for Regular Monitoring.		
7

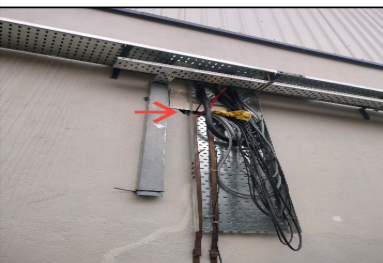
Location	Main building outer area ( power panel room outer)		
		Cleaning / sanitation & Housekeeping Issues	Nil		
		Structural Issue (Pest harbourages)	Cable trench line to wall having gaps		
		Access Issues	Nil		
		Description of Pest Infestation	It is Serious Threat for Ants, lizards, Rodents, flying insects and other crawling insects		
		Any other observations	Nil		
		Preventive Action suggested to customer	Gap should be closed with form sealent or cement		
		Curative action from	We are instructed to Technician for Regular Monitoring.

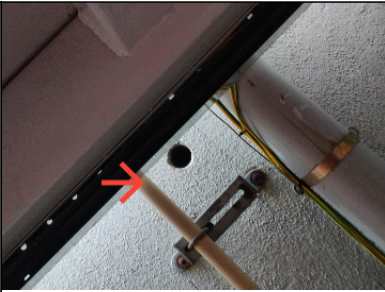
8

Location	Main building backside area ( vessels washing outer area)		
		Cleaning / sanitation & Housekeeping Issues	Nil		
		Structural Issue (Pest harbourages)	Wall hole observed		
		Access Issues	Nil		
		Description of Pest Infestation	It is Serious Threat for Ants, beetles, lizards and other crawling insects		
		Any other observations	Nil		
		Preventive Action suggested to customer	Hole should be closed with cement		
		Curative action from	We are instructed to Technician for Regular Monitoring.		
9

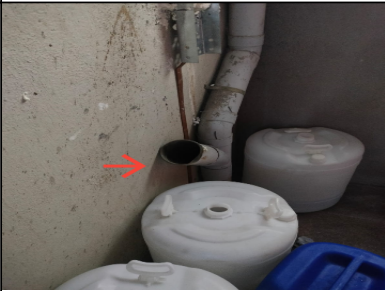
Location	Main building backside area ( vessels washing backside)		
		Cleaning / sanitation & Housekeeping Issues	Nil		
		Structural Issue (Pest harbourages)	Pipe was opened condition		
		Access Issues	Nil		
		Description of Pest Infestation	It is Serious Threat for Beetles, mosquito, ants, lizards and other crawling insects		
		Any other observations	Nil		
		Preventive Action suggested to customer	Pipe line gap should be closed

Curative action from	We are instructed to Technician for Regular Monitoring.		
10

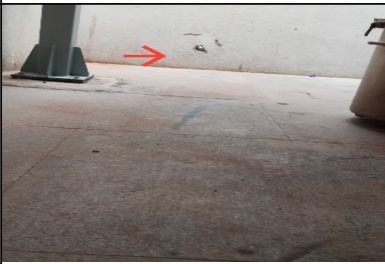
Location	Main building backside area.		
		Cleaning / sanitation & Housekeeping Issues	Nil		
		Structural Issue (Pest harbourages)	Wall hole observed		
		Access Issues	Nil		
		Description of Pest Infestation	It is Serious Threat for Ants, lizards, Rodents, snakes and other crawling insects		
		Any other observations	Nil		
		Preventive Action suggested to customer	Hole should be closed with cement		
		Curative action from	We are instructed to Technician for Regular Monitoring.

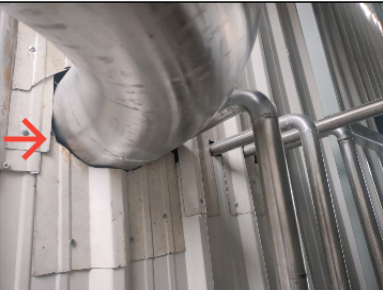
11

Location	Main building backside area		
		Cleaning / sanitation & Housekeeping Issues	Nil		
		Structural Issue (Pest harbourages)	Wall metal sheets to All SS pipe line surroundings having gaps		
		Access Issues	Nil		
		Description of Pest Infestation	It is Serious Threat for Ants, beetles, flying insects, lizards and other crawling insects		
		Any other observations	Nil		
		Preventive Action suggested to customer	Gaps should be closed with form sealent		
		Curative action from	We are instructed to Technician for Regular Monitoring.		
12

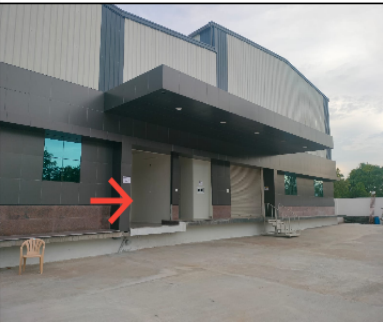
Location	Main hygiene entrance		
		Cleaning / sanitation & Housekeeping Issues	Nil		
		Structural Issue (Pest harbourages)	All entry points we observed no PVC strips and Aircutains		
		Access Issues	Nil		
		Description of Pest Infestation	It is Serious Threat for Ants, lizards Rodents, flying insects and other crawling insects		
		Any other observations	Nil

Preventive Action suggested to customer	All entry points should be placed PVC strips and Aircutains without any gaps		
		Curative action from	We are instructed to Technician for Regular Monitoring.		
13

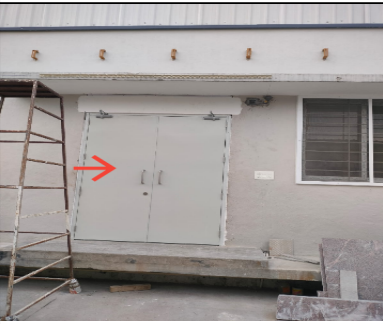
Location	Main building backside door area		
		Cleaning / sanitation & Housekeeping Issues	Nil		
		Structural Issue (Pest harbourages)	Door bottom Gaps observed And no PVC strips and Aircutains.		
		Access Issues	Nil		
		Description of Pest Infestation	It is Serious Threat for Beetles, lizards flying insects and		
		Any other observations	Nil		
		Preventive Action suggested to customer	All entry points should be placed PVC strips and Aircutains		
		Curative action from	We are instructed to Technician for Regular Monitoring.

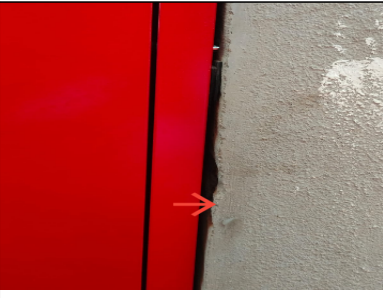
14

Location	Emergency door frame to Wall gap noticed		
		Cleaning / sanitation & Housekeeping Issues	Nil		
		Structural Issue (Pest harbourages)	Frame surroundings gaps observed and bottom also gap noticed		
		Access Issues	Nil		
		Description of Pest Infestation	It is Serious Threat for Ants, beetles, lizards, cockroaches mosquito and other crawling insects		
		Any other observations	Nil		
		Preventive Action suggested to customer	Gap should be closed with cement and rubber beading		
		Curative action from	We are instructed to Technician for Regular Monitoring.		
15

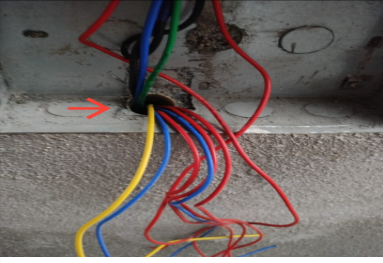
Location	Vessels washing backside		
		Cleaning / sanitation & Housekeeping Issues	Nil		
		Structural Issue (Pest harbourages)	Switch box opend condition		
		Access Issues	Nil		
		Description of Pest Infestation	It is Serious Threat for Ants beetles, lizards and other crawling insects		
		Any other observations	Nil		
		Preventive Action suggested to customer	Switch box lid should be placed

Curative action from	We are instructed to Technician for Regular Monitoring.		
16

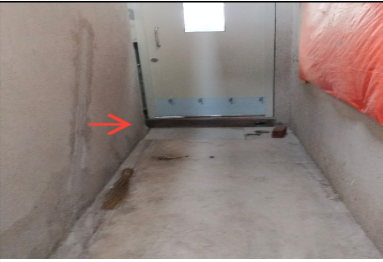
Location	Emergency main exit		
		Cleaning / sanitation & Housekeeping Issues	Nil		
		Structural Issue (Pest harbourages)	Door bottom and door surroundings gaps observed		
		Access Issues	Nil		
		Description of Pest Infestation	It is Serious Threat for Beetles, ants lizards flying insects and other crawling insects		
		Any other observations	Nil		
		Preventive Action suggested to customer	Gap should be closed with metal sheets		
		Curative action from	We are instructed to Technician for Regular Monitoring.

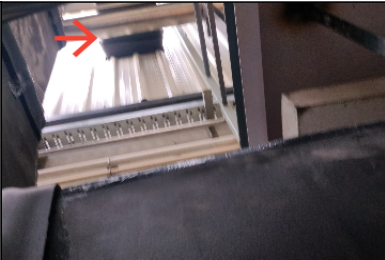
17

Location	Main building outer (AHU line)		
		Cleaning / sanitation & Housekeeping Issues	Nil		
		Structural Issue (Pest harbourages)	AHU line to Wall sheets gaps observed		
		Access Issues	Nil		
		Description of Pest Infestation	It is Serious Threat for Ants beetles, flying insects, lizards and other crawling insects		
		Any other observations	Nil		
		Preventive Action suggested to customer	Gap should be closed with form sealent		
		Curative action from	We are instructed to Technician for Regular Monitoring.		
18

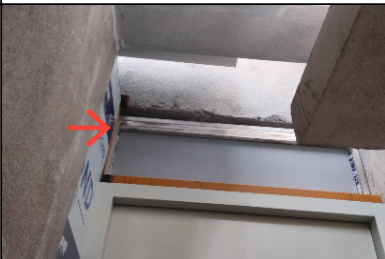
Location	Main emergency exit area		
		Cleaning / sanitation & Housekeeping Issues	Nil		
		Structural Issue (Pest harbourages)	Wall to wall sheet gap observed		
		Access Issues	Nil		
		Description of Pest Infestation	It is Serious Threat for Beetles, ants lizards flying insects and other crawling insects		
		Any other observations	Nil		
		Preventive Action suggested to customer	Gap should be closed with metal sheets

Curative action from	We are instructed to Technician for Regular Monitoring.		
19

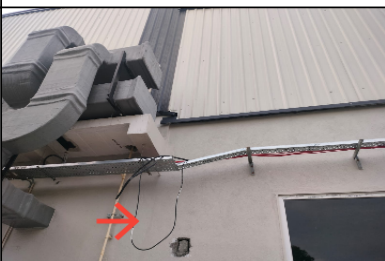
Location	Main building backside outer area		
		Cleaning / sanitation & Housekeeping Issues	Nil		
		Structural Issue (Pest harbourages)	Wall to wall metal sheets between gaps observed		
		Access Issues	Nil		
		Description of Pest Infestation	It is Serious Threat for Ants, lizards flying insects and other crawling insects		
		Any other observations	Nil		
		Preventive Action suggested to customer	Gap should be closed with form sealent		
		Curative action from	We are instructed to Technician for Regular Monitoring.
