## PEST CONTROL EXPERTS

Facility Name & Address: Azista Industry , kuppam	Audited On: 19-12-2023
Audited By: SURESH KUMAR.V	
Client Contact Person Name: Mr. Suresh QC	PC Experts Contact Person Name: SURESH KUMAR.V
Client Contact Person No: 9789217143	PC Experts Contact Person No: 9087200011

### FACILITY SURROUNDING

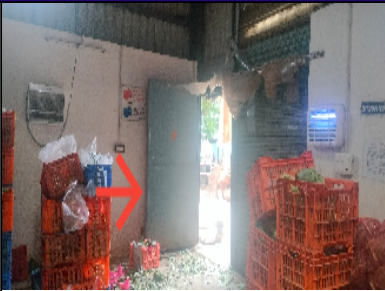
Internal Premises			REVIEW DATE	COMPLETION DATE
1

Location	RM receiving area	
		Cleaning / sanitation & Housekeeping Issues	Not cleaned properly	
		Structural Issue (Pest harbourages)	Doors open condition	
		Access Issues	Pvc strips and air curtains not properly worked	
		Description of Pest Infestation	It is Serious Threat for Beetles, ants, flying insects snake rodent lizard and other crawling insects	
		Any other observations	Nil	
		Preventive Action suggested to customer	Doors should be closed. Air curtains should be working condition. PVC strips should be placed properly	
		Curative action from	We are instructed to Technician for Regular Monitoring.

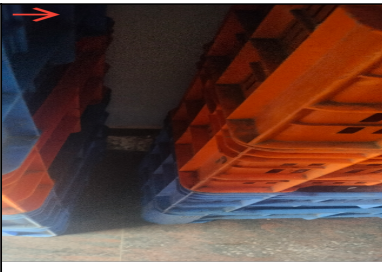
2

Location	FG area		
		Cleaning / sanitation & Housekeeping Issues	Nil		
		Structural Issue (Pest harbourages)	Nil		
		Access Issues	Crates kept wall side without any gaps		
		Description of Pest Infestation	It is Serious Threat for Beetles, lizard, rodent, snakes		
		Any other observations	Nil		
		Preventive Action suggested to customer	Don't keep the materials in wall side, gap should be required atleast 1 and 1/2 feet gap		
		Curative action from	We are instructed to Technician for Regular Monitoring.		
External Premises				REVIEW DATE	COMPLETION DATE
1

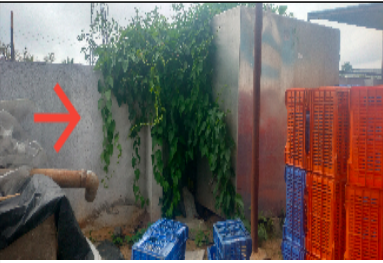
3

Location	ETP AREA		
		Cleaning / sanitation & Housekeeping Issues	Waste water stagnated ETP Area		
		Structural Issue (Pest harbourages)	Nil		
		Access Issues	Nil		
		Description of Pest Infestation	It is Serious Threat for Ants, flying insects and other crawling insects		
		Any other observations	Nil		
		Preventive Action suggested to customer	Don't allow the stagnated water factory premises		
		Curative action from	We are instructed to Technician for Regular Monitoring.		
4
