## PEST CONTROL EXPERTS

| Facility Name & Address: Azista Industry , kuppam | Audited On: 19-12-2023 |

### FACILITY SURROUNDING

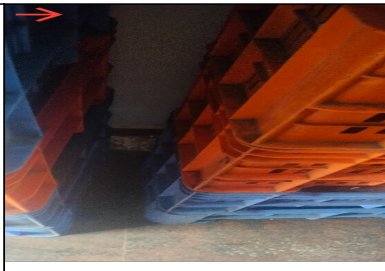
| 2 | | Location | FG area | | |

| | | Access Issues | Crates kept wall side without any gaps | | |
| | | Description of Pest Infestation | It is Serious Threat for Beetles, lizard, rodent, snakes | | |

| | | Preventive Action suggested to customer | Don't keep the materials in wall side, gap should be required atleast 1 and 1/2 feet gap | | |
| | | Curative action from | We are instructed to Technician for Regular Monitoring. | | |
