## PEST CONTROL EXPERTS

Facility Name & Address: Azista Industry , kuppam	Audited On: 19-12-2023
Audited By: SURESH KUMAR.V	
Client Contact Person Name: Mr. Suresh QC	PC Experts Contact Person Name: SURESH KUMAR.V
Client Contact Person No: 9789217143	PC Experts Contact Person No: 9087200011

### FACILITY SURROUNDING

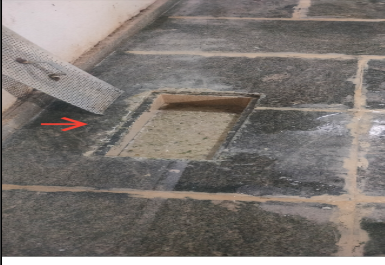
Location	Dryer line area		
		Cleaning / sanitation & Housekeeping Issues	Drainage line not cleaned properly		
		Structural Issue (Pest harbourages)	Nil		
		Access Issues	Nil		
		Description of Pest Infestation	It is Serious Threat for Beetles, ants, cockroach, flying insects and other crawling insects		
		Any other observations	Nil		
		Preventive Action suggested to customer	Drainage line should be clean on regular basis

Curative action from	We are instructed to Technician for Regular Monitoring.		
4

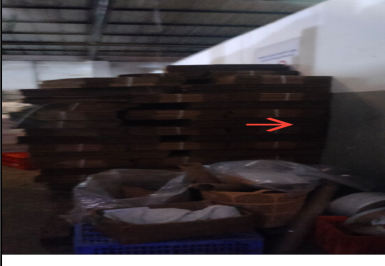
Location	Cotten Box storage area		
		Cleaning / sanitation & Housekeeping Issues	Ni		
		Structural Issue (Pest harbourages)	Nil		
		Access Issues	Nil		
		Description of Pest Infestation	It is Serious Threat for Beetles to Rodent, lizard and other crawling insects		
		Any other observations	Nil		
		Preventive Action suggested to customer	Don't allow the cotton boxes near the wall		
		Curative action from	We are instructed to Technician for Regular Monitoring.
