## PEST CONTROL EXPERTS

Facility Name & Address: Azista Industry , kuppam	Audited On: 19-12-2023
Audited By: SURESH KUMAR.V	
Client Contact Person Name: Mr. Suresh QC	PC Experts Contact Person Name: SURESH KUMAR.V
Client Contact Person No: 9789217143	PC Experts Contact Person No: 9087200011

### FACILITY SURROUNDING

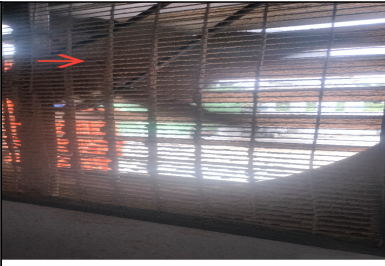
2

Location	Grading area		
		Cleaning / sanitation & Housekeeping Issues	Exhaust fan mesh was dust accumulated		
		Structural Issue (Pest harbourages)	Nil		
		Access Issues	Nil		
		Description of Pest Infestation	It is Serious Threat for Beetles,Ants, flying insects and other crawling insects and		
		Any other observations	Nil		
		Preventive Action suggested to customer	Mesh should be clean on regular basis		
		Curative action from	We are instructed to Technician for Regular Monitoring.		
3

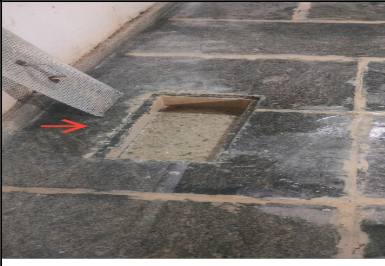
Location	Dryer line area		
		Cleaning / sanitation & Housekeeping Issues	Drainage line not cleaned properly		
		Structural Issue (Pest harbourages)	Nil		
		Access Issues	Nil		
		Description of Pest Infestation	It is Serious Threat for Beetles, ants, cockroach, flying insects and other crawling insects		
		Any other observations	Nil		
		Preventive Action suggested to customer	Drainage line should be clean on regular basis

Curative action from	We are instructed to Technician for Regular Monitoring.		
4

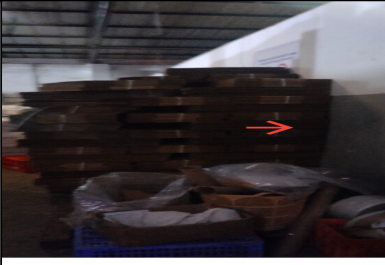
Location	Cotten Box storage area		
		Cleaning / sanitation & Housekeeping Issues	Ni		
		Structural Issue (Pest harbourages)	Nil		
		Access Issues	Nil		
		Description of Pest Infestation	It is Serious Threat for Beetles to Rodent, lizard and other crawling insects		
		Any other observations	Nil		
		Preventive Action suggested to customer	Don't allow the cotton boxes near the wall		
		Curative action from	We are instructed to Technician for Regular Monitoring.

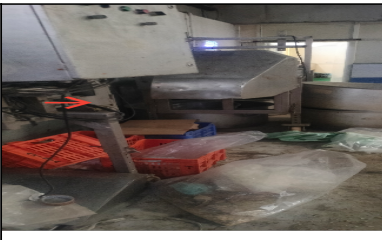
5

Location	Processing hall		
		Cleaning / sanitation & Housekeeping Issues	Nil		
		Structural Issue (Pest harbourages)	Nil		
		Access Issues	Nil		
		Description of Pest Infestation	It is Serious Threat for Ants, cockroach		
		Any other observations	Nil		
		Preventive Action suggested to customer	Don't allow the materials near machinery area		
		Curative action from	We are instructed to Technician for Regular Monitoring.		
External Premises				REVIEW DATE	COMPLETION DATE
1

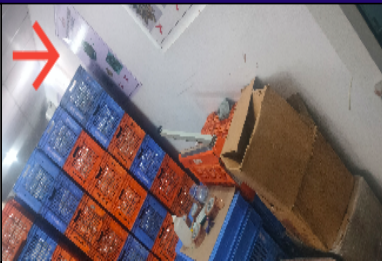
Location	Crate washing area		
		Cleaning / sanitation & Housekeeping Issues	Nil		
		Structural Issue (Pest harbourages)	Nil		
		Access Issues	Tree branches fall down on the compound wall		
		Description of Pest Infestation	It is Serious Threat for Beetles, Ants, lizard, Rodent, snakes and other crawling insects		
		Any other observations	Nil		
		Preventive Action suggested to customer	Tree branches should be trim on regular basis.

Curative action from	We are instructed to Technician for Regular Monitoring.		
2

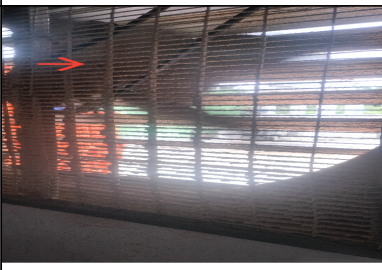
Location	ETP dry bed area		
		Cleaning / sanitation & Housekeeping Issues	Thick vegetation observed		
		Structural Issue (Pest harbourages)	Nil		
		Access Issues	Nil		
		Description of Pest Infestation	It is Serious Threat for Beetles, Ants, flying insects lizards, Rodent and other crawling insects		
		Any other observations	Nil		
		Preventive Action suggested to customer	Thick vegetation should be clean on regular		
		Curative action from	We are instructed to Technician for Regular Monitoring.

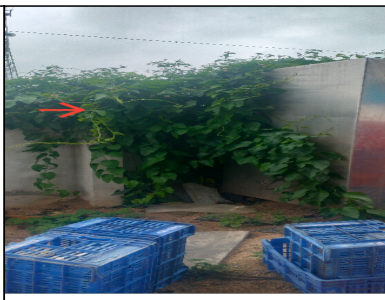
6

Location	Hygiene entrance behind area		
		Cleaning / sanitation & Housekeeping Issues	Drainage line not cleaned properly		
		Structural Issue (Pest harbourages)	Manholes opened condition		
		Access Issues	Nil		
		Description of Pest Infestation	It is Serious Threat for Beetles, Ants, cockroach, flying insects and other crawling insects		
		Any other observations	Nil		
		Preventive Action suggested to customer	Manholes lid should be placed without any gaps. Drainage line should be clean on regular basis		
		Curative action from	We are instructed to Technician for Regular Monitoring.		
7

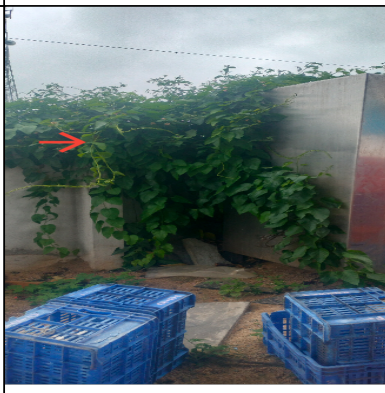
Location	Hygiene entrance area		
		Cleaning / sanitation & Housekeeping Issues	Nil		
		Structural Issue (Pest harbourages)	Doors Not closed properly it's opened condition. PVC strips was kept on doors. Aircurtain at exotic that time not worked		
		Access Issues	Nil		
		Description of Pest Infestation	It is Serious Threat for Beetles, Ants, flying insects lizards snake rodent and other crawling insects.		
		Any other observations	Nil		
		Preventive Action suggested to customer	Doors should be closed always. PVC strips don't hang on the door. Aircurtain should be working condition on regularly.		
		Curative action from	We are instructed to Technician for Regular Monitoring.		
Note: In General your all window mesh will be replaced all windows. Also in Processing area. Fly Killer Machine will be placed to Fly Catcher Machines
