Facility Name & Address: Sri Varsha Food park , Tirupati	Audited On: 19-09-2023
Audited By: SURESH KUMAR.V	
Client Contact Person Name: Mr. senthil	PC Experts Contact Person Name: SURESH KUMAR.V
Client Contact Person No: 9940284651	PC Experts Contact Person No: 9087200011

## FACILITY SURROUNDING

Internal Premises				REVIEW DATE	COMPLETION DATE
1

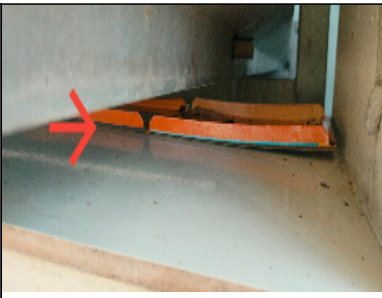
Location	Dispatch area shutter		
		Cleaning / sanitation & Housekeeping Issues	Nil		
		Structural Issue (Pest harbourages)	Dispatch area shutter gap observed between the shutter to wall		
		Access Issues	Nil		
		Description of Pest Infestation	It is Serious Threat for Ants, lizard, flying insects and other crawling insects		
		Any other observations	Nil		
		Preventive Action suggested to customer	Gap should be closed with rubber breading		
		Curative action from	We are instructed to Technician for Regular Monitoring.		
8

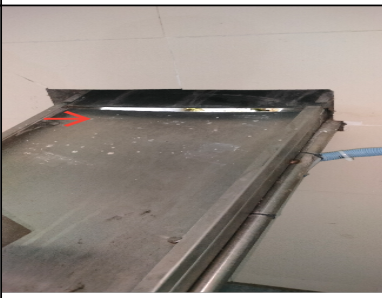
Location	Fruit Washing area door bottom		
		Cleaning / sanitation & Housekeeping Issues	Nil		
		Structural Issue (Pest harbourages)	Fruit Washing area door bottom gaps observed.		
		Access Issues	Nil		
		Description of Pest Infestation	It is Serious Threat for Ants, beetles, lizard and other crawling insects		
		Any other observations	Nil		
		Preventive Action suggested to customer	Gap should be closed with rubber breading or pvc brush

Curative action from	We are instructed to Technician for Regular Monitoring.		
External Premises				REVIEW DATE	COMPLETION DATE
1

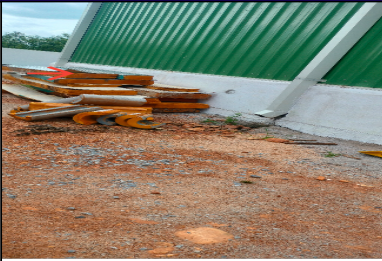
Location	Main building back side area		
		Cleaning / sanitation & Housekeeping Issues	Lot of used materials kept at main building Wall side.		
		Structural Issue (Pest harbourages)	Nil		
		Access Issues	Nil		
		Description of Pest Infestation	It is Serious Threat for snakes, rodent, lizards, Ants and crawling insects it will be hide in this place.		
		Any other observations	Nil		
		Preventive Action suggested to customer	Don't allow the materials at main building surrounding.		
		Curative action from	We are instructed to Technician for Regular Monitoring.

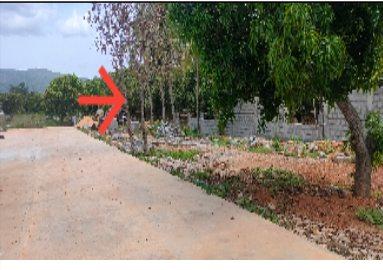
Location	Compound wall		
		Cleaning / sanitation & Housekeeping Issues	We observed lot of thick vegetation.		
		Structural Issue (Pest harbourages)	Compound wall construction work going on.		
		Access Issues	Nil		
		Description of Pest Infestation	It is Serious Threat for snake, rodent, forest animals, lizard and other crawling insects.		
		Any other observations	Nil		
		Preventive Action suggested to customer	Compound wall should be required		
		Curative action from	We are instructed to Technician for Regular Monitoring.		
3

**Note: compound wall required**

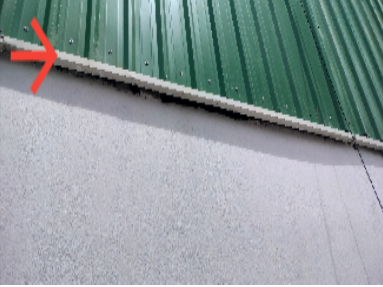
Location	Chemical Room Out side area		
		Cleaning / sanitation & Housekeeping Issues	Nil		
		Structural Issue (Pest harbourages)	We observed the gaps between the wall to sheet		
		Access Issues	Nil		
		Description of Pest Infestation	It is Serious Threat for Ants, lizards flying insects, beetles and other crawling insects will be hide in this place.		
		Any other observations	Nil

Preventive Action suggested to customer	Gap should be closed with cement		
		Curative action from	We are instructed to Technician for Regular Monitoring.		
4	 	Location	Ammonia plant office out side.		
		Cleaning / sanitation & Housekeeping Issues	Nil		
		Structural Issue (Pest harbourages)	AC pipe hole not closed properly		
		Access Issues	Nil		
		Description of Pest Infestation	It is Serious Threat for Ants, lizards flying insects and crawling insects.		
		Any other observations	Nil		
		Preventive Action suggested to customer	Ac pipe hole should be closed with cement.		
		Curative action from	We are instructed to Technician for Regular Monitoring.		
5

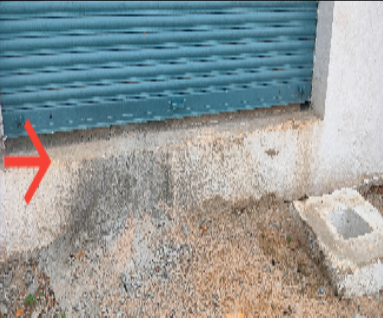
Location	Power panel shutter area.		
		Cleaning / sanitation & Housekeeping Issues	Nil		
		Structural Issue (Pest harbourages)	Gaps Observed between shutter and floor		
		Access Issues	Nil		
		Description of Pest Infestation	It is Serious Threat for Ants, lizards, rodent, snake flying insects and other crawling insects

Any other observations	Shutter centre also Holes observed		
		Preventive Action suggested to customer	Bottom of shutter should be placed rubber beading and shutter holes should be closed with mesh or SS metal sheet		
		Curative action from	We are instructed to Technician for Regular Monitoring.

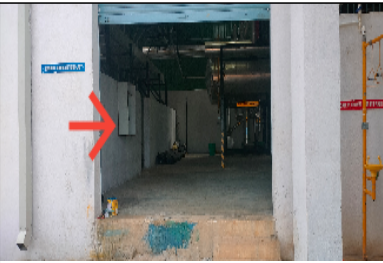
Location	Ammonia plant shutter area		
		Cleaning / sanitation & Housekeeping Issues	Nil		
		Structural Issue (Pest harbourages)	Ammonia plant shutter was opened.		
		Access Issues	Nil		
		Description of Pest Infestation	It is Serious Threat for Beetles, flying insects, lizards, snake, rodent and other crawling insects		
		Any other observations	Nil		
		Preventive Action suggested to customer	It should be closed always.		
		Curative action from	We are instructed to Technician for Regular Monitoring.		
7

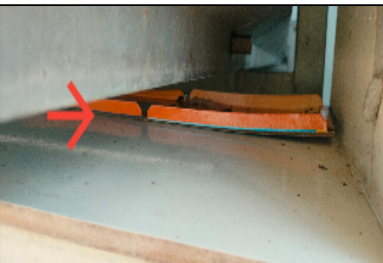
Location	Fruit feeding conveyor line area		
		Cleaning / sanitation & Housekeeping Issues	Nil		
		Structural Issue (Pest harbourages)	Fruit feeding conveyor belt under We observed gaps.		
		Access Issues	Nil		
		Description of Pest Infestation	It is Serious Threat for Ants, lizards, flying insects and other crawling insects.		
		Any other observations	Nil		
		Preventive Action suggested to customer	Gap should be closed with cement or metal sheet

Curative action from	We are instructed to Technician for Regular Monitoring.
