Facility Name & Address: SAROJ AGRO INDUSTRIES , Tumkur	Audited On: 15-05-2023
Audited By: SURESH KUMAR.V	
Client Contact Person Name: Mr. Naveen Kumar	PC Experts Contact Person Name: SURESH KUMAR.V
Client Contact Person No: 9164761942	PC Experts Contact Person No: 9087200011

FACILITY SURROUNDING

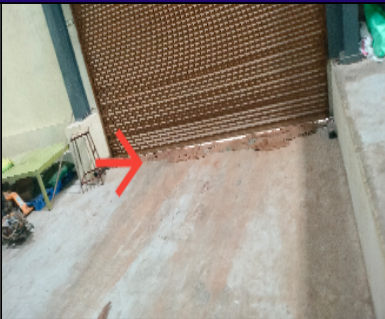
Location	Waste material dumping area	
		Cleaning / sanitation & Housekeeping Issues	Nil	
		Structural Issue (Pest harbourages)	Bottom of shutter gaps observed	
		Access Issues	Nil	
		Description of Pest Infestation	It is Serious Threat for Ants, beetles, cockroach, lizards, rodents, snakes, flying insects and other crawling insects.	
		Any other observations	Nil	
		Preventive Action suggested to customer	Shutter bottom gaps should be closed with rubber breading without any gaps.	
		Curative action from	We are instructed to Technician for Regular Monitoring.	
2

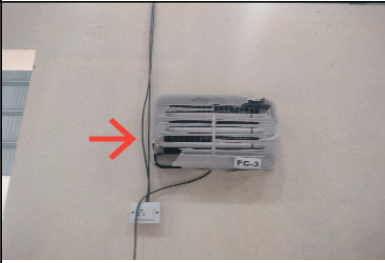
Location	Idli batter Area	
		Cleaning / sanitation & Housekeeping Issues	Nil	
		Structural Issue (Pest harbourages)	Nil	
		Access Issues	Fly catcher machine fasia was damaged	
		Description of Pest Infestation	It is Serious Threat for Ants, beetles, flying insects, lizard	
		Any other observations	Nil

Preventive Action suggested to customer	Fasia should be replaced	
		Curative action from	We are instructed to Technician for Regular Monitoring.
