PEST CONTROL EXPERTS

Facility Name & Address: SAROJ AGRO INDUSTRIES , Tumkur	Audited On: 26-08-2023
Audited By: SURESH KUMAR.V	
Client Contact Person Name: Mr. Naveen Kumar	PC Experts Contact Person Name: SURESH KUMAR.V
Client Contact Person No: 9164761942	PC Experts Contact Person No: 9087200011

FACILITY SURROUNDING

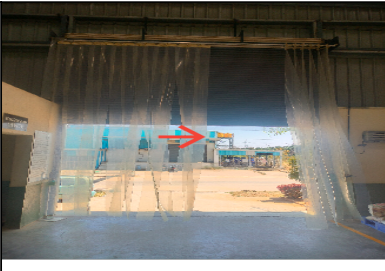
Location	Dispatch area		
		Cleaning / sanitation & Housekeeping Issues	PVC strips damaged condition		
		Structural Issue (Pest harbourages)	Nil		
		Access Issues	Nil		
		Description of Pest Infestation	It is Serious Threat for Beetles, lizard Ants, flying insects and other crawling insects		
		Any other observations	Nil		
		Preventive Action suggested to customer	Damaged PVC strips should be replaced		
		Curative action from	We are instructed to Technician for Regular Monitoring.		
4

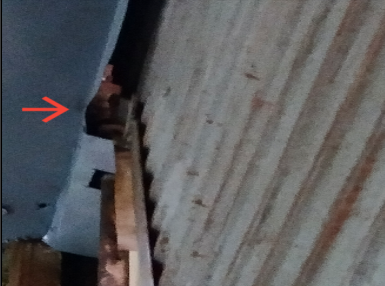
Location	Shutter area		
		Cleaning / sanitation & Housekeeping Issues	Nil		
		Structural Issue (Pest harbourages)	Top of the shutter gap should be closed		
		Access Issues	Nil		
		Description of Pest Infestation	It is Serious Threat for Ants, beetles, lizard flying insects and other crawling insects		
		Any other observations	Nil		
		Preventive Action suggested to customer	Gap should be closed with rubber breading or silicone sealant

Curative action from	We are instructed to Technician for Regular Monitoring.		
5

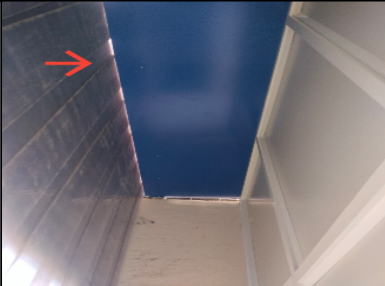
Location	Factory main entry area		
		Cleaning / sanitation & Housekeeping Issues	Nil		
		Structural Issue (Pest harbourages)	Top side of the entrance area sheet gaps observed		
		Access Issues	Nil		
		Description of Pest Infestation	It is Serious Threat for Beetles, Ants, lizard,flying insects and other crawling insects		
		Any other observations	Nil		
		Preventive Action suggested to customer	Gap should be closed with rubber breading or silicone sealant		
		Curative action from	We are instructed to Technician for Regular Monitoring.		
6

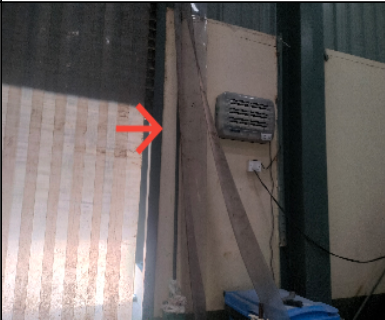
Location	Idli batter Area		
		Cleaning / sanitation & Housekeeping Issues	Nil		
		Structural Issue (Pest harbourages)	Some PVC strips was kept near the wall.fly catcher machine not worked		
		Access Issues	Nil		
		Description of Pest Infestation	It is Serious Threat for Ants, beetles, flying insects lizards and other crawling insects

Any other observations	Nil		
		Preventive Action suggested to customer	Fly catcher machine should be work on daily. Don't allow the pvc strips near the wall side		
		Curative action from	We are instructed to Technician for Regular Monitoring.

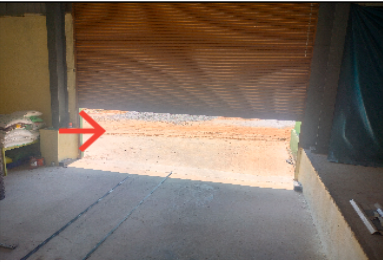
Location	Waste material dumping yard		
		Cleaning / sanitation & Housekeeping Issues	Nil		
		Structural Issue (Pest harbourages)	Shutter not closed properly		
		Access Issues	Nil		
		Description of Pest Infestation	It is Serious Threat for Beetles, cockroach rodent lizard spider flying insects snake and other crawling insects		
		Any other observations	Nil		
		Preventive Action suggested to customer	Shutter should be closed condition		
		Curative action from	We are instructed to Technician for Regular Monitoring.		
8

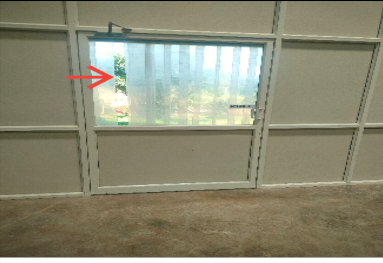
Location	Factory main entry area		
		Cleaning / sanitation & Housekeeping Issues	Nil		
		Structural Issue (Pest harbourages)	Main entrance door gaps observed		
		Access Issues	Nil		
		Description of Pest Infestation	It is Serious Threat for Ants, beetles, lizard.flying insects and other crawling insects		
		Any other observations	Nil		
		Preventive Action suggested to customer	Frame to door gap should be placed in the

Curative action from	We are instructed to Technician for Regular Monitoring.		
9

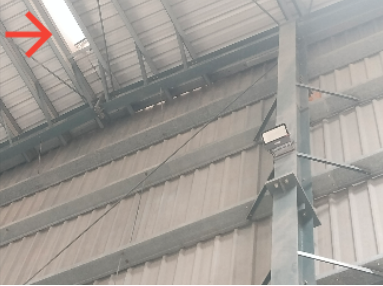
Location	Roof sheet area		
		Cleaning / sanitation & Housekeeping Issues	Nil		
		Structural Issue (Pest harbourages)	Exhaust purpose or ventilation purpose roof sheet gaps observed.		
		Access Issues	Nil		
		Description of Pest Infestation	It is Serious Threat for Beetles, flying insects lizards and other crawling insects		
		Any other observations	Nil		
		Preventive Action suggested to customer	Mesh should be placed in that particular area		
		Curative action from	We are instructed to Technician for Regular Monitoring.		
10

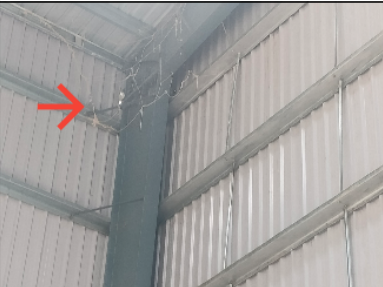
Location	Main building inside		
		Cleaning / sanitation & Housekeeping Issues	Nil		
		Structural Issue (Pest harbourages)	Wall sheet holes observed		
		Access Issues	Nil		
		Description of Pest Infestation	It is Serious Threat for Beetles, spider flying insects lizards and other crawling insects

Any other observations	Nil		
		Preventive Action suggested to customer	Hole should be closed with silicone sealant or foming sealant		
		Curative action from	We are instructed to Technician for Regular Monitoring.

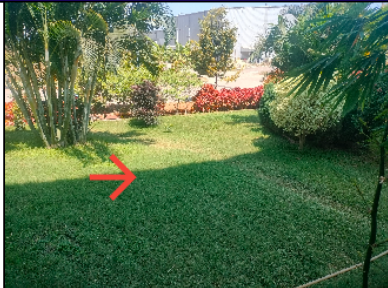
Location	MAIN BUILDING OUTER AREA		
		Cleaning / sanitation & Housekeeping Issues	Thick vegetation observed		
		Structural Issue (Pest harbourages)	Nil		
		Access Issues	Nil		
		Description of Pest Infestation	It is Serious Threat for Beetles, Ants, cockroach, lizards, snakes, rodents, flying insects and other crawling insects		
		Any other observations	Nil		
		Preventive Action suggested to customer	Thick vegetation should be clean on regular basis		
		Curative action from	We are instructed to Technician for Regular Monitoring.		
2

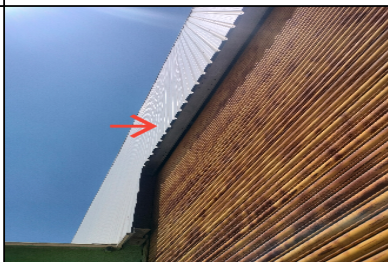
Location	Main building back side shutter area		
		Cleaning / sanitation & Housekeeping Issues	Nil		
		Structural Issue (Pest harbourages)	Gaps Observed between the Shutter Frame and Shutter		
		Access Issues	Nil		
		Description of Pest Infestation	It is Serious Threat for Beetles, Ants, flying insects lizards and other crawling insects

Any other observations	Nil		
		Preventive Action suggested to customer	Shutter gaps should be closed with rubber breading		
		Curative action from	We are instructed to Technician for Regular Monitoring.		
3

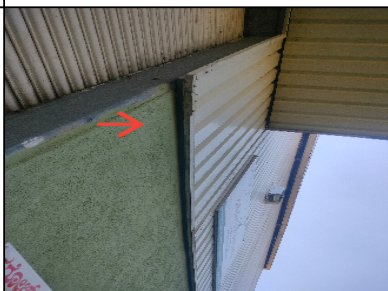
Location	MAIN BUILDING OUTER AREA		
		Cleaning / sanitation & Housekeeping Issues	Nil		
		Structural Issue (Pest harbourages)	Wall to wall sheet gaps observed		
		Access Issues	Nil		
		Description of Pest Infestation	It is Serious Threat for Ants, beetles, spider, lizard, flying insects and other crawling insects		
		Any other observations	Nil		
		Preventive Action suggested to customer	Gap should be closed with cement concrete or forming sealant		
		Curative action from	We are instructed to Technician for Regular Monitoring.		
Note: compound wall required
