Facility Name & Address: Frozen Tropical Pvt Ltd , Chittoor	Audited On: 11-09-2023
Audited By: SURESH KUMAR.V	
Client Contact Person Name: Mr. Surendra	PC Experts Contact Person Name: SURESH KUMAR.V
Client Contact Person No: 7702187499	PC Experts Contact Person No: 9087200011

FACILITY SURROUNDING

Internal Premises			REVIEW DATE	COMPLETION DATE
1

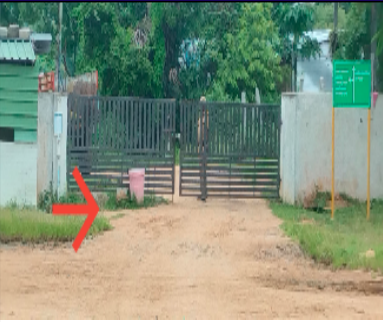
Location	Factory back side gate		
		Cleaning / sanitation & Housekeeping Issues	Nil		
		Structural Issue (Pest harbourages)	Lot of gaps observed in back side of the gate		
		Access Issues	Nil		
		Description of Pest Infestation	It is Serious Threat for snakes, Rodent, lizards ants, flying insects, dogs and other crawling insects		
		Any other observations	Middle of the gate also gaps observed.		
		Preventive Action suggested to customer	Bottom of gate should be closed with cement concrete, middle of the gate upto 2 feet mesh to be placed without any gaps.		
		Curative action from	We are instructed to Technician for Regular Monitoring.		
2

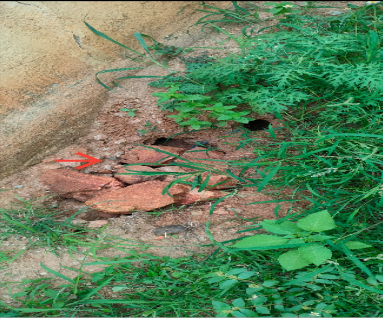
Location	In side of the compound wall		
		Cleaning / sanitation & Housekeeping Issues	Lot of thick vegetation observed		
		Structural Issue (Pest harbourages)	Rain water running purpose holes observed compound wall inside

Access Issues	Nil		
		Description of Pest Infestation	It is Serious Threat for snake, rodents, lizards, frog and other crawling insects		
		Any other observations	Nil		
		Preventive Action suggested to customer	Compound wall surrounding in and out 1 feet level cement concrete required.		
		Curative action from	We are instructed to Technician for Regular Monitoring.		
3

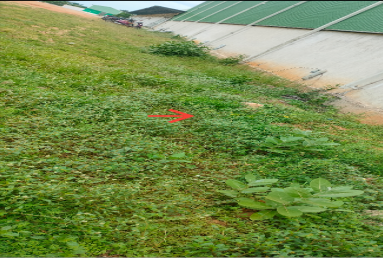
Location	Main building out side		
		Cleaning / sanitation & Housekeeping Issues	Thick vegetation observed.		
		Structural Issue (Pest harbourages)	Nil		
		Access Issues	Nil		
		Description of Pest Infestation	It is Serious Threat for Ants, snakes, rodents, lizards, frog and other crawling insects.		
		Any other observations	Nil		
		Preventive Action suggested to customer	Thick vegetation should be clean on regular basis.		
		Curative action from	We are instructed to Technician for Regular Monitoring.

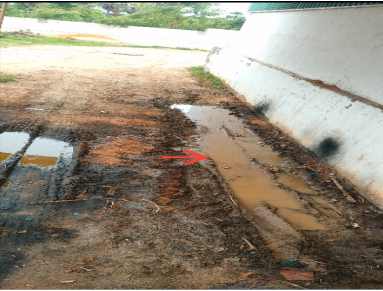
Location	Ripening Chambers out side area		
		Cleaning / sanitation & Housekeeping Issues	Waste water stagnated		
		Structural Issue (Pest harbourages)	Nil		
		Access Issues	Nil		
		Description of Pest Infestation	It is Serious Threat for Mosquitoes, Ants, flying insects, rodent, frog and other crawling insects

Any other observations	Nil		
		Preventive Action suggested to customer	Don't allow the water stagnated inside of the factory premises		
		Curative action from	We are instructed to Technician for Regular Monitoring.		
6

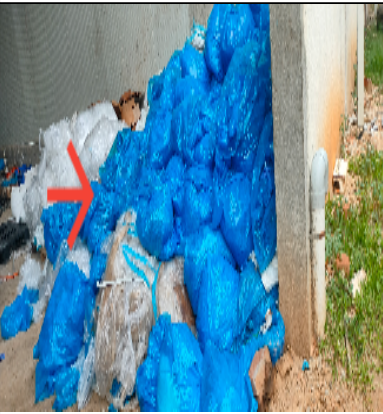
Location	Waste material or used material dumping yard.		
		Cleaning / sanitation & Housekeeping Issues	Waste Dumped inside of the facility.		
		Structural Issue (Pest harbourages)	In this area was opened condition.		
		Access Issues	Inside of the dumping yard no gaps from Wall to materials.		
		Description of Pest Infestation	It is Serious Threat for Flying insects, rodents, snakes, lizards, Ants and other crawling insects.		
		Any other observations	Nil		
		Preventive Action suggested to customer	Don't allow the waste materials should be clean on regular basis. In this area entrance shutter required. Don't store the materials near by Wall, gap required atleast 1&1/2 feet distance required from Wall to materials.

Curative action from	We are instructed to Technician for Regular Monitoring.

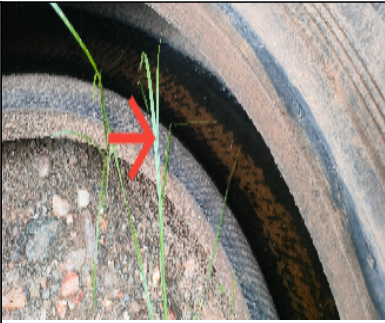
Location	Used material storage area.		
		Cleaning / sanitation & Housekeeping Issues	Tyre was kept near by storage area outside, in this tyre inside water stagnated.		
		Structural Issue (Pest harbourages)	Nil		
		Access Issues	Nil		
		Description of Pest Infestation	It is Serious Threat for Mosquitoes, snakes and other crawling insects		
		Any other observations	Nil		
		Preventive Action suggested to customer	Don't allow the water stagnated inside of the facility. Don't allow the tyres this type of storage.		
		Curative action from	We are instructed to Technician for Regular Monitoring.		
8

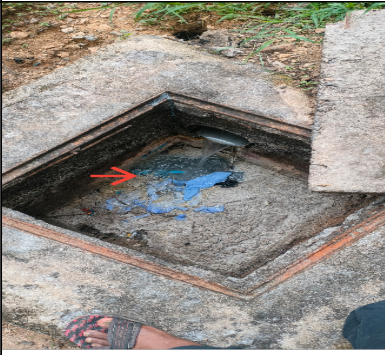
Location	Dispatch area.		
		Cleaning / sanitation & Housekeeping Issues	Drainage manhole not cleaned properly and manhole lid not closed.		
		Structural Issue (Pest harbourages)	Nil		
		Access Issues	Nil		
		Description of Pest Infestation	It is Serious Threat for Ants, flying insects, rodents, snakes, cockroaches, and other crawling insects.

Any other observations	In this area drainage water over flow and stagnated.		
		Preventive Action suggested to customer	Manhole lid should be placed. Manhole cleaning required on regular basis. Manhole surrounding don't allow the water stagnated.		
		Curative action from	We are instructed to Technician for Regular Monitoring.		
9

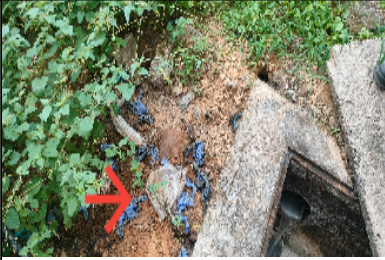
Location	Dispatch area.		
		Cleaning / sanitation & Housekeeping Issues	Manhole surrounding lot of waste clothes observed.		
		Structural Issue (Pest harbourages)	Nil		
		Access Issues	Nil		
		Description of Pest Infestation	It is Serious Threat for Ants, cockroachs, flying insects and other crawling insects.		
		Any other observations	In this area rodent Burrows observed.		
		Preventive Action suggested to customer	Don't allow the waste materials near by building.		
		Curative action from	We are instructed to Technician for Regular Monitoring.

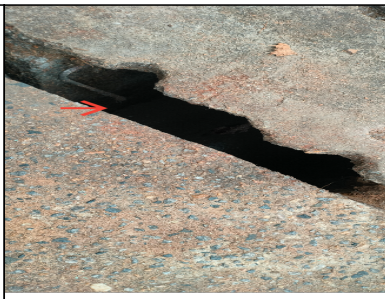
Location	RIPENING CHAMBERS AREA		
		Cleaning / sanitation & Housekeeping Issues	Drainage line was blocked.		
		Structural Issue (Pest harbourages)	Nil		
		Access Issues	Nil		
		Description of Pest Infestation	It is Serious Threat for Cockroaches, mosquitoes, flying insects, lizard, rodents, snake and other crawling insects.		
		Any other observations	Nil		
		Preventive Action suggested to customer	Don't allow the water stagnated in drainages.		
		Curative action from	We are instructed to Technician for Regular Monitoring.		
11

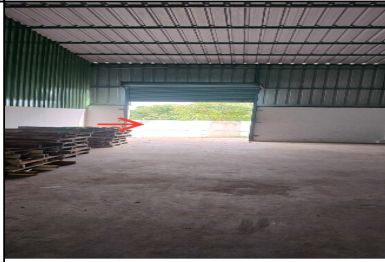
Location	Waste outlet conveyor near (main building).		
		Cleaning / sanitation & Housekeeping Issues	Nil		
		Structural Issue (Pest harbourages)	Gap observed between the wall to sheet.		
		Access Issues	Nil		
		Description of Pest Infestation	It is Serious Threat for lizards, spider, Ants, flying insects and other crawling insects.		
		Any other observations	Nil		
		Preventive Action suggested to customer	Gap should be closed with cement

Curative action from	We are instructed to Technician for Regular Monitoring.		
12

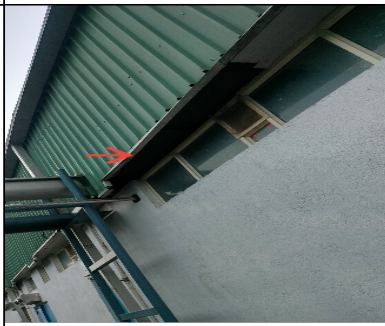
Location	Main building out side area		
		Cleaning / sanitation & Housekeeping Issues	Nil		
		Structural Issue (Pest harbourages)	Wall to sheet between gaps observed and window mesh not fixed properly.		
		Access Issues	Nil		
		Description of Pest Infestation	It is Serious Threat for Ants, lizards, flying insects and other crawling insects.		
		Any other observations	Nil		
		Preventive Action suggested to customer	Gap should be closed with cement. Mesh to be placed properly without any gaps.		
		Curative action from	We are instructed to Technician for Regular Monitoring.		
13

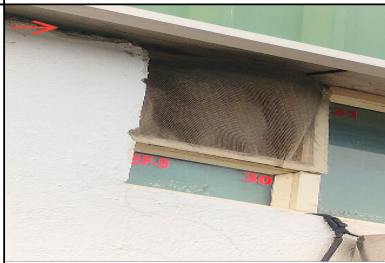
Location	MAIN BUILDING OUTER AREA		
		Cleaning / sanitation & Housekeeping Issues	Nil		
		Structural Issue (Pest harbourages)	Pvc mesh was not closed properly.		
		Access Issues	Nil		
		Description of Pest Infestation	It is Serious Threat for Ants, lizards, flying insects and other crawling insects.

Any other observations	Nil		
		Preventive Action suggested to customer	All Mesh to be fix properly without any gaps.		
		Curative action from	We are instructed to Technician for Regular Monitoring.		
Note: facility Surrounding farmers land observed.
