PEST CONTROL EXPERTS

Facility Name & Address: Frozen Tropical Foods pvt Ltd , Chittoor	Audited On: 29-11-2024
Audited By: SURESH KUMAR.V	
Client Contact Person Name: Mr. Surendra QH	PC Experts Contact Person Name: SURESH KUMAR.V
Client Contact Person No: 7702187499	PC Experts Contact Person No: 8248672110

External Premises			REVIEW DATE	COMPLETION DATE

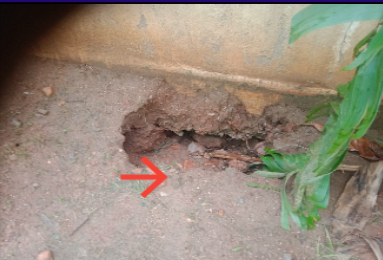
1

Location	Compound wall inside		
	Cleaning / sanitation & Housekeeping Issues	Nil		
	Structural Issue (Pest harbourages)	Rodent and rain water Holes observed		
	Access Issues	Nil		
	Description of Pest Infestation	It is Serious Threat for rodents, snake, other crawling insects		
	Any other observations	Nil		
	Preventive Action suggested to customer	Hole should be closed with cement concrete		
	Curative action from	We are instructed to Technician for Regular Monitoring.

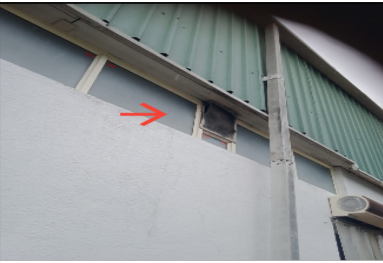
Location	Compound wall inside		
		Cleaning / sanitation & Housekeeping Issues	Nil		
		Structural Issue (Pest harbourages)	Rain water Holes observed		
		Access Issues	Nil		
		Description of Pest Infestation	It is Serious Threat for rodents and snacks		
		Any other observations	Nil		
		Preventive Action suggested to customer	Holes should be closed with cement concrete		
		Curative action from	We are instructed to Technician for Regular Monitoring.		
2

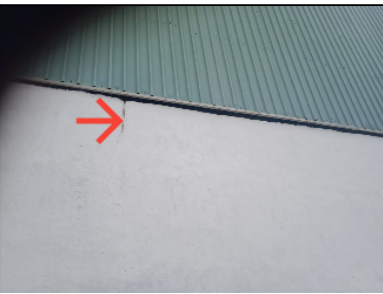
Location	Main building out side		
		Cleaning / sanitation & Housekeeping Issues	Nil		
		Structural Issue (Pest harbourages)	Mesh was not closed properly, gap observed		
		Access Issues	Nil		
		Description of Pest Infestation	It is Serious Threat for Ants, flying insects, lizard and other crawling insects		
		Any other observations	Nil		
		Preventive Action suggested to customer	Mesh should be placed properly without any gaps		
3

Curative action from	We are instructed to Technician for Regular Monitoring.

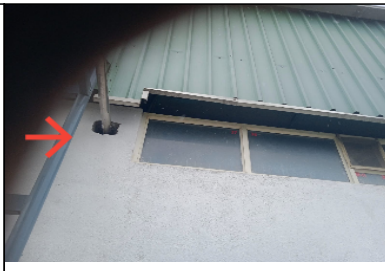
4

Location	Main building out side		
		Cleaning / sanitation & Housekeeping Issues	Nil		
		Structural Issue (Pest harbourages)	Wall and Wall sheet gaps observed		
		Access Issues	Nil		
		Description of Pest Infestation	It is Serious Threat for Ants, lizards, flying insects and other crawling insects		
		Any other observations	Nil		
		Preventive Action suggested to customer	Gap should be closed with cement or metal sheet without any gaps		
		Curative action from	We are instructed to Technician for Regular Monitoring.

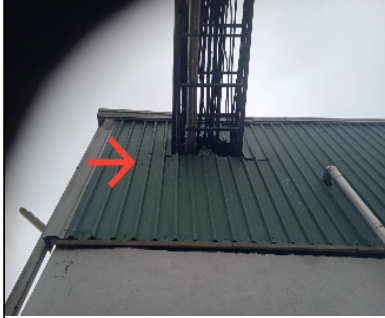
Location	Main building out side		
		Cleaning / sanitation & Housekeeping Issues	Nil		
		Structural Issue (Pest harbourages)	Hole observed on the wall		
		Access Issues	Nil		
		Description of Pest Infestation	It is Serious Threat for Ants, beetle, lizard, flying insects and other crawling insects		
		Any other observations	Nil		
		Preventive Action suggested to customer	Hole should be closed with cement without any gaps		
		Curative action from	We are instructed to Technician for Regular Monitoring.		
5

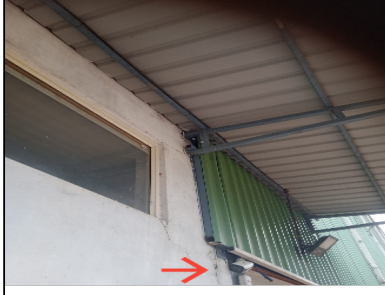
Location	Main building out side		
		Cleaning / sanitation & Housekeeping Issues	Nil		
		Structural Issue (Pest harbourages)	EB cable going trench area We observed gaps between the wall to wall sheet		
		Access Issues	Nil		
		Description of Pest Infestation	It is Serious Threat for Beetles, lizards, flying insects and other crawling insects		
		Any other observations	Nil		
		Preventive Action suggested to customer	Gap should be closed with silicone or rubber or foam without any gaps

Curative action from	We are instructed to Technician for Regular Monitoring.		
6
