Facility Name & Address: CG Foods India Pvt Ltd , Chittoor	Audited On: 28-09-2023
Audited By: SURESH KUMAR.V	
Client Contact Person Name: Mr.Nirjan	PC Experts Contact Person Name: SURESH KUMAR.V
Client Contact Person No: 9502481441	PC Experts Contact Person No: 9087200011

FACILITY SURROUNDING

External Premises				REVIEW DATE	COMPLETION DATE
1

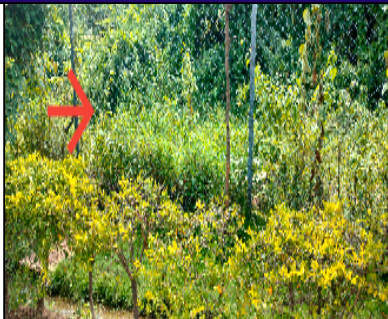
facility Surrounding lot of thick vegetation observed.

Location	Fencing area		
		Cleaning / sanitation & Housekeeping Issues	Lot of thick vegetation observed.		
		Structural Issue (Pest harbourages)	No compound wall		
		Access Issues	Nil		
		Description of Pest Infestation	It is Serious Threat for snakes, Rodents, lizards, monkeys, spiders, Ants flying insects and other crawling insects.		
		Any other observations	Nil		
		Preventive Action suggested to customer	Facility Surrounding compound wall required. Thick vegetation should be clean on regular basis.		
		Curative action from	We are instructed to Technician for Regular Monitoring.		
2

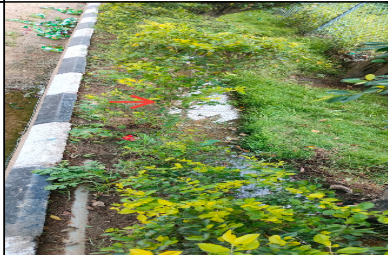
Location	Fencing area		
		Cleaning / sanitation & Housekeeping Issues	Lot of water stagnated		
		Structural Issue (Pest harbourages)	Nil		
		Access Issues	Nil		
		Description of Pest Infestation	It is Serious Threat for mosquitoes, beetles, Ants, flying insects and other crawling insects.

Any other observations	Nil		
		Preventive Action suggested to customer	Don't allow the water stagnated facility Surrounding.		
		Curative action from	We are instructed to Technician for Regular Monitoring.

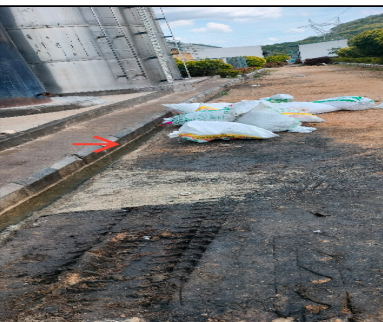
Location	Main building back side area		
		Cleaning / sanitation & Housekeeping Issues	Waste Dumped near by facility Surrounding		
		Structural Issue (Pest harbourages)	Nil		
		Access Issues	Nil		
		Description of Pest Infestation	It is Serious Threat for Ants, cockroach, rodent, lizard, monkeys, flying insects and other crawling insects.

Any other observations	Nil		
		Preventive Action suggested to customer	Don't allow the waste materials near by facility Surrounding. Waste material dumping purpose Separate area to be allotted.		
		Curative action from	We are instructed to Technician for Regular Monitoring.

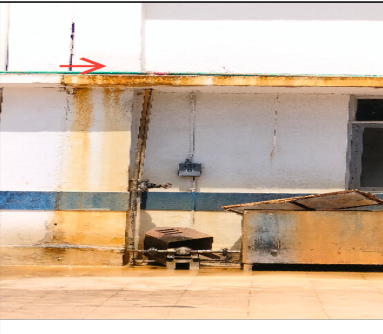
Location	Main building back side.		
		Cleaning / sanitation & Housekeeping Issues	Lot of hot water stagnated.		
		Structural Issue (Pest harbourages)	Hot water pipe line was damaged, so that hot water fall down.		
		Access Issues	Nil		
		Description of Pest Infestation	It is Serious Threat for Beetles, flying insects and other crawling insects.		
		Any other observations	Nil		
		Preventive Action suggested to customer	Pipe should be replaced. Pipe should be replaced. Don't allow the fall down the hot water.		
		Curative action from	We are instructed to Technician for Regular Monitoring.		
8

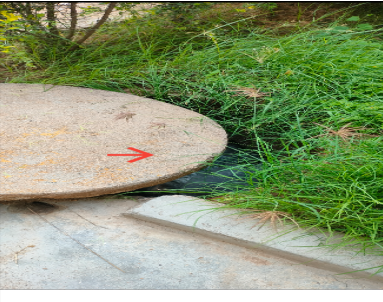
Location	Hygiene entrance area		
		Cleaning / sanitation & Housekeeping Issues	Manhole not cleaned properly.		
		Structural Issue (Pest harbourages)	Manhole was opened condition.		
		Access Issues	Nil		
		Description of Pest Infestation	It is Serious Threat for Cockroaches, mosquitoes, flying insects, Ants, and other crawling insects.

Any other observations	Nil		
		Preventive Action suggested to customer	Manhole should be closed with manhole lid without any gaps.		
		Curative action from	We are instructed to Technician for Regular Monitoring.		
9

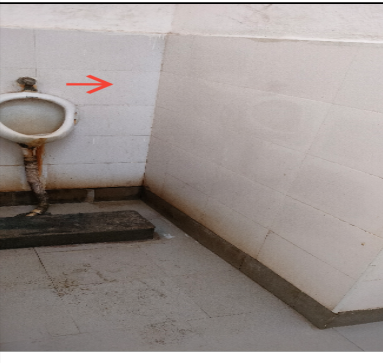
Location	Hygiene entrance toilet area.		
		Cleaning / sanitation & Housekeeping Issues	Not cleaned regularly. It's worst condition.		
		Structural Issue (Pest harbourages)	Toilet exhaust gaps observed. Toilet doors not closed properly and gaps observed.		
		Access Issues	Nil		
		Description of Pest Infestation	It is Serious Threat for Cockroaches, bacteria, fungal, lizard, flying insects and other crawling insects.		
		Any other observations	Nil		
		Preventive Action suggested to customer	All toilet area must be clean on regular basis. Doors also should be closed. All gaps should be closed with rubber breading, cement and mesh.		
		Curative action from	We are instructed to Technician for Regular Monitoring.

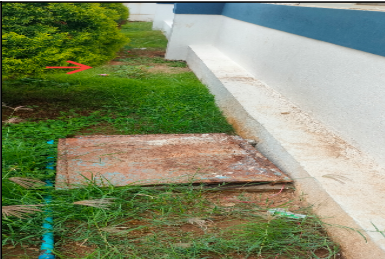
Location	Main building outer surface		
		Cleaning / sanitation & Housekeeping Issues	Lot of thick vegetation observed		
		Structural Issue (Pest harbourages)	Nil		
		Access Issues	We can't able to monitoring the boxes.		
		Description of Pest Infestation	It is Serious Threat for Beetles, snakes, rodents, lizards, Ants, frog and other crawling insects		
		Any other observations	Nil		
		Preventive Action suggested to customer	Thick vegetation should be clean on regular basis.		
		Curative action from	We are instructed to Technician for Regular Monitoring.		
11

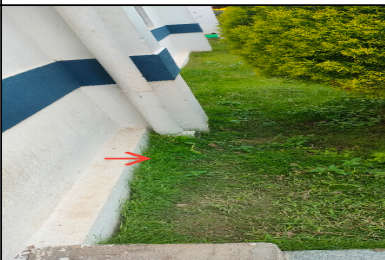
Location	Main building surrounding area		
		Cleaning / sanitation & Housekeeping Issues	Lot of thick vegetation observed		
		Structural Issue (Pest harbourages)	Nil		
		Access Issues	Nil		
		Description of Pest Infestation	It is Serious Threat for Beetles, Ants, cockroach, snakes, rodents, lizards and other crawling insects.		
		Any other observations	Nil

Preventive Action suggested to customer	Thick vegetation should be clean on regular basis.		
12

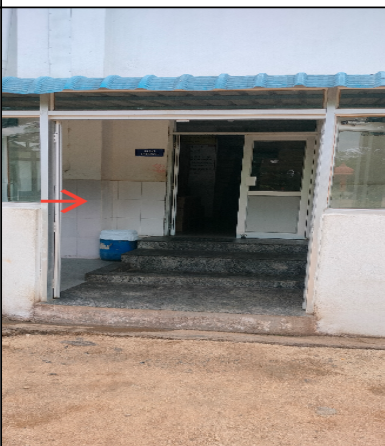
Location	Hygiene entrance area		
		Cleaning / sanitation & Housekeeping Issues	Floor not cleaned properly		
		Structural Issue (Pest harbourages)	Hygiene entrance doors always opend condition. Not closed properly.		
		Access Issues	Nil		
		Description of Pest Infestation	It is Serious Threat for Ants, cockroach, flying insects, rodents, snakes, lizards and other crawling insects.		
		Any other observations	Doors frame to doors gaps observed. Toilet exhaust fan mesh not fixed properly.in this area gaps observed between the wall to Wall Sheet and Wall Sheet to roof sheet.		
		Preventive Action suggested to customer	Floor should be clean on regular basis. All gaps should be closed with cement or rubber breading or Mesh without any gaps.		
		Curative action from	We are instructed to Technician for Regular Monitoring.

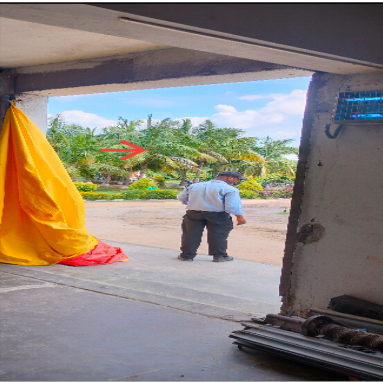
Location	RM area		
		Cleaning / sanitation & Housekeeping Issues	Nil		
		Structural Issue (Pest harbourages)	RM area shutter was damaged condition		
		Access Issues	Nil		
		Description of Pest Infestation	It is Serious Threat for Beetles, lizard, spiders, rodents, Ants, snakes, dogs, frogg, flying insects and other crawling insects.		
		Any other observations	2nd shutter also gaps observed between the shutter to shutter frame		
		Preventive Action suggested to customer	Shutter should be placed without any gaps. Bottom of shutter should be placed rubber beading without any gaps.		
		Curative action from	We are instructed to Technician for Regular Monitoring.		
14

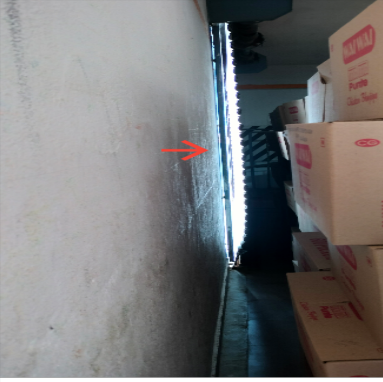
Location	FG area		
		Cleaning / sanitation & Housekeeping Issues	Nil		
		Structural Issue (Pest harbourages)	FG area shutter was damaged condition, lot of gaps observed and shutter was opened condition.		
		Access Issues	In FG area all FG material kept at wall side without any gaps.

Description of Pest Infestation	It is Serious Threat for Ants, cockroach, lizard, rodent, snake, flying insects and other crawling insects.		
		Any other observations	In side of FG area all materials kept at wall side without gaps.		
		Preventive Action suggested to customer	Shutter should be replaced. Shutter gaps closed with rubber breading or mesh or cement without any gaps.		
		Curative action from	We are instructed to Technician for Regular Monitoring.		
15

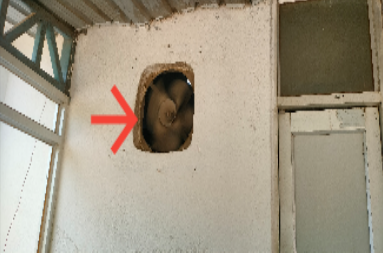
Location	Hygiene entrance toilet area.		
		Cleaning / sanitation & Housekeeping Issues	Toilets not cleaned properly		
		Structural Issue (Pest harbourages)	Mesh not fixed on Exhaust fan.		
		Access Issues	Nil		
		Description of Pest Infestation	It is Serious Threat for Cockroaches, Ants, beetles, lizard, flying insects and other crawling insects.		
		Any other observations	Nil		
		Preventive Action suggested to customer	Mesh to be placed without any gaps.

Curative action from	We are instructed to Technician for Regular Monitoring.

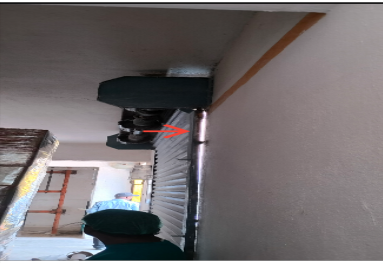
Location	RM shutter area		
		Cleaning / sanitation & Housekeeping Issues	Nil		
		Structural Issue (Pest harbourages)	Gaps observed between the Shutter frame to Wall		
		Access Issues	Nil		
		Description of Pest Infestation	It is Serious Threat for Beetles, Ants, cockroach, lizard, flying insects and other crawling insects.		
		Any other observations	Nil		
		Preventive Action suggested to customer	Gap should be closed with cement concrete		
		Curative action from	We are instructed to Technician for Regular Monitoring.		
17

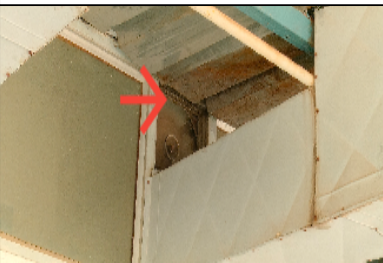
Location	Hygiene entrance area		
		Cleaning / sanitation & Housekeeping Issues	Nil		
		Structural Issue (Pest harbourages)	Wall sheet opened condition		
		Access Issues	Nil		
		Description of Pest Infestation	It is Serious Threat for Ants, beetles, flying insects, lizards and other crawling insects.		
		Any other observations	Nil		
		Preventive Action suggested to customer	Sheet to be placed without any gaps

Curative action from	We are instructed to Technician for Regular Monitoring.
