Facility Name & Address: INTERNATIONAL FLAVOURS AND FRAGRANCES PVT LTD,	Audited On: 06-12-2023
Reviewed By: MOHAMMED YOUNUS.A	
Client Contact Person Name: Mr.SIVA NAGA KUMAR	PC Experts Contact Person Name: MOHAMMED YOUNUS.A
Client Contact Person No: 7305428288	PC Experts Contact Person No: 9087200011

FACILITY SURROUNDING

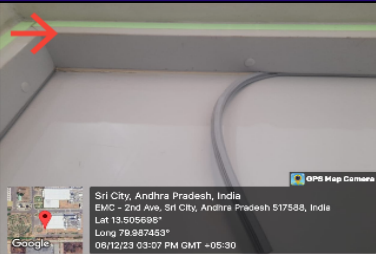
Location	FG OFFICE	05-01-2024	05-01-2024
		Cleaning / sanitation & Housekeeping Issues	Nil		
		Structural Issue (Pest harbourages)	Gaps Observed between Door and Door Frame		
		Access Issues	Nil		
		Description of Pest Infestation	It is Serious Threats for Flies, Lizards, Spiders, & Aphids.		
		Any other observations	Nil		
		Preventive Action suggested to customer	Gap closure will be placed between the Door and Frame.		
		Curative action from	We are instructed to Technician for Regular Monitoring.		
2

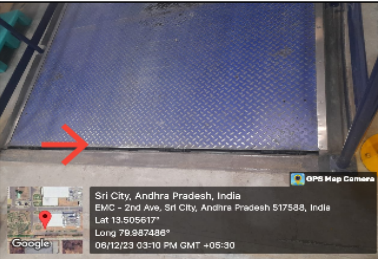
Location	FG OFFICE	05-01-2024	05-01-2024
		Cleaning / sanitation & Housekeeping Issues	Nil		
		Structural Issue (Pest harbourages)	Gaps Observed between the Shutter Frame and Shutter		
		Access Issues	Nil		
		Description of Pest Infestation	It is Serious Threat for Ants, Flies and Lizards.		
		Any other observations	Nil		
		Preventive Action suggested to customer	Side Shutter Gap will be closed with proper closure.

Curative action from	We are instructed to Technician for Regular Monitoring.

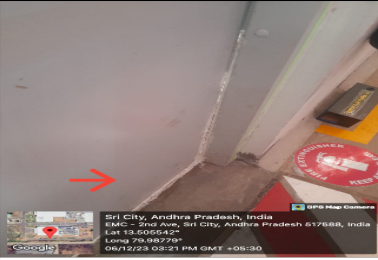
Location	FG OFFICE	05-01-2024	05-01-2024
		Cleaning / sanitation & Housekeeping Issues	Nil		
		Structural Issue (Pest harbourages)	All docks gap Noticed.		
		Access Issues	Nil		
		Description of Pest Infestation	It is Serious Threats for Flies and Lizards.		
		Any other observations	Nil		
		Preventive Action suggested to customer	Around the docks Gap will be closed with proper rubber beeding.		
4

Curative action from	We are instructed to Technician for Regular Monitoring.	05-01-2024	05-01-2024
		Location	RM OFFICE		
		Cleaning / sanitation & Housekeeping Issues	Nil		
		Structural Issue (Pest harbourages)	Gaps Observed between Door and Door Frame		
		Access Issues	Nil		
		Description of Pest Infestation	It is Serious Threats for Flies, Lizards, Spiders, & Crawling Insects.		
		Any other observations	Nil		
5

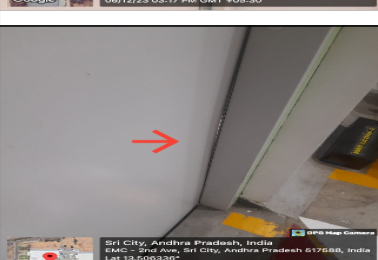
Curative action from	We are instructed to Technician for Regular Monitoring.		
		Location	RM Cold Room		
		Cleaning / sanitation & Housekeeping Issues	Nil		
		Structural Issue (Pest harbourages)	Gaps Observed Around the Pipe and Sheet.		
		Access Issues	Nil		
		Description of Pest Infestation	It is Serious Threats for Flies, Lizards, Spiders, & Aphids.		
6

Any other observations	Nil	05-01-2024	05-01-2024
		Preventive Action suggested to customer	Around the Pipeline Gap will be closed with cement mortar or Foam Sealant.		
		Curative action from	We are instructed to Technician for Regular Monitoring.		
		Location	RM COLD ROOM		
		Cleaning / sanitation & Housekeeping Issues	Nil		
		Structural Issue (Pest harbourages)	Gaps Observed between Door and Door Frame		
		Access Issues	Nil

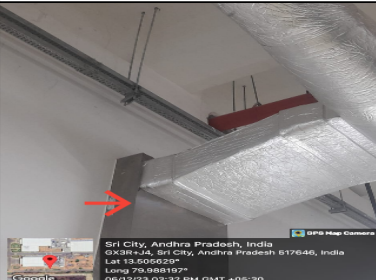
Location	FG Store	05-01-2024	05-01-2024
		Cleaning / sanitation & Housekeeping Issues	Nil		
		Structural Issue (Pest harbourages)	Gaps Observed between Door and Door Frame		
		Access Issues	Nil		
		Description of Pest Infestation	It is Serious Threats for Flies, Lizards, Spiders, & Crawling Insects.		
		Any other observations	Nil		
		Preventive Action suggested to customer	Gap closure will be placed between the Door and Frame.		
		Curative action from	We are instructed to Technician for Regular Monitoring.		
8

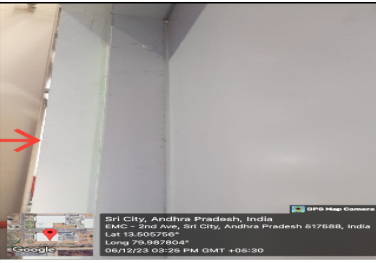
Location	PRODUCTION AREA	05-01-2024	05-01-2024
		Cleaning / sanitation & Housekeeping Issues	Nil		
		Structural Issue (Pest harbourages)	Gaps Observed Around the Pipe and Wall		
		Access Issues	Nil		
		Description of Pest Infestation	It is Serious Threats for Flies, Lizards, Spiders, & Crawling Insects.		
		Any other observations	Nil		
		Preventive Action suggested to customer	Around the Pipeline Gap will be closed with cement mortar or Foam Sealant.

Curative action from	We are instructed to Technician for Regular Monitoring.		
9

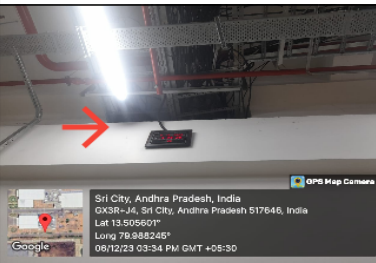
Location	Scrap Yard	05-01-2024	05-01-2024
		Cleaning / sanitation & Housekeeping Issues	Nil		
		Structural Issue (Pest harbourages)	Gaps Observed between Door Frame and Wall		
		Access Issues	Nil		
		Description of Pest Infestation	It is Serious Threats for Flies, Lizards, Spiders, & Crawling Insects.		
		Any other observations	Nil		
		Preventive Action suggested to customer	Gap closure will be placed between the Door and wall.		
		Curative action from	We are instructed to Technician for Regular Monitoring.		
10

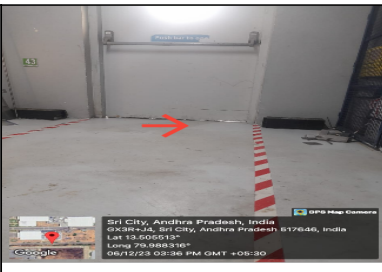
Location	PRODUCTION AREA	06-12-2023	05-01-2024
		Cleaning / sanitation & Housekeeping Issues	Nil		
		Structural Issue (Pest harbourages)	Gaps Observed between the Cable Trench and Wall		
		Access Issues	Nil		
		Description of Pest Infestation	It is Serious Threats for Rodents, Lizards &, Spiders.		
		Any other observations	Nil

Preventive Action suggested to customer	Around the Cable Tray Gap will be closed with cement mortar or Foam Sealant.		
		Curative action from	We are instructed to Technician for Regular Monitoring.

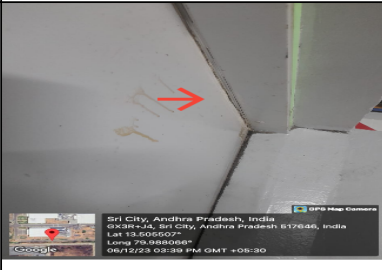
Location	PRODUCTION AREA	05-01-2024	05-01-2024
		Cleaning / sanitation & Housekeeping Issues	Nil		
		Structural Issue (Pest harbourages)	Gaps Observed Door Bottom.		
		Access Issues	Nil		
		Description of Pest Infestation	It is Serious Threats for Flies, Lizards, Spiders, & Crawling Insects.		
		Any other observations	Nil		
		Preventive Action suggested to customer	Gap closure will be placed between the Door and Floor.		
		Curative action from	We are instructed to Technician for Regular Monitoring.		
12

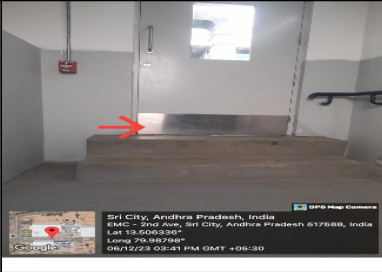
Location	PRODUCTION AREA	05-01-2024	05-01-2024
		Cleaning / sanitation & Housekeeping Issues	Nil		
		Structural Issue (Pest harbourages)	Gaps Observed between Door Frame and Wall		
		Access Issues	Nil		
		Description of Pest Infestation	It is Serious Threats for Flies, Lizards, Spiders, & Crawling Insects.		
		Any other observations	Nil		
		Preventive Action suggested to customer	Gap will be closed with Rubber Beeding.

Curative action from	We are instructed to Technician for Regular Monitoring.		
13

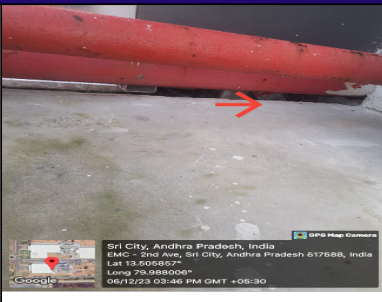
Location	STEPS AREA	05-01-2024	05-01-2024
		Cleaning / sanitation & Housekeeping Issues	Nil		
		Structural Issue (Pest harbourages)	Gaps Observed between Door Frame and Wall		
		Access Issues	Nil		
		Description of Pest Infestation	It is Serious Threats for Flies, Lizards, Spiders, & Crawling Insects.		
		Any other observations	Nil		
		Preventive Action suggested to customer	Gap closure will be placed between the Door and Frame.		
		Curative action from	We are instructed to Technician for Regular Monitoring.		
External Premises				REVIEW DATE	COMPLETION DATE
1

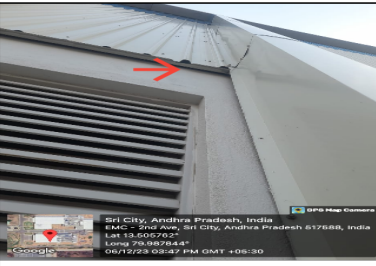
Location	Fire Pipeline	05-01-2024	05-01-2024
		Cleaning / sanitation & Housekeeping Issues	Nil		
		Structural Issue (Pest harbourages)	Gaps Observed Around the Fire Pipe Line.		
		Access Issues	Nil		
		Description of Pest Infestation	It is Serious Threats for Flies, Lizards, Spiders, & Crawling Insects.

Any other observations	Nil		
		Preventive Action suggested to customer	Around the Fire Pipeline Gap will be closed with cement mortar or Foam Sealant.		
		Curative action from	We are instructed to Technician for Regular Monitoring.

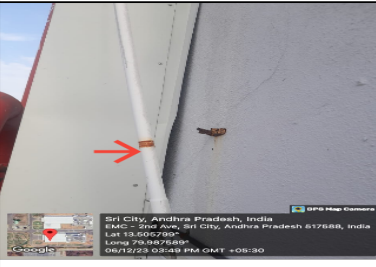
Location	Plant Outside	05-01-2024	05-01-2024
		Cleaning / sanitation & Housekeeping Issues	Nil		
		Structural Issue (Pest harbourages)	Gaps Observed between the side Sheet.		
		Access Issues	Nil		
		Description of Pest Infestation	It is Serious Threats for Flies, Lizards, Spiders, & Aphids.		
		Any other observations	Nil		
		Preventive Action suggested to customer	Roof Sheet gap will be closed Properly.		
		Curative action from	We are instructed to Technician for Regular Monitoring.		
3

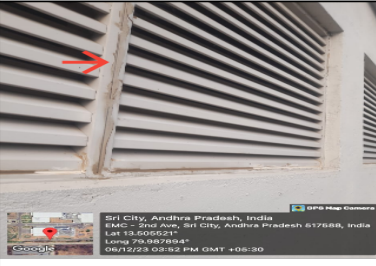
Location	Plant Outside	05-01-2024	05-01-2024
		Cleaning / sanitation & Housekeeping Issues	Nil		
		Structural Issue (Pest harbourages)	Gaps Observed between cable and AC Copper Wire		
		Access Issues	Nil		
		Description of Pest Infestation	It is Serious Threats for Flies, Lizards.		
		Any other observations	Nil		
		Preventive Action suggested to customer	Around the Pipeline Gap will be closed with cement mortar or Foam Sealant.

Curative action from	We are instructed to Technician for Regular Monitoring.		
4

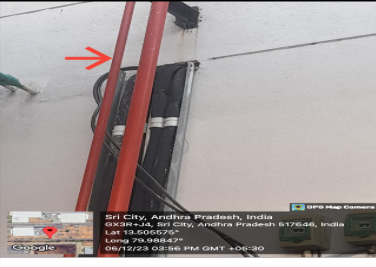
Location	Plant Outside	05-01-2024	05-01-2024
		Cleaning / sanitation & Housekeeping Issues	Nil		
		Structural Issue (Pest harbourages)	Mesh will be Placed Outside.		
		Access Issues	Nil		
		Description of Pest Infestation	It is Serious Threats for Flies, Lizards, Spiders, & Crawling Insects.		
		Any other observations	Nil		
		Preventive Action suggested to customer	Mesh will be placed.		
		Curative action from	We are instructed to Technician for Regular Monitoring.		
5

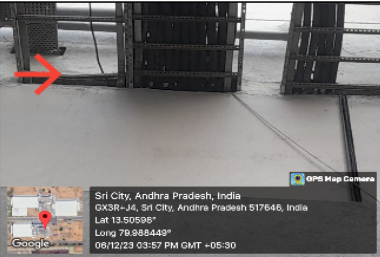
Location	MCC ROOM	05-01-2024	05-01-2024
		Cleaning / sanitation & Housekeeping Issues	Nil		
		Structural Issue (Pest harbourages)	Gaps Observed between the Pipe and Cable Line		
		Access Issues	Nil		
		Description of Pest Infestation	It is Serious Threats for Rodents, Lizards & Spiders.		
		Any other observations	Nil		
		Preventive Action suggested to customer	Around the Pipeline Gap will be closed with cement mortar or Foam Sealant.

Curative action from	We are instructed to Technician for Regular Monitoring.

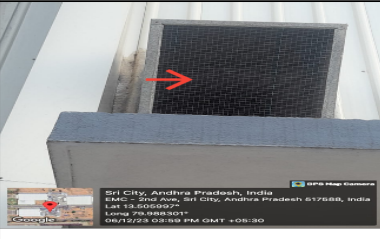
Location	MCC ROOM	05-01-2024	05-01-2024
		Cleaning / sanitation & Housekeeping Issues	Nil		
		Structural Issue (Pest harbourages)	Gaps Observed between the Cable Trench and Wall		
		Access Issues	Nil		
		Description of Pest Infestation	It is Serious Threats for Rodents, Lizards & Spiders.		
		Any other observations	Nil		
		Preventive Action suggested to customer	Around the Pipeline Gap will be closed with cement mortar or Foam Sealant.		
7

Curative action from	We are instructed to Technician for Regular Monitoring.	05-01-2024	05-01-2024
		Location	Outside Air Duct Area		
		Cleaning / sanitation & Housekeeping Issues	Nil		
		Structural Issue (Pest harbourages)	Mesh will be replaced Inside to outside.		
		Access Issues	Nil		
		Description of Pest Infestation	It is Serious Threats for Flies, Lizards & Cockroaches.		
		Any other observations	Nil		
		Preventive Action suggested to customer	Mesh will be placed.
