## PEST CONTROL EXPERTS

Facility Name & Address: Frozen Tropical Foods Pvt Ltd , Chittoor	Audited On: 30-12-2023
Audited By: SURESH KUMAR.V	
Client Contact Person Name: Mr. Surendra QM	PC Experts Contact Person Name: SURESH KUMAR.V
Client Contact Person No: 7702187499	PC Experts Contact Person No: 9087200011

### FACILITY SURROUNDING

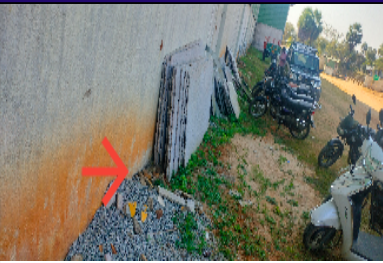
Location	Building outer area		
		Cleaning / sanitation & Housekeeping Issues	Nil		
		Structural Issue (Pest harbourages)	Nil		
		Access Issues	Granite Materials Dumped. We are not able to access.		
		Description of Pest Infestation	It is Serious Threat for Rodent, Snakes and other crawling insects		
		Any other observations	Nil		
		Preventive Action suggested to customer	Don't Store the materials building outside		
		Curative action from	We are instructed to Technician for Regular Monitoring.

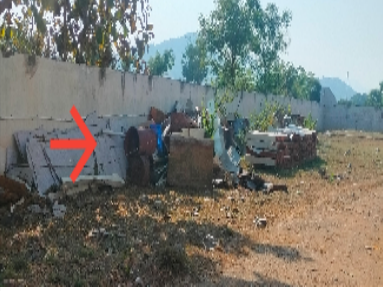
Location	COMPOUND WALL IN SIDE		
		Cleaning / sanitation & Housekeeping Issues	Nil		
		Structural Issue (Pest harbourages)	Nil		
		Access Issues	Lot of granites and other materials attached compound wall		
		Description of Pest Infestation	It is Serious Threat for snakes, Rodent and other crawling insects		
		Any other observations	Nil		
		Preventive Action suggested to customer	Don't Store the materials near by compound wall

Curative action from	We are instructed to Technician for Regular Monitoring.		
4

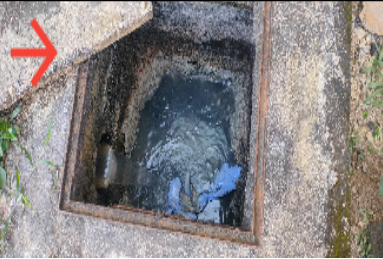
Location	Loading Area		
		Cleaning / sanitation & Housekeeping Issues	Nil		
		Structural Issue (Pest harbourages)	Manhole lid not closed properly		
		Access Issues	Nil		
		Description of Pest Infestation	It is Serious Threat for Ants, mosquitoes, Rodent, cockroach, snakes and other crawling insects		
		Any other observations	Nil		
		Preventive Action suggested to customer	Manholes lid should be closed without any gaps		
		Curative action from	We are instructed to Technician for Regular Monitoring.

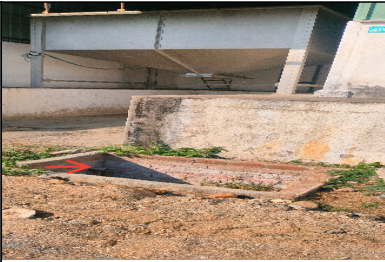
5

Location	Fruit waste receiving area		
		Cleaning / sanitation & Housekeeping Issues	Near by samp waste water stagnated		
		Structural Issue (Pest harbourages)	Samp was Opened Condition		
		Access Issues	Nil		
		Description of Pest Infestation	It is Serious Threat for Ants, cockroach, Rodent, snakes and other crawling insects		
		Any other observations	Nil		
		Preventive Action suggested to customer	Samp lid should be without any gaps		
		Curative action from	We are instructed to Technician for Regular Monitoring.
