Facility Name & Address: Frozen Tropical Foods Pvt Ltd , Chittoor	Audited On: 30-12-2023
Audited By: SURESH KUMAR.V	
Client Contact Person Name: Mr. Surendra QM	PC Experts Contact Person Name: SURESH KUMAR.V
Client Contact Person No: 7702187499	PC Experts Contact Person No: 9087200011

Internal Premises			REVIEW DATE	COMPLETION DATE	
1

External Premises				REVIEW DATE	COMPLETION DATE
1

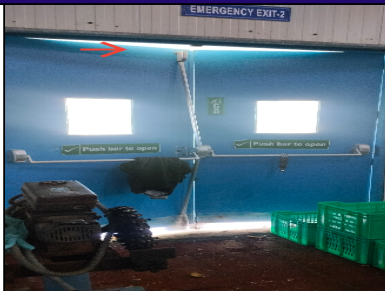
Location	Fruit Washing area		
		Cleaning / sanitation & Housekeeping Issues	Nil		
		Structural Issue (Pest harbourages)	Emergency exit doors was opened condition. Lot of gaps observed.		
		Access Issues	Nil		
		Description of Pest Infestation	It is Serious Threat for Ants, snakes, rodent, lizard, flying insects and other crawling insects		
		Any other observations	Nil		
		Preventive Action suggested to customer	Gap should be closed without any gaps.		
		Curative action from	We are instructed to Technician for Regular Monitoring.

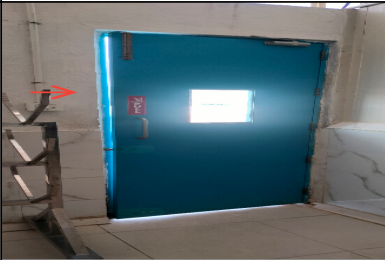
2

Location	Fruit receiving area		
		Cleaning / sanitation & Housekeeping Issues	Nil		
		Structural Issue (Pest harbourages)	PVC strips was damaged condition		
		Access Issues	Nil		
		Description of Pest Infestation	It is Serious Threat for Ants, flying insects		
		Any other observations	Nil		
		Preventive Action suggested to customer	Pvc strips should be replaced		
		Curative action from	We are instructed to Technician for Regular Monitoring.		
3

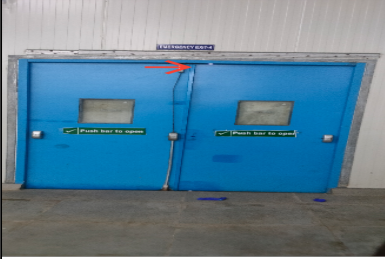
4

Location	Packing area.		
		Cleaning / sanitation & Housekeeping Issues	Nil		
		Structural Issue (Pest harbourages)	Emergency doors gaps observed		
		Access Issues	Nil		
		Description of Pest Infestation	It is Serious Threat for Ants, lizards and other crawling insects		
		Any other observations	Nil		
		Preventive Action suggested to customer	Gap should be closed with rubber breading		
		Curative action from	We are instructed to Technician for Regular Monitoring.		
5

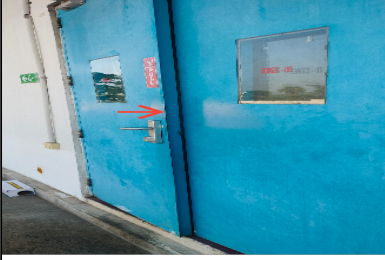
Location	Processing hall		
		Cleaning / sanitation & Housekeeping Issues	Nil		
		Structural Issue (Pest harbourages)	Emergency exit door was opened condition		
		Access Issues	Nil		
		Description of Pest Infestation	It is Serious Threat for Ants,. lizard, flying insects and other crawling insects		
		Any other observations	Nil		
		Preventive Action suggested to customer	Nil doors should be closed without any gaps		
		Curative action from	We are instructed to Technician for Regular Monitoring.

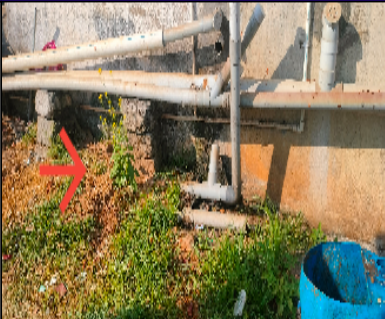
Location	ETP Area	09-02-2024	
		Cleaning / sanitation & Housekeeping Issues	Waste observed.		
		Structural Issue (Pest harbourages)	Bottom of the compound wall holes observed		
		Access Issues	Nil		
		Description of Pest Infestation	It is Serious Threat for Ants, fly, Rodent, snakes and other crawling insects		
		Any other observations	Nil		
		Preventive Action suggested to customer	Holes sh be close with cement concrete. Waste should be clean on regular basis, pipe hole should be closed.		
		Curative action from	We are instructed to Techni AQcian for Regular Monitoring.		
2

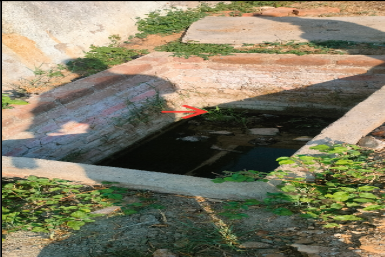
Location	Waste collecting area		
		Cleaning / sanitation & Housekeeping Issues	Waste water stagnated		
		Structural Issue (Pest harbourages)	Lid not available in the sump area		
		Access Issues	Nil		
		Description of Pest Infestation	It is Serious Threat for cockroach, mosquitoes, snakes, flying insects and other crawling insects

Any other observations	Nil		
		Preventive Action suggested to customer	Sump lid should be closed. Don't allow the waste water,		
		Curative action from	We are instructed to Technician for Regular Monitoring.		
3

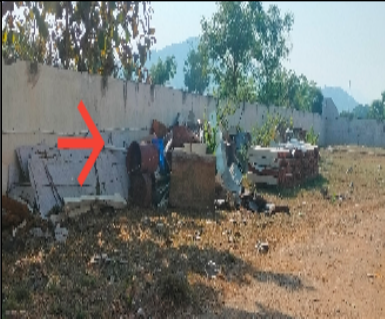
Location	COMPOUND WALL IN SIDE		
		Cleaning / sanitation & Housekeeping Issues	Nil		
		Structural Issue (Pest harbourages)	Nil		
		Access Issues	Lot of granites and unused materials touching on compound wall		
		Description of Pest Infestation	It is Serious Threat for snakes, rodent and other crawling insects		
		Any other observations	Nil		
		Preventive Action suggested to customer	Don't allow the unused materials near by compound wall		
		Curative action from	We are instructed to Technician for Regular Monitoring.

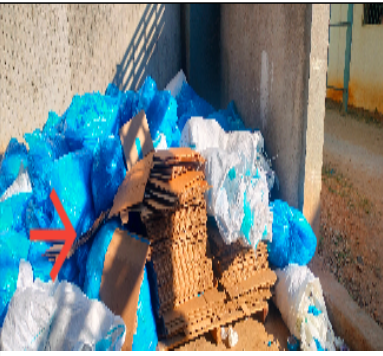
4

Location	Open cold storage area		
		Cleaning / sanitation & Housekeeping Issues	Nil		
		Structural Issue (Pest harbourages)	Opened place		
		Access Issues	Granite Materials, pallets , drums, waste Dumped. We are not able to access.		
		Description of Pest Infestation	It is Serious Threat for snakes, Rodent, lizard and other crawling insects		
		Any other observations	Nil		
		Preventive Action suggested to customer	Gap should be required materials to material,Waste material should be clean on regular basis. Don't allow the materials near by wall		
		Curative action from	We are instructed to Technician for Regular Monitoring.		
5

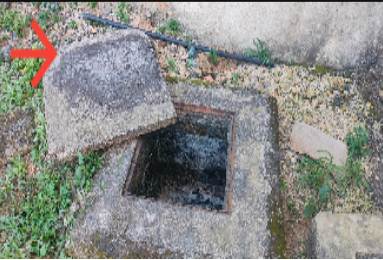
Location	Loading Area		
		Cleaning / sanitation & Housekeeping Issues	Nil		
		Structural Issue (Pest harbourages)	Lid not closed properly		
		Access Issues	Nil		
		Description of Pest Infestation	It is Serious Threat for Ants, cockroach, flies, rodent, snakes and other crawling insects

Any other observations	Nil		
		Preventive Action suggested to customer	Lid should be closed without any gaps		
		Curative action from	We are instructed to Technician for Regular Monitoring.		
6

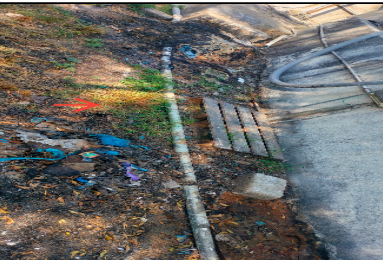
Location	ETP Area		
		Cleaning / sanitation & Housekeeping Issues	Not cleaned properly		
		Structural Issue (Pest harbourages)	Nil		
		Access Issues	Lot of waste dumped near by the wall		
		Description of Pest Infestation	It is Serious Threat for Beetles, flies, cockroach, rodent, snakes and other crawling insects		
		Any other observations	Nil		
		Preventive Action suggested to customer	Waste should be clean on regular basis		
		Curative action from	We are instructed to Technician for Regular Monitoring.

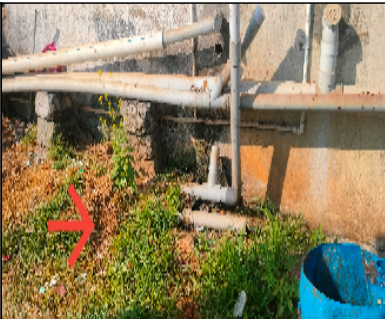
7

Location	ETP Area		
		Cleaning / sanitation & Housekeeping Issues	Not cleaned properly		
		Structural Issue (Pest harbourages)	Lot Holes observed compound wall under		
		Access Issues	Nil		
		Description of Pest Infestation	It is Serious Threat for Beetles, cockroach,, mosquitoes,,rodents, snakes and other crawling insects		
		Any other observations	Nil		
		Preventive Action suggested to customer	Hole should be closed with cement concrete, properly xlew		
		Curative action from	We are instructed to Technician for Regular Monitoring.		
8

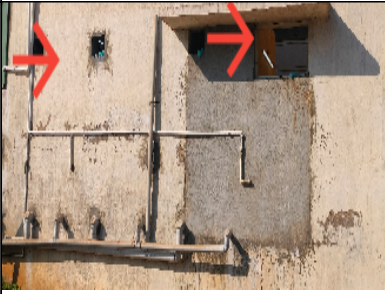
Location	ETP Area		
		Cleaning / sanitation & Housekeeping Issues	Nil		
		Structural Issue (Pest harbourages)	Pipe and compound bottom hap		
		Access Issues	Nil		
		Description of Pest Infestation	It is Serious Threat for Cockroaches, rodent, snake, other crawling insects		
		Any other observations	Nil		
		Preventive Action suggested to customer	Hole should be closed with cement concrete, pipe should be replaced.

Curative action from	We are instructed to Technician for Regular Monitoring.		
9

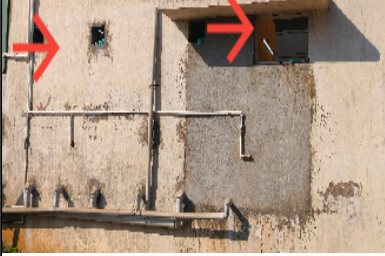
Location	Rest Room back side		
		Cleaning / sanitation & Housekeeping Issues	Nil		
		Structural Issue (Pest harbourages)	Ventilation was opened condition		
		Access Issues	Nil		
		Description of Pest Infestation	It is Serious Threat for Ants, flying insects, lizard and other crawling insects		
		Any other observations	Nil		
		Preventive Action suggested to customer	Ventilation should be closed with mesh.		
		Curative action from	We are instructed to Technician for Regular Monitoring.

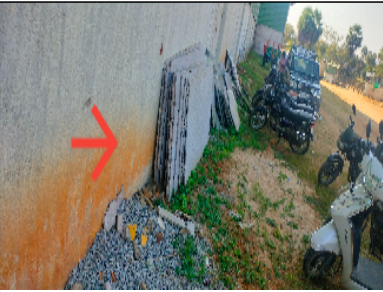
10

Location	Main building outside		
		Cleaning / sanitation & Housekeeping Issues	Nil		
		Structural Issue (Pest harbourages)	Nil		
		Access Issues	Granite Materials Dumped. We are not able to access.		
		Description of Pest Infestation	It is Serious Threat for snakes, Rodent and other crawling insects		
		Any other observations	Nil		
		Preventive Action suggested to customer	Don't Store the materials near by building surrounding areas		
		Curative action from	We are instructed to Technician for Regular Monitoring.		
11

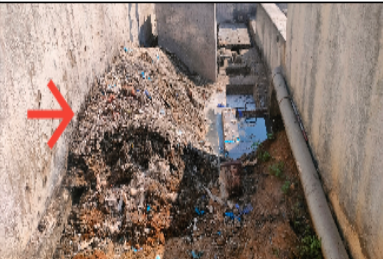
Location	ETP Area		
		Cleaning / sanitation & Housekeeping Issues	Waste observed		
		Structural Issue (Pest harbourages)	Nil		
		Access Issues	Nil		
		Description of Pest Infestation	It is Serious Threat for Ants, cockroach, flying insects, rodent, and other crawling insects		
		Any other observations	Nil		
		Preventive Action suggested to customer	Waste should be clean on regular basis.

Curative action from	We are instructed to Technician for Regular Monitoring.		
12

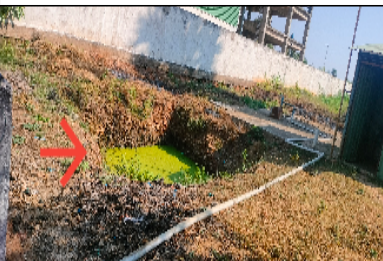
Location	ETP AREA		
		Cleaning / sanitation & Housekeeping Issues	Nil		
		Structural Issue (Pest harbourages)	Nil		
		Access Issues	Waste water stagnated		
		Description of Pest Infestation	It is Serious Threat for Beetles, mosquitoes, frog, snake, rodent		
		Any other observations	Nil		
		Preventive Action suggested to customer	Don't allow the waste water stagnated.		
		Curative action from	We are instructed to Technician for Regular Monitoring.

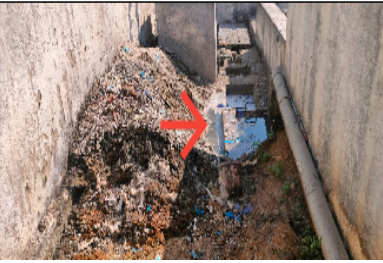
13

Location	ETP Area		
		Cleaning / sanitation & Housekeeping Issues	Waste water stagnated and over flow		
		Structural Issue (Pest harbourages)	Nil		
		Access Issues	Nil		
		Description of Pest Infestation	It is Serious Threat for Ants, snakes, beetles, mosquitoes, flying insects and other crawling insects		
		Any other observations	Nil		
		Preventive Action suggested to customer	Don't allow the over flow of waste water.		
		Curative action from	We are instructed to Technician for Regular Monitoring.		
14

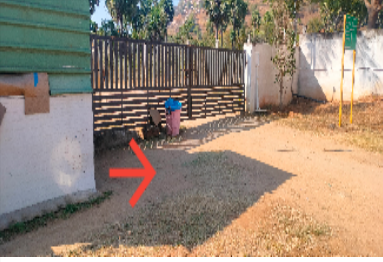
Location	Back side gate		
		Cleaning / sanitation & Housekeeping Issues	Nil		
		Structural Issue (Pest harbourages)	Bottom of the gate we observed the gap		
		Access Issues	Nil		
		Description of Pest Infestation	It is Serious Threat for dogs, snakes, rodent,		
		Any other observations	Nil		
		Preventive Action suggested to customer	Bottom of the gate should be closed with cement concrete.

Curative action from	We are instructed to Technician for Regular Monitoring.		
15

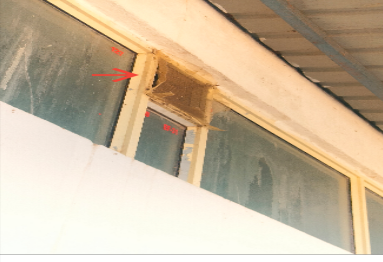
Location	Main building outside		
		Cleaning / sanitation & Housekeeping Issues	Nil		
		Structural Issue (Pest harbourages)	Ventilation mesh was damaged condition		
		Access Issues	Nil		
		Description of Pest Infestation	It is Serious Threat for Ants, lizard, flying insects and other crawling insects		
		Any other observations	Nil		
		Preventive Action suggested to customer	Ventilation mesh should be replaced		
		Curative action from	We are instructed to Technician for Regular Monitoring.

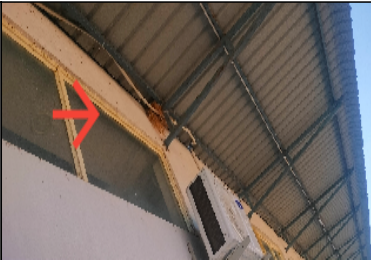
16

Location	Main building outside area		
		Cleaning / sanitation & Housekeeping Issues	Nil		
		Structural Issue (Pest harbourages)	Nil		
		Access Issues	Birds nesting observed		
		Description of Pest Infestation	It is Serious Threat for birds, ants and lizard. Disease it will come due to birds droppings.		
		Any other observations	Nil		
		Preventive Action suggested to customer	Birds nest remove from the place		
		Curative action from	We are instructed to Technician for Regular Monitoring.		
17

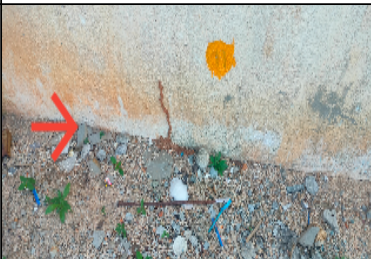
Location	Main building surrounding area.		
		Cleaning / sanitation & Housekeeping Issues	We observed the termite tubes		
		Structural Issue (Pest harbourages)	Nil		
		Access Issues	Nil		
		Description of Pest Infestation	It is Serious damaged our material like woods paper, clothes		
		Any other observations	Nil		
		Preventive Action suggested to customer	Termite treatment should be required		
		Curative action from	We are instructed to Technician for Regular Monitoring.

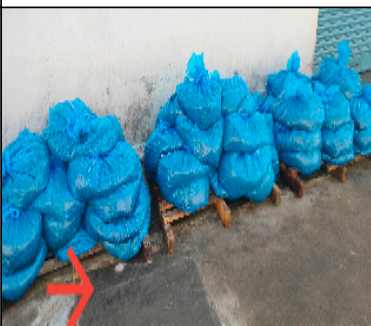
18

Location	RM to main building passage area		
		Cleaning / sanitation & Housekeeping Issues	Lot of coconut waste stored, in this waste oil was developed.		
		Structural Issue (Pest harbourages)	Nil		
		Access Issues	That surface oil area so man movement critical in this area.		
		Description of Pest Infestation	It is Serious Threat for Ants, flies, Rodent		
		Any other observations	Nil		
		Preventive Action suggested to customer	Don't Store the waste material near by building. Make bari guard where ever slipping area.		
		Curative action from	We are instructed to Technician for Regular Monitoring.

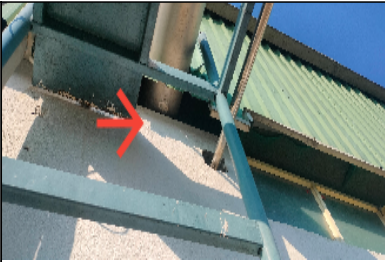
19

Location	Fruit waste receiving conveyor line		
		Cleaning / sanitation & Housekeeping Issues	Nil		
		Structural Issue (Pest harbourages)	Conveyor line outer to wall gaps observed		
		Access Issues	Nil		
		Description of Pest Infestation	It is Serious Threat for cats, squirrel, rodent, lizard, flying insects and other crawling insects		
		Any other observations	Nil		
		Preventive Action suggested to customer	Gap should be closed with metal sheet		
		Curative action from	We are instructed to Technician for Regular Monitoring.
