PEST CONTROL EXPERTS

Facility Name & Address: LEVTURE WELLNESS PVT LTD , Chittoor	Audited On: 28-05-2024
Audited By: SURESH KUMAR.V	
Client Contact Person Name: Mr. Hidayat Abbas (QC)	PC Experts Contact Person Name: SURESH KUMAR.V
Client Contact Person No: 8400955576	PC Experts Contact Person No: 8248672110

Internal Premises				REVIEW DATE	COMPLETION DATE
1

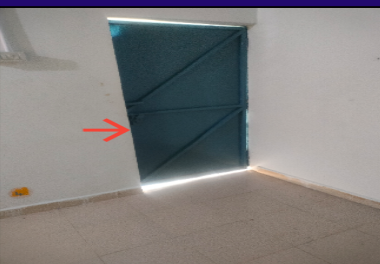
Location	Hygiene entry area		
		Cleaning / sanitation & Housekeeping Issues	Nil		
		Structural Issue (Pest harbourages)	Gaps Observed between Door Frame and Wall		
		Access Issues	Nil		
		Description of Pest Infestation	It is Serious Threat for Ants, lizard, flies and other crawling insects		
		Any other observations	Nil		
		Preventive Action suggested to customer	Gap should be closed rubber beading without any gaps		
		Curative action from	We are instructed to Technician for Regular Monitoring.

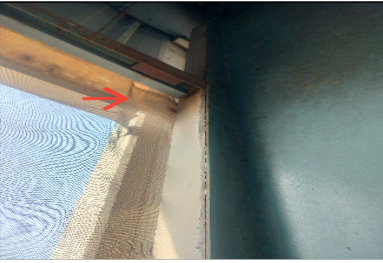
2

Location	Fruit RM area		
		Cleaning / sanitation & Housekeeping Issues	Nil		
		Structural Issue (Pest harbourages)	Mesh was not fixed properly		
		Access Issues	Nil		
		Description of Pest Infestation	It is Serious Threat for Ants, lizard, flying insects and other crawling insects		
		Any other observations	Nil		
		Preventive Action suggested to customer	Mesh to be fix without any gaps		
		Curative action from	We are instructed to Technician for Regular Monitoring.		
3

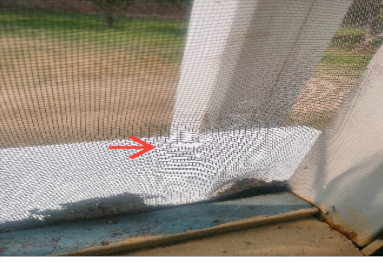
Location	Fruit RM area		
		Cleaning / sanitation & Housekeeping Issues	Nil		
		Structural Issue (Pest harbourages)	Mesh was Damaged Condition		
		Access Issues	Nil		
		Description of Pest Infestation	It is Serious Threat for Ants, beetle, flying insects, lizard and other crawling insects		
		Any other observations	Nil		
		Preventive Action suggested to customer	Mesh should be replaced		
		Curative action from	We are instructed to Technician for Regular Monitoring.

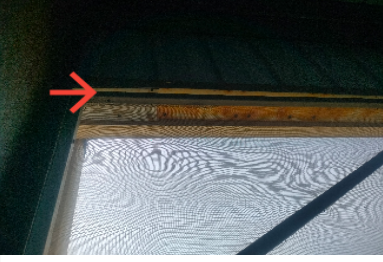
4

Location	RM fruit receiving area		
		Cleaning / sanitation & Housekeeping Issues	Nil		
		Structural Issue (Pest harbourages)	Mesh frame to Wall metal gap observed		
		Access Issues	Nil		
		Description of Pest Infestation	It is Serious Threat for Beetles, Ants, flying insects and other crawling insects		
		Any other observations	Nil		
		Preventive Action suggested to customer	Mesh frame to metal gap should be closed with sealent		
		Curative action from	We are instructed to Technician for Regular Monitoring.

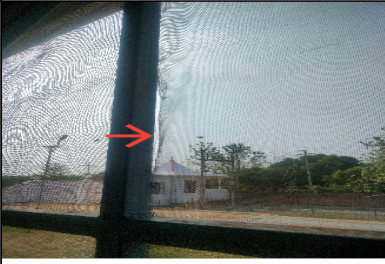
5

Location	RM fruit receiving area		
		Cleaning / sanitation & Housekeeping Issues	Nil		
		Structural Issue (Pest harbourages)	Mesh was Damaged Condition		
		Access Issues	Nil		
		Description of Pest Infestation	It is Serious Threat for Ants. Beetle, flying insects and lizard		
		Any other observations	Nil		
		Preventive Action suggested to customer	Damaged Mesh should h HV HV		
		Curative action from	We are instructed to Technician for Regular Monitoring.		
6

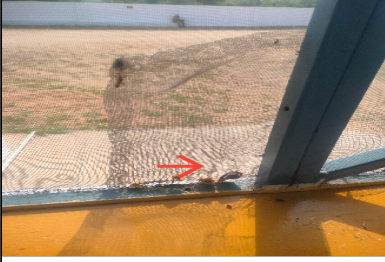
Location	RM fruit receiving area		
		Cleaning / sanitation & Housekeeping Issues	Nil		
		Structural Issue (Pest harbourages)	Mesh was damaged condition		
		Access Issues	Nil		
		Description of Pest Infestation	It is Serious Threat for Ants, beetle, flying insects and lizard		
		Any other observations	Nil		
		Preventive Action suggested to customer	Mesh should be replaced		
		Curative action from	We are instructed to Technician for Regular Monitoring.

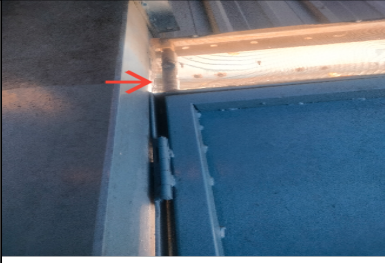
7

Location	RM emergency doors		
		Cleaning / sanitation & Housekeeping Issues	Nil		
		Structural Issue (Pest harbourages)	Mesh not properly Placed.		
		Access Issues	Nil		
		Description of Pest Infestation	It is Serious Threat for Beetles, flying insects, lizard and other crawling insects		
		Any other observations	Nil		
		Preventive Action suggested to customer	Mesh should be placed without any gaps		
		Curative action from	We are instructed to Technician for Regular Monitoring.

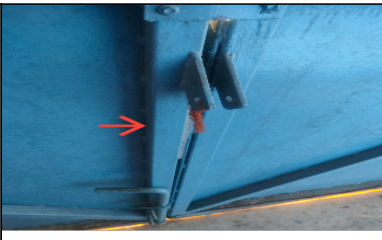
8

Location	RM fruit receiving area		
		Cleaning / sanitation & Housekeeping Issues	Ant nuts observed		
		Structural Issue (Pest harbourages)	Nil		
		Access Issues	Nil		
		Description of Pest Infestation	It is Serious Threat for Ants.		
		Any other observations	Nil		
		Preventive Action suggested to customer	Ant net should be clean		
		Curative action from	We are instructed to Technician for Regular Monitoring.		
External Premises				REVIEW DATE	COMPLETION DATE
9

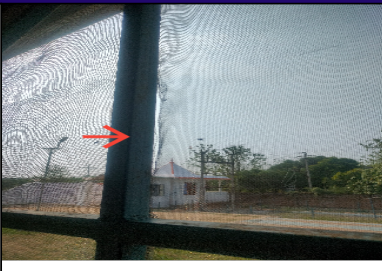
Location	RM fruit receiving area		
		Cleaning / sanitation & Housekeeping Issues	Nil		
		Structural Issue (Pest harbourages)	Mesh was Damaged Condition		
		Access Issues	Nil		
		Description of Pest Infestation	It is Serious Threat for Ants, beetle, flying insects,lizard and other crawling insects		
		Any other observations	Nil		
		Preventive Action suggested to customer	Mesh should be replaced		
		Curative action from	We are instructed to Technician for Regular Monitoring.

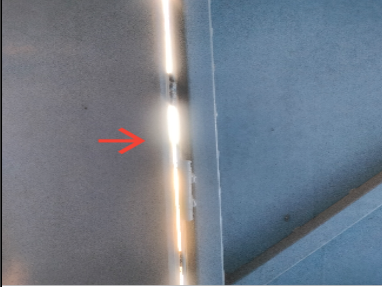
10

Location	RM emergency doors		
		Cleaning / sanitation & Housekeeping Issues	Nil		
		Structural Issue (Pest harbourages)	Door frame to wall gap noticed		
		Access Issues	Nil		
		Description of Pest Infestation	It is Serious Threat for Beetles, flying insects, lizard and other crawling insects		
		Any other observations	Nil		
		Preventive Action suggested to customer	Door fram and wall fram gap should be closed with rubber beading		
		Curative action from	W

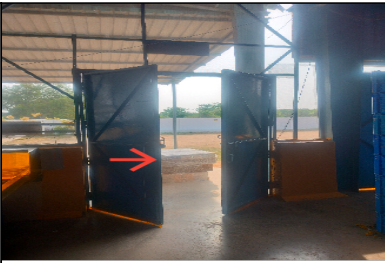
11

Location	RM emergency doors		
		Cleaning / sanitation & Housekeeping Issues	Nil		
		Structural Issue (Pest harbourages)	At the time of inspection doors was opened condition		
		Access Issues	Nil		
		Description of Pest Infestation	It is Serious Threat for Beetles, rodent, lizard, flying insects and other crawling insects		
		Any other observations	Nil		
		Preventive Action suggested to customer	Door should be closed without any gaps		
		Curative action from	We are instructed to Technician for Regular Monitoring.		
12

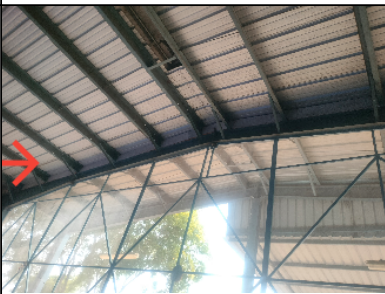
Location	RM small		
		Cleaning / sanitation & Housekeeping Issues	Nil		
		Structural Issue (Pest harbourages)	Nil		
		Access Issues	Nil		
		Description of Pest Infestation	It is Serious Threat for Ants, lizard, spider flying insects and other crawling insects		
		Any other observations	Nil		
		Preventive Action suggested to customer	Gap should be closed with rubber beading without any gaps

Curative action from	We are instructed to Technician for Regular Monitoring.		
Note: Nil					
For Pest Control Experts Authorized Signature. Name: SURESH KUMAR.V Designation: MANAGER Emp.Code: 002 Phone Number: 8248672110			For M/s. LEVTURE WELLNESS PVT LTD , Authorized Signature. Name: Designation: Emp.Code: Phone Number:
