PEST CONTROL EXPERTS

Facility Name & Address: Bluejay Nuts Pvt Ltd , Chittoor	Audited On: 03-07-2024
Audited By: SURESH KUMAR.V	
Client Contact Person Name: Mr. Byragi	PC Experts Contact Person Name: SURESH KUMAR.V
Client Contact Person No: 6303817139	PC Experts Contact Person No: 8248672110

FACILITY SURROUNDING

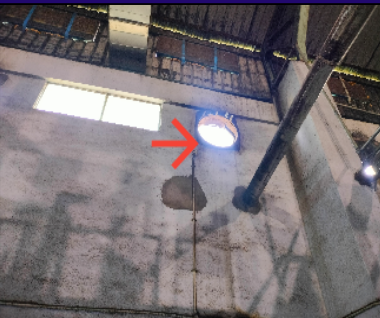
Location	Electrical panel room		
		Cleaning / sanitation & Housekeeping Issues	Nil		
		Structural Issue (Pest harbourages)	Exhaust fan not available and hole was opened condition		
		Access Issues	Nil		
		Description of Pest Infestation	It is Serious Threat for Beetles, flying insects,lizard, Ants and other crawling insects		
		Any other observations	Nil		
		Preventive Action suggested to customer	Exhaust fan should be placed and out side mesh should be placed		
		Curative action from	We are instructed to Technician for Regular Monitoring.

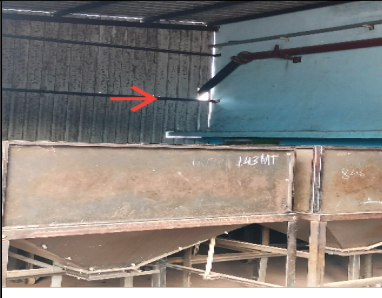
2

Location	RM material receiving area		
		Cleaning / sanitation & Housekeeping Issues	Nil		
		Structural Issue (Pest harbourages)	Gap noticed between the wall to sheet		
		Access Issues	Nil		
		Description of Pest Infestation	It is Serious Threat for Ants, beetle, flying insects, lizard and other crawling insects		
		Any other observations	Nil		
		Preventive Action suggested to customer	Gap should be closed with rubber beading or silicone sealant or form sealant		
		Curative action from	We are instructed to Technician for Regular Monitoring.		
External Premises				REVIEW DATE	COMPLETION DATE
3

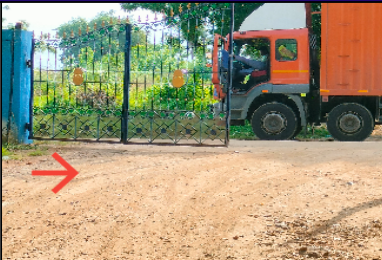
Location	Main gate		
		Cleaning / sanitation & Housekeeping Issues	Nil		
		Structural Issue (Pest harbourages)	Main gate bottom gap noticed		
		Access Issues	Ni		
		Description of Pest Infestation	It is Serious Threat for snakes, rats, Ants,and other crawling insects		
		Any other observations	Nil		
		Preventive Action suggested to customer	Gap should be closed with rubber beading

Curative action from	We are instructed to Technician for Regular Monitoring.		
4

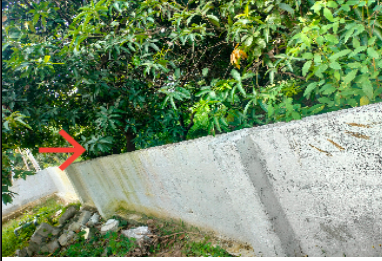
Location	Backside compound wall		
		Cleaning / sanitation & Housekeeping Issues	Tree branches fall down on the wall		
		Structural Issue (Pest harbourages)	Nil		
		Access Issues	Nil		
		Description of Pest Infestation	It is Serious Threat for Beetles, lizard, snake, rodent and other crawling insects		
		Any other observations	Nil		
		Preventive Action suggested to customer	Tree branches should be trim on regular basis		
		Curative action from	We are instructed to Technician for Regular Monitoring.

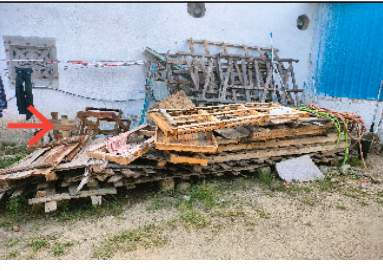
5

Location	Canteen back side		
		Cleaning / sanitation & Housekeeping Issues	Nil		
		Structural Issue (Pest harbourages)	Nil		
		Access Issues	Lot of unused material dumped		
		Description of Pest Infestation	It is Serious Threat for rodent, snakes, other crawling insects		
		Any other observations	Nil		
		Preventive Action suggested to customer	Don't allow the material nearby building		
		Curative action from	We are instructed to Technician for Regular Monitoring.		
6

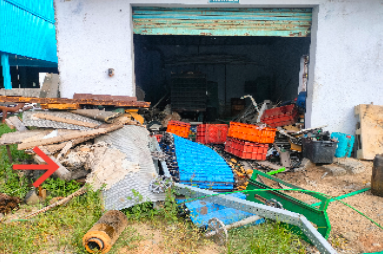
Location	Unused material dumping yard		
		Cleaning / sanitation & Housekeeping Issues	Nil		
		Structural Issue (Pest harbourages)	Nil		
		Access Issues	Lot of material dumped improper		
		Description of Pest Infestation	It is Serious Threat for rodent, snakes and other crawling insects		
		Any other observations	Nil		
		Preventive Action suggested to customer	Material should be kept proper storage		
		Curative action from	We are instructed to Technician for Regular Monitoring.

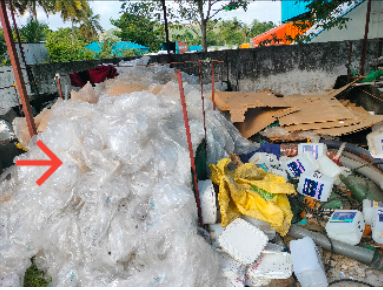
7

Location	Waste material dumping yard		
		Cleaning / sanitation & Housekeeping Issues	Lot of Waste material kept at waste material dumping yard		
		Structural Issue (Pest harbourages)	Nil		
		Access Issues	Nil		
		Description of Pest Infestation	It is Serious Threat for rodent, snakes and other crawling insects		
		Any other observations	Nil		
		Preventive Action suggested to customer	Waste material should be removed on regular basis		
		Curative action from	We are instructed to Technician for Regular Monitoring.

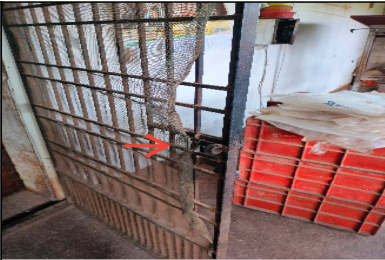
8

Location	Husk checking area		
		Cleaning / sanitation & Housekeeping Issues	Nil		
		Structural Issue (Pest harbourages)	Mesh was damaged condition and gaps observed		
		Access Issues	Nil		
		Description of Pest Infestation	It is Serious Threat for Ants, lizard, rodent, snakes and other crawling insects		
		Any other observations	Nil		
		Preventive Action suggested to customer	Mesh should be replaced without any gaps		
		Curative action from	We are instructed to Technician for Regular Monitoring.		
9

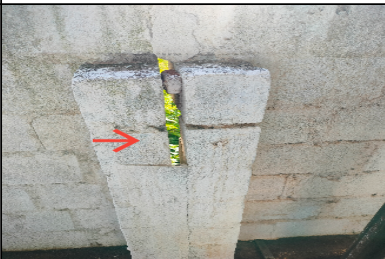
Location	Compound wall		
		Cleaning / sanitation & Housekeeping Issues	Nil		
		Structural Issue (Pest harbourages)	Compound wall gap noticed		
		Access Issues	Nil		
		Description of Pest Infestation	It is Serious Threat for Ants, lizard, snakes, rodent and other crawling insects		
		Any other observations	Nil		
		Preventive Action suggested to customer	Gap should be closed with cement		
		Curative action from	We are instructed to Technician for Regular Monitoring.

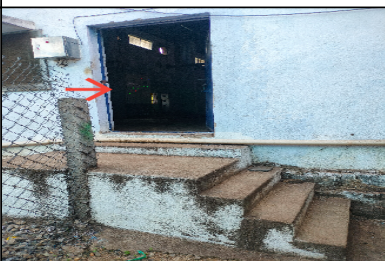
10

Location	Electrical panel room		
		Cleaning / sanitation & Housekeeping Issues	Nil		
		Structural Issue (Pest harbourages)	Nil		
		Access Issues	Electrical panel room opened condition		
		Description of Pest Infestation	It is Serious Threat for Ants, lizard, rodent, snakes and other crawling insects & flying insects		
		Any other observations	Nil		
		Preventive Action suggested to customer	Doors should be closed condition		
		Curative action from	We are instructed to Technician for Regular Monitoring.

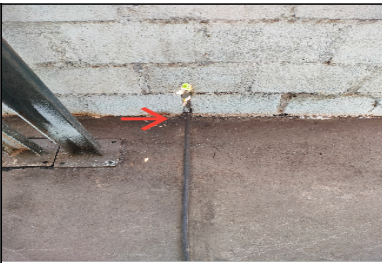
11

Location	COMPOUND WALL		
		Cleaning / sanitation & Housekeeping Issues	Nil		
		Structural Issue (Pest harbourages)	Gap noticed between the wall		
		Access Issues	Nil		
		Description of Pest Infestation	It is Serious Threat for Beetles, Ants, snakes, lizard rodent and other crawling insects		
		Any other observations	Nil		
		Preventive Action suggested to customer	Gap should be closed with cement		
		Curative action from	We are instructed to Technician for Regular Monitoring.		
12

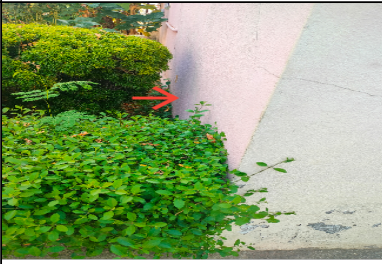
Location	Conference Hall outer		
		Cleaning / sanitation & Housekeeping Issues	Thick vegetation observed		
		Structural Issue (Pest harbourages)	Nil		
		Access Issues	Nil		
		Description of Pest Infestation	It is Serious Threat for Beetles, Ants, lizard, rodent, snakes and other crawling insects		
		Any other observations	Nil		
		Preventive Action suggested to customer	Vegetation should be trim on regular basis		
		Curative action from	We are instructed to Technician for Regular Monitoring.

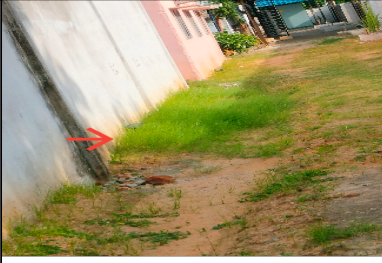
13

Location	RM back side		
		Cleaning / sanitation & Housekeeping Issues	Thick vegetation observed		
		Structural Issue (Pest harbourages)	Nil		
		Access Issues	Nil		
		Description of Pest Infestation	It is Serious Threat for Ants, beetle, lizard, rodent, snakes, and other crawling insects		
		Any other observations	Nil		
		Preventive Action suggested to customer	Vegetation should be trim on regular basis		
		Curative action from	We are instructed to Technician for Regular Monitoring.		
Note:					
For Pest Control Experts			For M/s. Bluejay Nuts Pvt Ltd ,		
Authorized Signature.			Authorized Signature.		
Name: SURESH KUMAR.V			Name:		
Designation: MANAGER			Designation:		
Emp.Code: 002			Emp.Code:		
Phone Number: 8248672110			Phone Number:
