Facility Name & Address: foods industry , chittoor	Audited On: 08-05-2023
Audited By: SURESH KUMAR.V	
Client Contact Person Name: Lev true wellness Pvt Ltd	PC Experts Contact Person Name: SURESH KUMAR.V
Client Contact Person No: 9936293940	PC Experts Contact Person No: 9087200011

FACILITY SURROUNDING

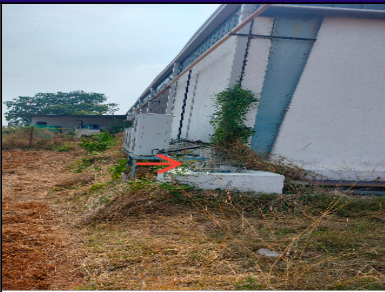
Location	Main building back side area	25-05-2023	27-06-2023
		Cleaning / sanitation & Housekeeping Issues	Lot of thick vegetation observed		
		Structural Issue (Pest harbourages)	Manhold lid not closed		
		Access Issues	Nil		
		Description of Pest Infestation	It is Serious Thread for Flies, Lizards, Spiders, snakes, & Aphids.		
		Any other observations	Nil		
		Preventive Action suggested to customer	Building surrounding thick vegetation should be clean on regular basis		
		Curative action from	We are instructed to Technician for Regular Monitoring.		
2

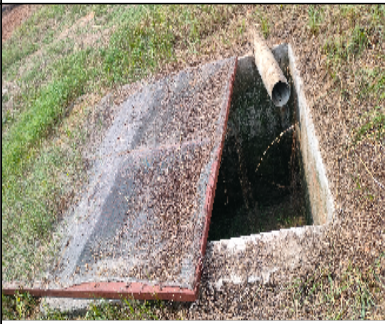
Location	Waste water collecting area	15-05-2023	26-06-2023
		Cleaning / sanitation & Housekeeping Issues	Thick vegetation observed		
		Structural Issue (Pest harbourages)	Lid not closed properly		
		Access Issues	Nil		
		Description of Pest Infestation	It is Serious Thread for Flies, mosquito, Lizards & Cockroaches.

Any other observations	Nil		
		Preventive Action suggested to customer	Thick vegetation should be clean on regular basis and waste water collecting tank lid should be closed always without any gaps.		
		Curative action from	We are instructed to Technician for Regular Monitoring.

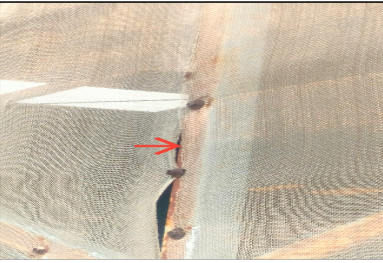
Location	Fruit feeding area	15-05-2023	27-06-2023
		Cleaning / sanitation & Housekeeping Issues	Nil		
		Structural Issue (Pest harbourages)	Mesh was Damaged Condition		
		Access Issues	Nil		
		Description of Pest Infestation	It is Serious Thread for Flies, Lizards, Spiders, & Aphids.		
		Any other observations	Nil		
		Preventive Action suggested to customer	Replaced New mesh		
		Curative action from	We are instructed to Technician for Regular Monitoring.		
4

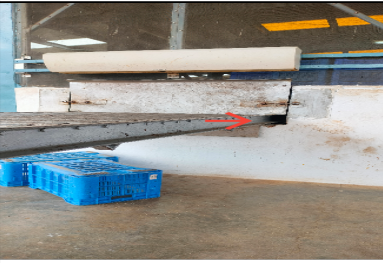
Location	Fruit collection area	15-05-2023	29-06-2023

Cleaning / sanitation & Housekeeping Issues	Nil		
		Structural Issue (Pest harbourages)	Gap observed between the tray running line to Wall		
		Access Issues	Nil		
		Description of Pest Infestation	It is Serious Thread for Flies,ants, Lizards & Cockroaches.		
		Any other observations	Nil		
		Preventive Action suggested to customer	Closed the gaps with mesh or metal sheet		
		Curative action from	We are instructed to Technician for Regular Monitoring.		
6

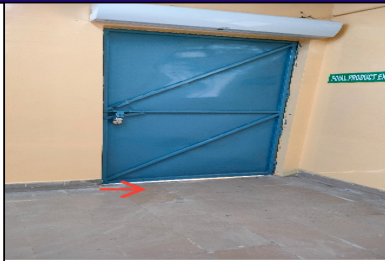
Location	Final product dispatching area	15-05-2023	30-05-2023
		Cleaning / sanitation & Housekeeping Issues	Nil		
		Structural Issue (Pest harbourages)	Gap observed bottom of the door		
		Access Issues	Nil		
		Description of Pest Infestation	It is serious thread snakes, lizards,ants, flies and other crawling insects		
		Any other observations	Nil		
		Preventive Action suggested to customer	Bottom of the door should be placed rubber beading		
		Curative action from	We are instructed to Technician for Regular Monitoring.		
2

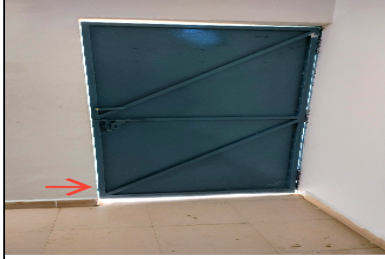
Location	Hygiene entrance area	15-05-2023	31-05-2023
		Cleaning / sanitation & Housekeeping Issues	Nil		
		Structural Issue (Pest harbourages)	Gap observed between the door to door frame		
		Access Issues	Nil		
		Description of Pest Infestation	It is Serious Thread for Flies, Lizards, crawling insects & Cockroaches.		
		Any other observations	Nil

Preventive Action suggested to customer	Door gap should be closed with rubber beading		
		Curative action from	We are instructed to Technician for Regular Monitoring.		
External Premises				REVIEW DATE	COMPLETION DATE
1
