Facility Name & Address: Newgen Agro Processors Pvt Ltd, Krishnagiri	Audited On: 01/06/2023
Audited By: Sarath Kumar	
Client Contact Person Name: Mr Sudhagar	PC Experts Contact Person Name: MOHAMMED YOUNUS.A
Client Contact Person No: 7373799008	PC Experts Contact Person No: 9087200011

### FACILITY SURROUNDING

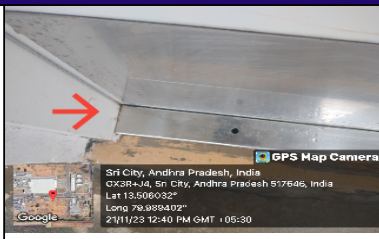
Location	Location RM Emergency exit door		
		Cleaning / sanitation & Housekeeping Issues	Nil		
		Structural Issue (Pest harbourages)	Gap observed		
		Access Issues	Nil		
		Description of Pest Infestation	It is Serious Threat for Ants, millipede		
		Any other observations	Nil		
		Preventive Action suggested to customer	Gap should be closed with rubber breading		
		Curative action from	We are instructed to Technician for Regular Monitoring		
External Premises			REVIEW DATE	COMPLETION DATE	
1	Location		RM Emergency Exit Area		
	Cleaning / sanitation & Housekeeping Issues		Nil		
	Structural Issue (Pest harbourages)		Door frame to floor and door frame to doors gaps observed		
	Access Issues		RM Emergency doors regularly using man movement, so it was not closed properly.		
	Description of Pest Infestation		It is Serious Threat for Ants,millipede and other crawling insects.

Any other observations		Nil		
	Preventive Action suggested to customer		Gap should be closed with rubber breading or silicone sealant.

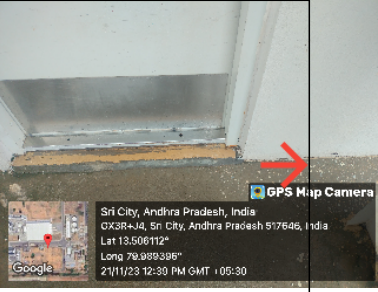
<table><tr> <td>Location</td> <td>We are instructed to Technician for Regular Monitoring.</td> </tr><tr> <td>Structural Issue (Pest harbourages)</td> <td>Gap observed between the doors to doors frame.</td> </tr><tr> <td>Description of Pest Infestation</td> <td>We observed live millipede out side of the building.</td> </tr><tr> <td>Any other observations</td> <td>Due to rain all crawling insects come and hide some places like cracks and gaps area</td> </tr></table>

<table><tr> <td>Location</td> <td>We are instructed to Technician for Regular Monitoring.</td> </tr><tr> <td>Preventive Action suggested to customer</td> <td>In this area where ever cracks and gaps identified that area should be closed with cement concrete.</td> </tr><tr> <td>Curative action from</td> <td>We are instructed to Technician for Regular Monitoring.</td> </tr></table>
