| Facility Name & Address: BELL IFF , Sricity | Audited On: 05-04-2023 |

FACILITY SURROUNDING

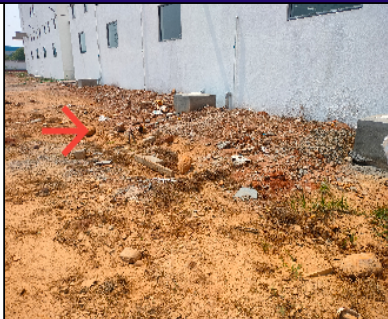
| External Premises | | | | REVIEW DATE | COMPLETION DATE |
|---|---|---|--|---|---|
| 1 | | Location | MAIN BUILDING OUTER AREA | 12-05-2023 | 08-06-2023 |

| External Premises | | | | REVIEW DATE | COMPLETION DATE |
|---|---|---|--|---|---|
| | | Structural Issue (Pest harbourages) | Building surrounding cement concrete floor not available | | |
| | | Description of Pest Infestation | It is serious thread for rodent, snake's, lizard, crawling insects hiding and developing in this place | | |

| External Premises | | | | REVIEW DATE | COMPLETION DATE |
|---|---|---|--|---|---|
| | | Preventive Action suggested to customer | Building surrounding cement concrete floor required upto 1 & 1/2 feet. | | |

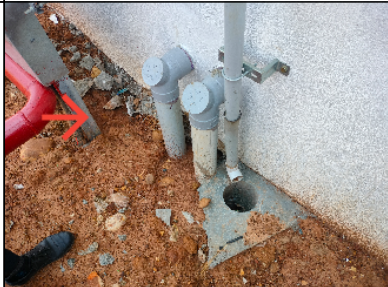
| External Premises | | | | REVIEW DATE | COMPLETION DATE |
|---|---|---|--|---|---|
| 2 | | Location | Fragrance main building backside area | 08-05-2023 | 08-06-2023 |

| External Premises | | | | REVIEW DATE | COMPLETION DATE |
|---|---|---|--|---|---|
| | | Structural Issue (Pest harbourages) | We observed open pipe hole without lid | | |
| | | Description of Pest Infestation | It is serious thread for rodent snake's lizard crawling insects hiding and developing in the place | | |

| External Premises | | | | REVIEW DATE | COMPLETION DATE |
|---|---|---|--|---|---|
| | | Preventive Action suggested to customer | Close the all pipe hole with lid. Gaps should be closed with cement concrete. | | |

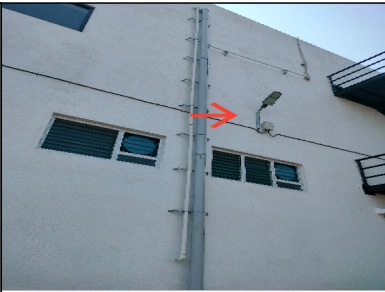
| 3 | | Location | Main building outside steps area | 08-05-2023 | 08-06-2023 |

| | | Structural Issue (Pest harbourages) | All lights placed on building Wall | | |
| | | Description of Pest Infestation | It is serious thread lizard, flies and other crawling insects | | |

| | | Preventive Action suggested to customer | Light should be placed separate pole, light focus should be Wall | | |

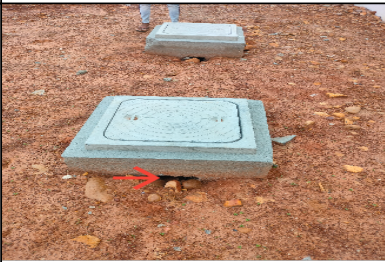
| 5 | | Location | Rain water manhole area | 08-05-2023 | 08-06-2023 |

| | | Structural Issue (Pest harbourages) | Rain water manhole gaps observed | | |
| | | Description of Pest Infestation | It is Serious Thread for Snakes, Fogg, crawling insects hiding and developing in the place. | | |

| | | Preventive Action suggested to customer | All manhole gaps should be closed with cement | | |

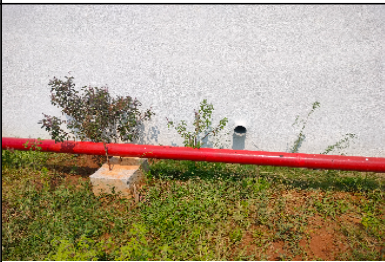
| 6 | | Location | Flavour plant building outside | 08-05-2023 | 08-06-2023 |

| | | Structural Issue (Pest harbourages) | We observed pipe hole. | | |
| | | Description of Pest Infestation | It is Serious Thread for Snakes, lizard, rodents and other crawling insects | | |

| | | Preventive Action suggested to customer | All pipes should be closed with cement or lid | | |

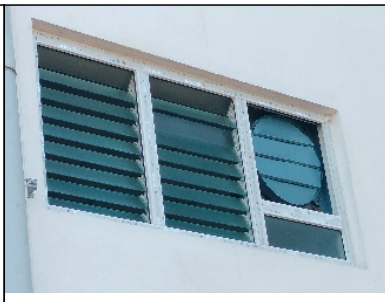
| 7 | | Location | Main building Rest room area | 08-05-2023 | 08-06-2023 |

| | | Structural Issue (Pest harbourages) | We observed gaps between exhaust fan to windows frame. Some windows glass not fixed properly | | |
| | | Description of Pest Infestation | It is Serious Thread for Flies, Lizards, Spiders, & Aphids. | | |

| | | Preventive Action suggested to customer | Mesh to placed all windows and exhaust fan | | |

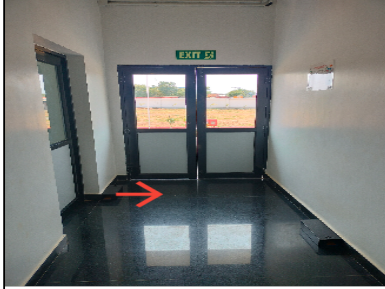
| 2 | | Location | Hygiene entrance area | 08-05-2023 | 08-06-2023 |

| | | Structural Issue (Pest harbourages) | Door gaps observed | | |
| | | Description of Pest Infestation | It is Serious Thread for snake, frog, Flies, Lizards, Spiders, & Aphids. | | |

| | | Preventive Action suggested to customer | Close the all doors gaps silican sileant or rubber beading | | |

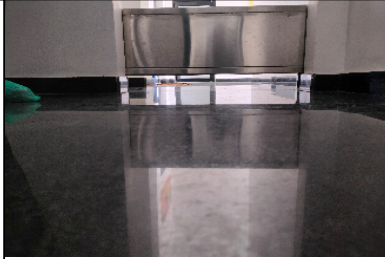
| 3 | | Location | Hygiene inside area | 08-05-2023 | 08-06-2023 |

| | | Structural Issue (Pest harbourages) | Man entry area table under we observed the gaps | | |
| | | Description of Pest Infestation | Snakes, lizards, ants, spider, rodent going to inside plant | | |

| | | Preventive Action suggested to customer | Should be placed table without gaps | | |

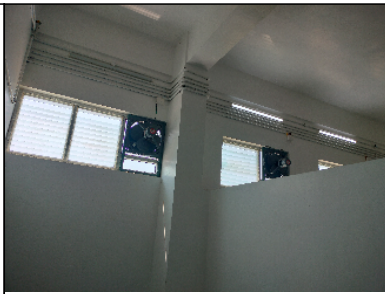
| 4 | | Location | Change room area | 08-05-2023 | 08-06-2023 |

| | | Structural Issue (Pest harbourages) | In windows some of glass pieces fixed in that place gaps observed. | | |
| | | Description of Pest Infestation | It is Serious Thread for Flies, Lizards, Spiders, & Aphids. | | |

| | | Preventive Action suggested to customer | Mesh Should be placed without gaps in out side area. | | |

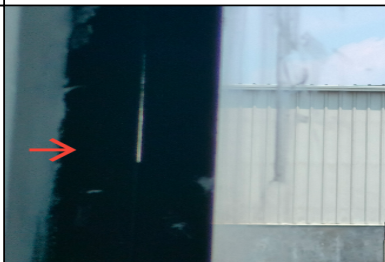
| 5 | | Location | Inside door frame area | 08-05-2023 | 08-06-2023 |

| | | Structural Issue (Pest harbourages) | Gap observed between the door frame to door | | |
| | | Description of Pest Infestation | It is Serious Thread for Flies, Lizards, Spiders, & Aphids. | | |

| | | Preventive Action suggested to customer | Gap will be closed with Foam Sealant. | | |

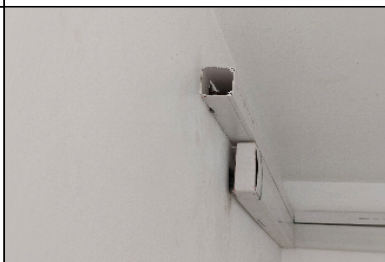
| 6 | | Location | Flavour plant inside (steps area) | 08-05-2023 | 08-06-2023 |

| | | Structural Issue (Pest harbourages) | Cable pipe hole observed | | |
| | | Description of Pest Infestation | It is serious thread for lizards, ants, spider | | |

| | | Preventive Action suggested to customer | All pipes holes should be closed with lid or silicon sealent | | |

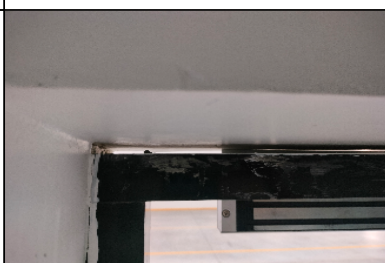
| 7 | | Location | Flavour to fragrance entrance area | 08-05-2023 | 08-06-2023 |

| | | Structural Issue (Pest harbourages) | Gaps Observed between Door Frame and Wall | | |
| | | Description of Pest Infestation | IT is serious thread for lizards, ants, spider, flies | | |

| | | Preventive Action suggested to customer | Around Gap will be closed with cement mortar or Foam Sealant. | | |
