Facility Name & Address: Global Farm Fresh Pvt Ltd , Chittoor	Audited On: 12-10-2023
Audited By: SURESH KUMAR.V	
Client Contact Person Name: Mr.Ibrahim	PC Experts Contact Person Name: SURESH KUMAR.V
Client Contact Person No: 7989833056	PC Experts Contact Person No: 9087200011

Internal Premises				REVIEW DATE	COMPLETION DATE
1

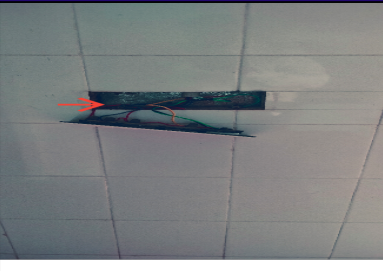
Location	Hygiene entrance area		
		Cleaning / sanitation & Housekeeping Issues	Nil		
		Structural Issue (Pest harbourages)	Cable switch box opened condition		
		Access Issues	Nil		
		Description of Pest Infestation	It is Serious Threat for Ants, lizard, cockroach, other crawling insects.		
		Any other observations	Nil		
		Preventive Action suggested to customer	Switch box should be closed without any gaps.		
		Curative action from	We are instructed to Technician for Regular Monitoring.		
2

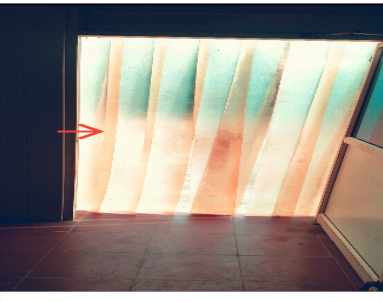
Location	Hygiene entrance area		
		Cleaning / sanitation & Housekeeping Issues	Nil		
		Structural Issue (Pest harbourages)	Hygiene entrance door was opened, not closed properly		
		Access Issues	Nil		
		Description of Pest Infestation	It is Serious Threat for Beetles, Ants, cockroach, lizard, rodent, snake, flying insects and other crawling insects		
		Any other observations	Nil

Preventive Action suggested to customer	Hygiene entrance doors should be closed		
		Curative action from	We are instructed to Technician for Regular Monitoring.

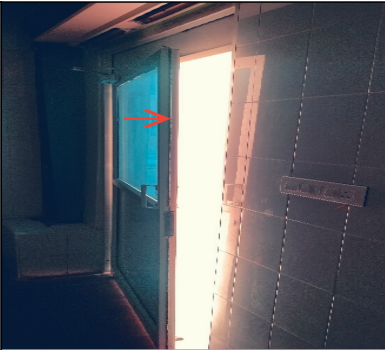
Location	Hygiene entrance area (ladies section).		
		Cleaning / sanitation & Housekeeping Issues	Nil		
		Structural Issue (Pest harbourages)	Door not closed properly and Air curtains not worked at the time of audit.		
		Access Issues	Nil		
		Description of Pest Infestation	It is Serious Threat for Ants, beetles, rodent, snakes, cockroach, lizard flying insects and other crawling insects		
		Any other observations	Nil		
		Preventive Action suggested to customer	Doors should be closed. Air curtains must be working condition		
		Curative action from	We are instructed to Technician for Regular Monitoring.		
4

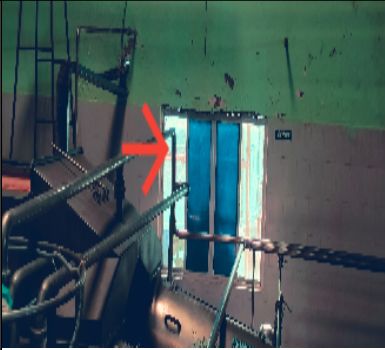
Location	Processing building window area.		
		Cleaning / sanitation & Housekeeping Issues	Nil		
		Structural Issue (Pest harbourages)	Window frame to Wall gaps observed. cable line area wall to cable duct gaps observed.		
		Access Issues	Nil		
		Description of Pest Infestation	It is Serious Threat for Beetles, cockroach, Ants lizard, flying insects and other crawling insects.

Any other observations	Nil		
		Preventive Action suggested to customer	Window frame to Wall gaps should be closed with cement. Cable duct area should be closed with cement without any gaps.		
		Curative action from	We are instructed to Technician for Regular Monitoring.		
5

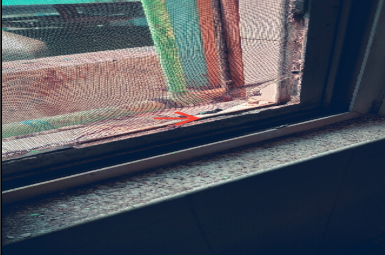
Location	Fruit crushing area.		
		Cleaning / sanitation & Housekeeping Issues	Nil		
		Structural Issue (Pest harbourages)	Mesh was damaged condition		
		Access Issues	Nil		
		Description of Pest Infestation	It is Serious Threat for Beetles, Ants, cockroach, flying insects, lizards, and other crawling insects		
		Any other observations	Nil		
		Preventive Action suggested to customer	Mesh should be replaced.		
		Curative action from	We are instructed to Technician for Regular Monitoring.

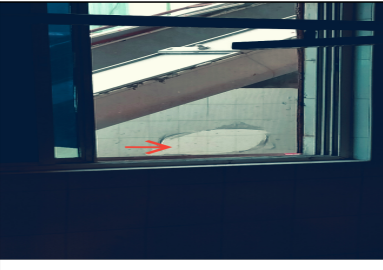
Location	Waste fruit outlet conveyor area.		
		Cleaning / sanitation & Housekeeping Issues	Nil		
		Structural Issue (Pest harbourages)	Mesh was damaged condition		
		Access Issues	Nil		
		Description of Pest Infestation	It is Serious Threat for Beetles, Ants, cockroach, lizards, flying insects and other crawling insects.		
		Any other observations	Nil		
		Preventive Action suggested to customer	Mesh should be replaced		
		Curative action from	We are instructed to Technician for Regular Monitoring.		
7

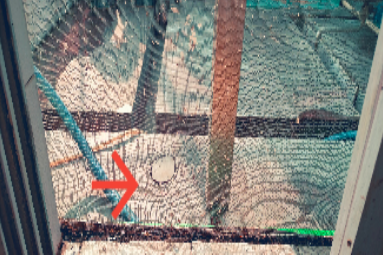
Location	Cooling tower area		
		Cleaning / sanitation & Housekeeping Issues	Nil		
		Structural Issue (Pest harbourages)	Mesh was damaged condition		
		Access Issues	Nil		
		Description of Pest Infestation	It is Serious Threat for Beetles, cockroach, lizards, flying insects and other crawling insects.		
		Any other observations	Nil		
		Preventive Action suggested to customer	Mesh should be replaced

Curative action from	We are instructed to Technician for Regular Monitoring.		
8

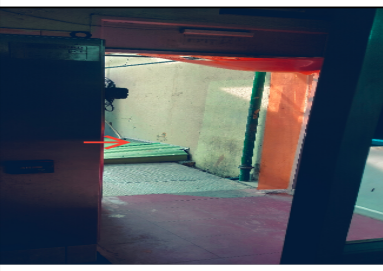
Location	Micro lab area		
		Cleaning / sanitation & Housekeeping Issues	Nil		
		Structural Issue (Pest harbourages)	Door was opened condition.		
		Access Issues	Nil		
		Description of Pest Infestation	It is Serious Threat for Ants, beetles, cockroach, lizards, rodent, snake, flying insects and other crawling insects		
		Any other observations	Nil		
		Preventive Action suggested to customer	Doors should be closed.		
		Curative action from	We are instructed to Technician for Regular Monitoring.		
9

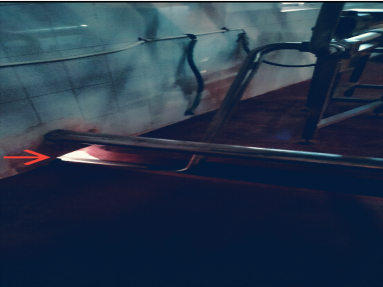
Location	Processing hall		
		Cleaning / sanitation & Housekeeping Issues	Nil		
		Structural Issue (Pest harbourages)	Waste water running line was opened condition		
		Access Issues	Nil		
		Description of Pest Infestation	It is Serious Threat for Ants, lizard, rodents snake, flying insects and other crawling insects		
		Any other observations	Nil

Preventive Action suggested to customer	Waste water running line area Mesh should be placed without any gaps.		
		Curative action from	We are instructed to Technician for Regular Monitoring.

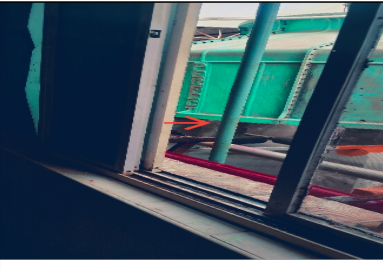
Location	Cooling tower area		
		Cleaning / sanitation & Housekeeping Issues	Nil		
		Structural Issue (Pest harbourages)	Window was opened condition		
		Access Issues	Nil		
		Description of Pest Infestation	It is Serious Threat for Ants, beetles, cockroach, lizards, flying insects and other crawling insects.		
		Any other observations	Nil		
		Preventive Action suggested to customer	Window should be closed without any gaps.		
		Curative action from	We are instructed to Technician for Regular Monitoring.		
11	 	Location	Pulp filling area		
		Cleaning / sanitation & Housekeeping Issues	Nil		
		Structural Issue (Pest harbourages)	Exhaust fan to windows frame between gaps observed.		
		Access Issues	Nil		
		Description of Pest Infestation	It is Serious Threat for Ants, beetles, cockroach lizards flying insects and other crawling insects		
		Any other observations	Nil		
		Preventive Action suggested to customer	Windows should be closed without any gaps.

Curative action from	We are instructed to Technician for Regular Monitoring.		
12	 	Location	Fruit conveyor line area		
		Cleaning / sanitation & Housekeeping Issues	Nil		
		Structural Issue (Pest harbourages)	Cable to wall between gaps observed		
		Access Issues	Nil		
		Description of Pest Infestation	It is Serious Threat for Ants, beetles, cockroach, lizards, flying insects and other crawling insects.		
		Any other observations	Nil		
		Preventive Action suggested to customer	Gap should be closed with cement without any gaps.		
		Curative action from	We are instructed to Technician for Regular Monitoring.		
13	 	Location	Empty drums receiving area		
		Cleaning / sanitation & Housekeeping Issues	Nil		
		Structural Issue (Pest harbourages)	Door was opened condition		
		Access Issues	Nil		
		Description of Pest Infestation	It is Serious Threat for Ants, beetles, cockroach, lizards, snakes, rodents, flying insects and other crawling insects

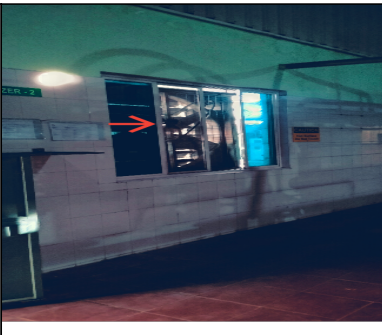
Location	Pulp filling area		
		Cleaning / sanitation & Housekeeping Issues	Nil		
		Structural Issue (Pest harbourages)	Exhaust Fan out side door not closed properly. Gap observed.		
		Access Issues	Nil		
		Description of Pest Infestation	It is Serious Threat for Ants, beetles, cockroach, lizards, flying insects and other crawling insects.		
		Any other observations	Nil		
		Preventive Action suggested to customer	Exhaust fan doors should be closed without any gaps non working time.		
		Curative action from	We are instructed to Technician for Regular Monitoring.		
External Premises				REVIEW DATE	COMPLETION DATE
1

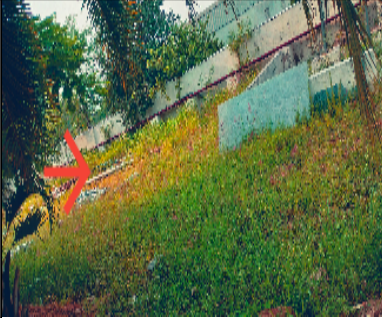
Location	Compound wall inside		
		Cleaning / sanitation & Housekeeping Issues	Thick vegetation observed		
		Structural Issue (Pest harbourages)	Nil		
		Access Issues	Nil		
		Description of Pest Infestation	It is Serious Threat for Beetles, cockroach, lizards, snakes, rodents, flying insects and other crawling insects

Any other observations	Nil		
		Preventive Action suggested to customer	Compound wall surrounding and building surrounding thick vegetation should be clean on regular basis.		
		Curative action from	We are instructed to Technician for Regular Monitoring.		
2

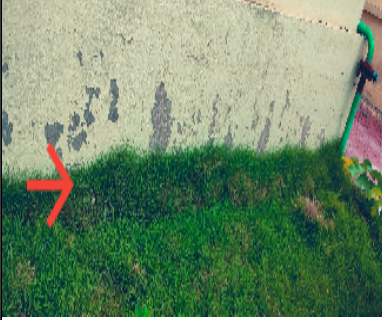
Location	Main building out side area		
		Cleaning / sanitation & Housekeeping Issues	Thick vegetation observed		
		Structural Issue (Pest harbourages)	Nil		
		Access Issues	Nil		
		Description of Pest Infestation	It is Serious Threat for Beetles, Ants, cockroach, lizards, snakes, rodents, flying insects and other crawling insects		
		Any other observations	Nil		
		Preventive Action suggested to customer	Building surrounding thick vegetation should be clean on regular basis.		
		Curative action from	We are instructed to Technician for Regular Monitoring.

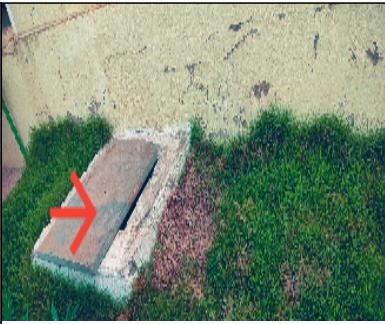
Location	DG area		
		Cleaning / sanitation & Housekeeping Issues	Thick vegetation observed		
		Structural Issue (Pest harbourages)	Manhole lid not closed properly		
		Access Issues	Nil		
		Description of Pest Infestation	It is Serious Threat for Beetles, ants, cockroach, lizards, snakes, rodents, flying insects and other crawling insects		
		Any other observations	Nil		
		Preventive Action suggested to customer	Thick vegetation should be clean on regular basis. Manhole lid should be closed properly.		
		Curative action from	We are instructed to Technician for Regular Monitoring.		
4

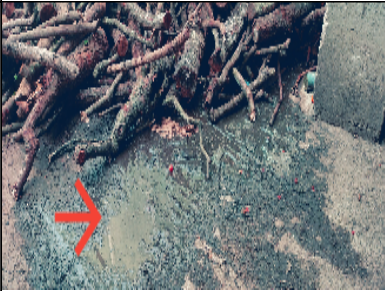
Location	Fire wood		
		Cleaning / sanitation & Housekeeping Issues	Fire wood dumping area not cleaned properly		
		Structural Issue (Pest harbourages)	Nil		
		Access Issues	Nil		
		Description of Pest Infestation	It is Serious Threat for Ants, rodents, lizards, flying insects, frog, snakes and other crawling insects

Any other observations	Nil		
		Preventive Action suggested to customer	Fire wood dumping yard should be clean. Don't allow the waste water.		
		Curative action from	We are instructed to Technician for Regular Monitoring.		
5

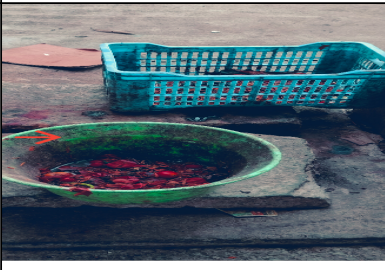
Location	Fruit Washing area		
		Cleaning / sanitation & Housekeeping Issues	Waste fruit dumping & collecting area.		
		Structural Issue (Pest harbourages)	Nil		
		Access Issues	Nil		
		Description of Pest Infestation	It is Serious Threat for Ants, flying insects, rodent, cockroach and other crawling insects		
		Any other observations	Nil		
		Preventive Action suggested to customer	Waste should be clean on regular intervals basis.		
		Curative action from	We are instructed to Technician for Regular Monitoring.
