Facility Name & Address: Levtrue Wellness Pvt Ltd , Chittoor	Audited On: 19-06-2023
Audited By: SURESH KUMAR.V	
Client Contact Person Name: Mr.Abbbas (QC)	PC Experts Contact Person Name: SURESH KUMAR.V
Client Contact Person No: 8400955576	PC Experts Contact Person No: 9087200011

FACILITY SURROUNDING

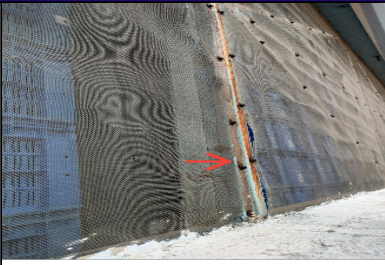
External Premises				REVIEW DATE	COMPLETION DATE
1

Location	RM AREA OUTER	20-06-2023	22-06-2023
		Cleaning / sanitation & Housekeeping Issues	Nil		
		Structural Issue (Pest harbourages)	Mesh not properly Placed.		
		Access Issues	Nil		
		Description of Pest Infestation	It is Serious Thread for Flies, Lizards, Spiders, & Crawling Insects.		
		Any other observations	Nil		
		Preventive Action suggested to customer	Mesh to be placed properly without any gaps		
		Curative action from	We are instructed to Technician for Regular Monitoring.		
2

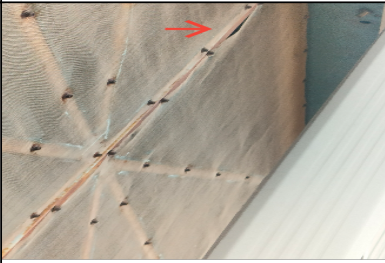
Location	RM AREA OUTER	19-06-2023	22-06-2023
		Cleaning / sanitation & Housekeeping Issues	Nil		
		Structural Issue (Pest harbourages)	Mesh not properly Placed.		
		Access Issues	Nil		
		Description of Pest Infestation	It is Serious Thread for Flies, Lizards, Spiders, & Aphids.		
		Any other observations	Nil		
		Preventive Action suggested to customer	Mesh to be placed without any gaps

Curative action from	We are instructed to Technician for Regular Monitoring.

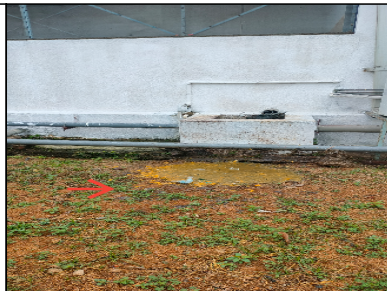
3

Location	Cutting area outside	19-06-2023	22-06-2023
		Cleaning / sanitation & Housekeeping Issues	Mango waste not cleaned properly		
		Structural Issue (Pest harbourages)	Manhole mesh not placed		
		Access Issues	Nil		
		Description of Pest Infestation	It is Serious Thread for Flies, Lizards, Spiders, & Crawling Insects.		
		Any other observations	Nil		
		Preventive Action suggested to customer	Regular cleaning required and don't allow to Store the waste near by building.		
		Curative action from	We are instructed to Technician for Regular Monitoring.		
4

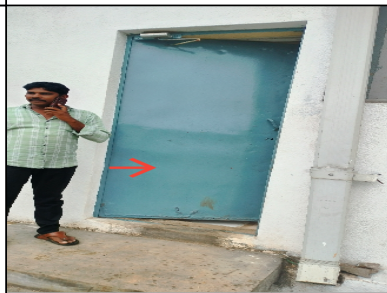
Location	Packing material receiving area.	19-06-2023	22-06-2023
		Cleaning / sanitation & Housekeeping Issues	Nil		
		Structural Issue (Pest harbourages)	Door was opened condition		
		Access Issues	Nil		
		Description of Pest Infestation	It is Serious Thread for snakes,Flies, Lizards, Spiders, & Aphids.		
		Any other observations	Nil		
		Preventive Action suggested to customer	Door to be closed always and out side to be placed PVC strips curtains

Curative action from	We are instructed to Technician for Regular Monitoring.		
Internal Premises				REVIEW DATE	COMPLETION DATE
1

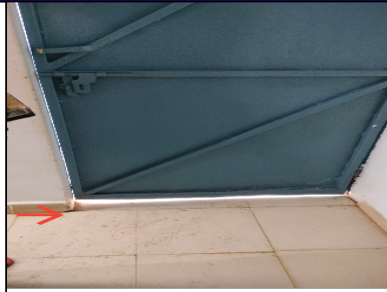
Location	Hygiene entrance area	19-06-2023	22-06-2023
		Cleaning / sanitation & Housekeeping Issues	Nil		
		Structural Issue (Pest harbourages)	Gap observed between the door bottom		
		Access Issues	Nil		
		Description of Pest Infestation	It is Serious Thread for frog's,Flies, Lizards, Spiders, & Aphids.		
		Any other observations	Nil		
		Preventive Action suggested to customer	Door bottom should be placed rubber beading without any gaps.		
		Curative action from	We are instructed to Technician for Regular Monitoring.

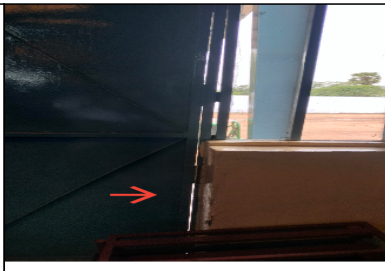
2

Location	Mango receiving area	19-06-2023	22-06-2023
		Cleaning / sanitation & Housekeeping Issues	Nil		
		Structural Issue (Pest harbourages)	Gaps Observed between Door Frame and door		
		Access Issues	Nil		
		Description of Pest Infestation	It is Serious Thread for Flies, Lizards & Cockroaches.		
		Any other observations	Nil		
		Preventive Action suggested to customer	That gaps should be closed with rubber beading without any gaps.		
		Curative action from	We are instructed to Technician for Regular Monitoring.		
External Premises				REVIEW DATE	COMPLETION DATE
1

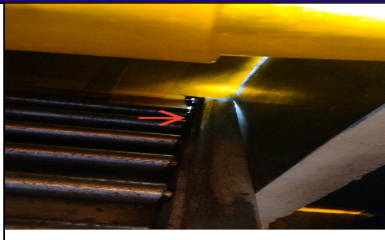
Location	RM fruit conveyor line area	19-06-2023	22-06-2023
		Cleaning / sanitation & Housekeeping Issues	Nil		
		Structural Issue (Pest harbourages)	Gap observed between the fruit conveyor line		
		Access Issues	Ni		
		Description of Pest Infestation	It is Serious Thread for Flies, Lizards & Cockroaches.		
		Any other observations	Nil

Preventive Action suggested to customer	Gap should be closed with rubber beading.		
		Curative action from	We are instructed to Technician for Regular Monitoring.		
Internal Premises				REVIEW DATE	COMPLETION DATE
1

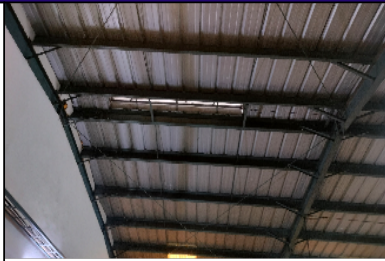
Location	RM AREA INNER	19-06-2023	22-06-2023
		Cleaning / sanitation & Housekeeping Issues	Nil		
		Structural Issue (Pest harbourages)	Gap observed between the roof sheet area		
		Access Issues	Over hight		
		Description of Pest Infestation	It is serious thread for lizards ants spider rodent		
		Any other observations	Nil		
		Preventive Action suggested to customer	Air circulation purpose fixed in that area put mesh without any gaps.		
		Curative action from	We are instructed to Technician for Regular Monitoring.		
2

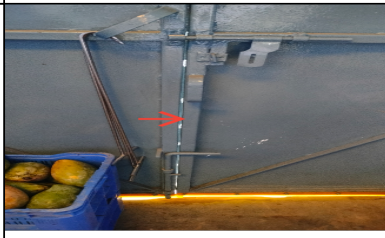
Location	RM fruit receiving area main door.	19-06-2023	22-06-2023
		Cleaning / sanitation & Housekeeping Issues	Nil		
		Structural Issue (Pest harbourages)	Gap observed between the doors

Access Issues	Nil		
		Description of Pest Infestation	It is Serious Thread for Flies, Lizards & Cockroaches.		
		Any other observations	Nil		
		Preventive Action suggested to customer	Doors gaps closed with rubber beading.		
		Curative action from	We are instructed to Technician for Regular Monitoring.

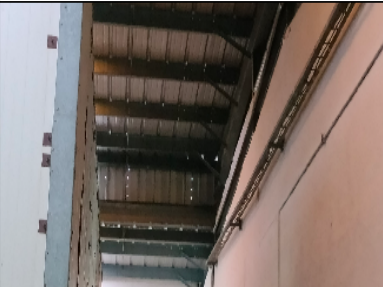
Location	Drying area near lab top sides	22-06-2023	22-06-2023
		Cleaning / sanitation & Housekeeping Issues	Nil		
		Structural Issue (Pest harbourages)	Gaps Observed between roof sheet to Wall sheet Door and Door Frame		
		Access Issues	Work at height		
		Description of Pest Infestation	It is Serious Threat for Lizards & Cockroaches.		
		Any other observations	Nil		
		Preventive Action suggested to customer	Gaps should be closed with cement concrete or silicon sealent

Curative action from	We are instructed to Technician for Regular Monitoring.		
5

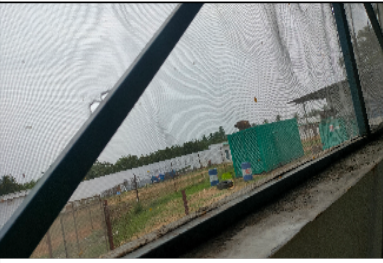
Location	Drying area	19-06-2023	22-06-2023
		Cleaning / sanitation & Housekeeping Issues	Nil		
		Structural Issue (Pest harbourages)	Mesh was Damaged Condition		
		Access Issues	Nil		
		Description of Pest Infestation	It is Serious Threat for flies, lizard, Cockroaches.		
		Any other observations	Nil		
		Preventive Action suggested to customer	Mesh to be replaced or closed with mesh without any gaps.		
		Curative action from	We are instructed to Technician for Regular Monitoring.		
6

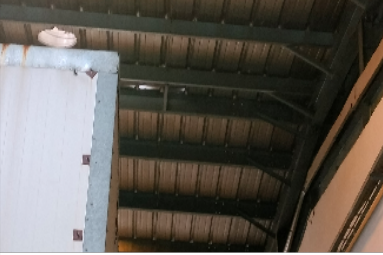
Location	Drying area	19-06-2023	22-06-2023
		Cleaning / sanitation & Housekeeping Issues	Nil		
		Structural Issue (Pest harbourages)	Root top gaps observed		
		Access Issues	Nil		
		Description of Pest Infestation	IT is serious thread for lizards, crawling insects		
		Any other observations	Nil		
		Preventive Action suggested to customer	Gap should be closed with silicone sealant without any gaps

Curative action from	We are instructed to Technician for Regular Monitoring.

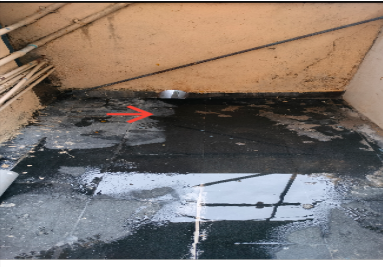
Location	Drying area	19-06-2023	22-06-2023
		Cleaning / sanitation & Housekeeping Issues	Nil		
		Structural Issue (Pest harbourages)	Waste water pipe line hole was opened condition		
		Access Issues	Nil		
		Description of Pest Infestation	It is serious threat for rodent, lizard, frog's, crawling insects and flying insects.		
		Any other observations	Nil		
		Preventive Action suggested to customer	Pipe hole should be closed with mesh without any gaps.

Curative action from	We are instructed to Technician for Regular Monitoring.		
9

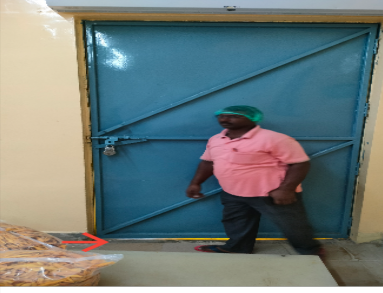
Location	FG loading area	19-06-2023	22-06-2023
		Cleaning / sanitation & Housekeeping Issues	Nil		
		Structural Issue (Pest harbourages)	Door bottom gaps observed		
		Access Issues	Nil		
		Description of Pest Infestation	It is serious threat for rodent, snake, lizard, cockroach flying insects and crawling insects		
		Any other observations	Nil		
		Preventive Action suggested to customer	Door bottom should be closed with rubber beading without any gaps		
		Curative action from	We are instructed to Technician for Regular Monitoring.		
10

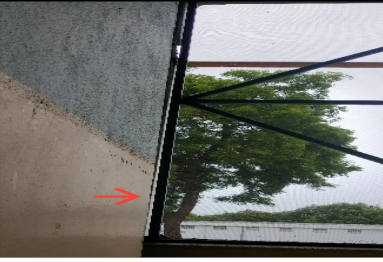
Location	Drying area	19-06-2023	22-06-2023
		Cleaning / sanitation & Housekeeping Issues	Nil		
		Structural Issue (Pest harbourages)	Mesh frame not fixed properly.		
		Access Issues	Nil		
		Description of Pest Infestation	IT is serious threat for lizards, crawling insects and flying insects

Any other observations	Nil		
		Preventive Action suggested to customer	Mesh frame should be placed without any gaps		
		Curative action from	We are instructed to Technician for Regular Monitoring.

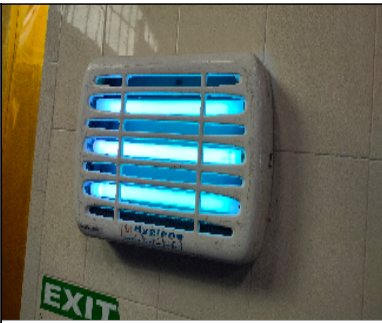
11

Location	Drying area, packing area and hygiene area	19-06-2023	22-06-2023
		Cleaning / sanitation & Housekeeping Issues	Nil		
		Structural Issue (Pest harbourages)	Nil		
		Access Issues	Fly catcher machine fixed over hight.		
		Description of Pest Infestation	It is serious thread for flying insects and lizard		
		Any other observations	3 fly catcher machine not sufficient in this plant		
		Preventive Action suggested to customer	All 3 fly catcher machine should be placed 5 and 1/2 feet or 6 feet level only. Additional 3 fly catcher machine required (1- packing section, 1- cutting area, 1- FG loading area).		
		Curative action from	We are instructed to Technician for Regular Monitoring.		
12

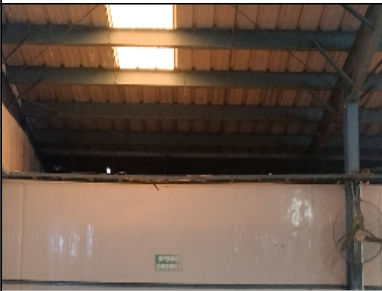
Location	RM roof to wall sheet area	19-06-2023	22-06-2023
		Cleaning / sanitation & Housekeeping Issues	Nil		
		Structural Issue (Pest harbourages)	Gap observed between the wall sheet to roof sheet

Access Issues	Nil		
		Description of Pest Infestation	It is Serious Thread for spiders, lizard and crawling insects		
		Any other observations	Nil		
		Preventive Action suggested to customer	Sheet to sheet gap should be closed with silicone sealant without any gaps.		
		Curative action from	We are instructed to Technician for Regular Monitoring.		
Note: Note: In General your all window mesh will be replaced all windows. Also in Processing area. Fly Killer Machine will be placed to Fly Catcher Machines					
For Pest Control Experts			For M/s. Levtrue Wellness Pvt Ltd ,		
Authorized Signature.			Authorized Signature.		
Name: SURESH KUMAR.V			Name:		
Designation: MANAGER			Designation:		
Emp.Code: 002			Emp.Code:		
Phone Number: 9087200011			Phone Number:
