PEST CONTROL EXPERTS

Facility Name & Address: Sri Varsha Integrated Food Park Pvt Ltd , Kodur, Kadapa Dist,	Audited On: 22-01-2024
Audited By: SURESH KUMAR.V	
Client Contact Person Name: Mr. Sendhil QC	PC Experts Contact Person Name: SURESH KUMAR.V
Client Contact Person No: 9940284651	PC Experts Contact Person No: 8248672110

FACILITY SURROUNDING

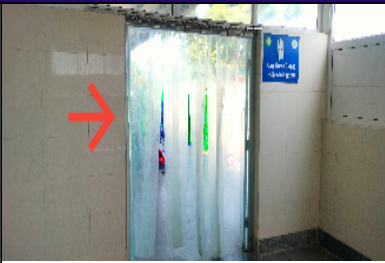
Location	Fruit Washing area		
		Cleaning / sanitation & Housekeeping Issues	Nil		
		Structural Issue (Pest harbourages)	At the time of inspection Doors was opened condition		
		Access Issues	Nil		
		Description of Pest Infestation	It is Serious Threat for Ants, flies, other crawling insects		
		Any other observations	Nil		
		Preventive Action suggested to customer	Doors should be closed		
		Curative action from	We are instructed to Technician for Regular Monitoring.

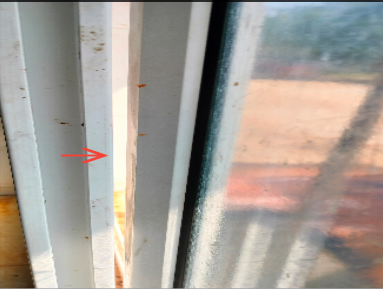
4

Location	Main building (Fruit waste conveyor line near window)		
		Cleaning / sanitation & Housekeeping Issues	Nil		
		Structural Issue (Pest harbourages)	Fruit waste conveyor line near window frame gaps observed		
		Access Issues	Nil		
		Description of Pest Infestation	It is Serious Threat for Ants, beetle, flies and lizards		
		Any other observations	Nil		
		Preventive Action suggested to customer	Gap should be closed with rubber breading or out side should be placed mesh		
		Curative action from	We are instructed to Technician for Regular Monitoring.		
5

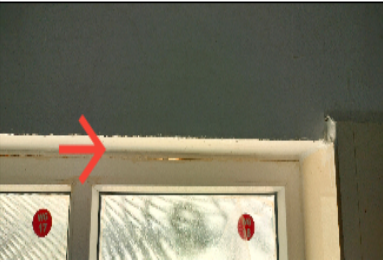
Location	Main building (window frame)		
		Cleaning / sanitation & Housekeeping Issues	Nil		
		Structural Issue (Pest harbourages)	Cutting conveyor line near Window frame to Wall gap observed.		
		Access Issues	Nil		
		Description of Pest Infestation	It is Serious Threat for Ants, beetles, flies		
		Any other observations	Nil		
		Preventive Action suggested to customer	Gap will be closed with cement mortar or Foam Sealant.

Curative action from	We are instructed to Technician for Regular Monitoring.

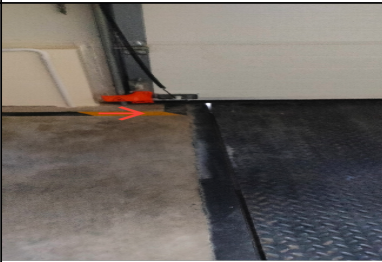
Location	Dispatch area		
		Cleaning / sanitation & Housekeeping Issues	Nil		
		Structural Issue (Pest harbourages)	Lifting area we observed gap		
		Access Issues	Nil		
		Description of Pest Infestation	It is Serious Threat for Ants, lizard, other crawling insects		
		Any other observations	Nil		
		Preventive Action suggested to customer	Gap should be closed with rubber breadding		
		Curative action from	We are instructed to Technician for Regular Monitoring.

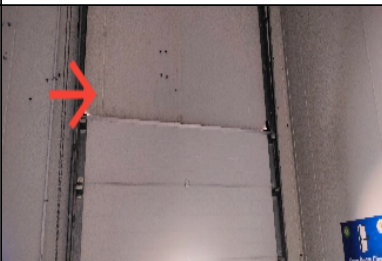
8

Location	Dispatch area		
		Cleaning / sanitation & Housekeeping Issues	Nil		
		Structural Issue (Pest harbourages)	shutter top side gap observed		
		Access Issues	Nil		
		Description of Pest Infestation	It is Serious Threat for Ants, beetles, lizard and flying insects		
		Any other observations	Nil		
		Preventive Action suggested to customer	Gap should be closed with rubber breadding		
		Curative action from	We are instructed to Technician for Regular Monitoring.		
External Premises				REVIEW DATE	COMPLETION DATE

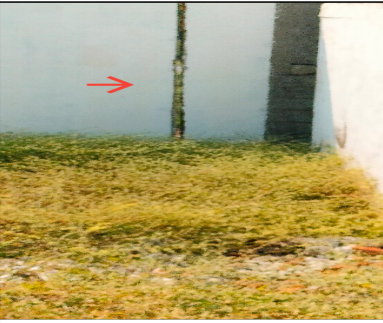
9

Location	COMPOUND WALL IN SIDE		
		Cleaning / sanitation & Housekeeping Issues	Thick vegetation observed		
		Structural Issue (Pest harbourages)	Gap observed between the compound wall to wall		
		Access Issues	Nil		
		Description of Pest Infestation	It is Serious Threat for Snakes, Rodent, lizards, Ants and other crawling insects		
		Any other observations	Nil		
		Preventive Action suggested to customer	Thick vegetation should be clean on regular basis. Gap should be closed with cement concrete or rubber breading between the wall gaps.		
		Curative action from	We are instructed to Technician for Regular Monitoring.		
10

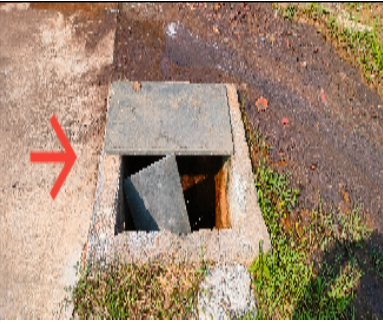
Location	Fruit waste receiving area		
		Cleaning / sanitation & Housekeeping Issues	Waste water stagnated the near building		
		Structural Issue (Pest harbourages)	Manhole lid was damaged and not closed properly		
		Access Issues	Nil		
		Description of Pest Infestation	It is Serious Threat for Beetles, flies, rodent, cockroach, mosquitoes lizard, snakes and other crawling insects

Any other observations	Nil		
		Preventive Action suggested to customer	Manhole lid should be changed and closed properly without any gaps. Don't allow the waste water stagnated around the building surrounding		
		Curative action from	We are instructed to Technician for Regular Monitoring.		
11

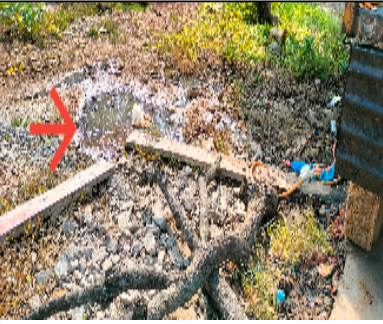
Location	Fruit waste receiving area near		
		Cleaning / sanitation & Housekeeping Issues	Waste water stagnated and don't allow the materials near by building.		
		Structural Issue (Pest harbourages)	Nil		
		Access Issues	Nil		
		Description of Pest Infestation	It is Serious Threat for Ants, flies, cockroach, lizard, rodent, snakes and other crawling insects		
		Any other observations	Nil		
		Preventive Action suggested to customer	Don't allow the waste water near by building. Don't keep the materials near by building surrounding		
		Curative action from	We are instructed to Technician for Regular Monitoring.

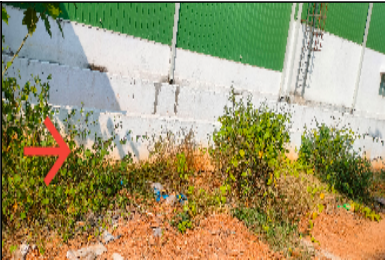
12

Location	Main building back side		
		Cleaning / sanitation & Housekeeping Issues	Thick vegetation observed		
		Structural Issue (Pest harbourages)	Nil		
		Access Issues	Nil		
		Description of Pest Infestation	It is Serious Threat for snakes, rodent, beetles, lizard and other crawling insects		
		Any other observations	Nil		
		Preventive Action suggested to customer	Thick vegetation should be clean on regular basis		
		Curative action from	We are instructed to Technician for Regular Monitoring.		
13

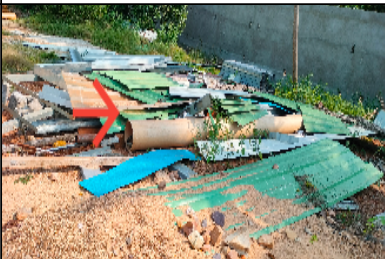
Location	Main building back side		
		Cleaning / sanitation & Housekeeping Issues	Nil		
		Structural Issue (Pest harbourages)	Nil		
		Access Issues	Unused materials stored		
		Description of Pest Infestation	It is Serious Threat for snakes, Rodent and other crawling insects		
		Any other observations	Nil		
		Preventive Action suggested to customer	Don't Store the materials near by building surrounding

Curative action from	We are instructed to Technician for Regular Monitoring.		
14

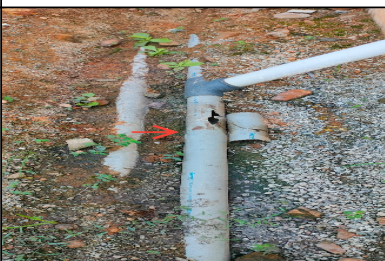
Location	Conference Hall outer		
		Cleaning / sanitation & Housekeeping Issues	Nil		
		Structural Issue (Pest harbourages)	Pipe was damaged condition		
		Access Issues	Nil		
		Description of Pest Infestation	It is Serious Threat for Cockroaches, Ants, Rodent, other crawling insects		
		Any other observations	Nil		
		Preventive Action suggested to customer	Pipe should be replaced		
		Curative action from	We are instructed to Technician for Regular Monitoring.
