PEST CONTROL EXPERTS

Facility Name & Address: RMM FOOD PRODUCTS PRIVATE LIMITED , Chittoor	Audited On: 13-05-2024
Audited By: SURESH KUMAR.V	
Client Contact Person Name: Mr. Chengal Reddy	PC Experts Contact Person Name: SURESH KUMAR.V
Client Contact Person No: 9441911123	PC Experts Contact Person No: 8248672110

Internal Premises			REVIEW DATE	COMPLETION DATE	
1

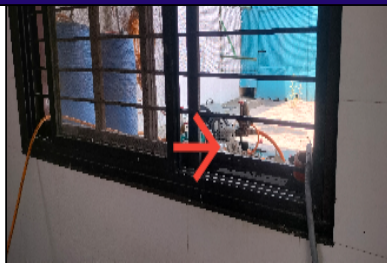
Location	Main process hall		
		Cleaning / sanitation & Housekeeping Issues	Nil		
		Structural Issue (Pest harbourages)	Mesh was Damaged Condition		
		Access Issues	Nil		
		Description of Pest Infestation	It is Serious Threat for Ants, beetle, Lizard, cockroach and Rodent		
		Any other observations	Nil		
		Preventive Action suggested to customer	Mesh to be replaced without any gaps		
		Curative action from	We are instructed to Technician for Regular Monitoring.

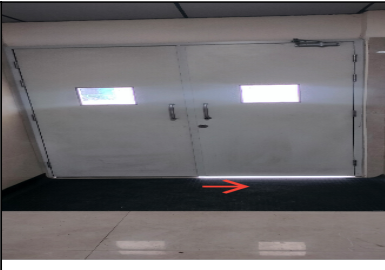
2

Location	Hygienic Entrance area		
		Cleaning / sanitation & Housekeeping Issues	Nil		
		Structural Issue (Pest harbourages)	Gaps Observed between bottom of the Door and Floor		
		Access Issues	Nil		
		Description of Pest Infestation	It is Serious Threat for Ants, beetle, flies, Lizard, cockroach		
		Any other observations	Nil		
		Preventive Action suggested to customer	Gap should be closed with rubber beading		
		Curative action from	We are instructed to Technician for Regular Monitoring.		
3

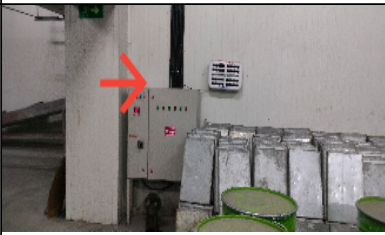
4

Location	Frozen area		
		Cleaning / sanitation & Housekeeping Issues	Nil		
		Structural Issue (Pest harbourages)	Nil		
		Access Issues	Fly catcher machine not worked		
		Description of Pest Infestation	It is Serious Threat for Ants, beetle, lizard flies		
		Any other observations	Nil		
		Preventive Action suggested to customer	Fly Catcher machine should be working condition		
		Curative action from	We are instructed to Technician for Regular Monitoring.		
5

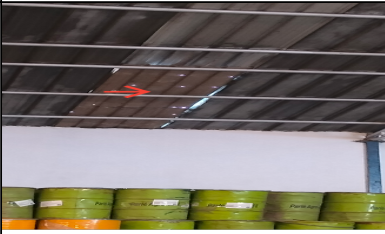
Location	FG area		
		Cleaning / sanitation & Housekeeping Issues	Nil		
		Structural Issue (Pest harbourages)	Root sheet was damaged condition		
		Access Issues	Nil		
		Description of Pest Infestation	It is Serious Threat for Ants, lizard		
		Any other observations	Nil		
		Preventive Action suggested to customer	Sheet should be replaced		
		Curative action from	We are instructed to Technician for Regular Monitoring.

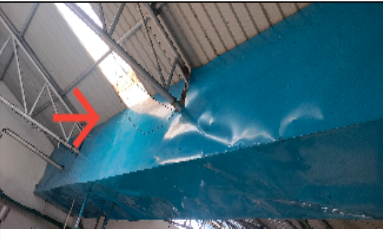
6

Location	Processing Hall					
		Cleaning / sanitation & Housekeeping Issues	Nil					
		Structural Issue (Pest harbourages)	Roof sheet damaged					
		Access Issues	Nil					
		Description of Pest Infestation	It is Serious Threat for Ants, lizard					
		Any other observations	Nil					
		Preventive Action suggested to customer	Roof sheet should be replaced					
		Curative action from	We are instructed to Technician for Regular Monitoring.					
7

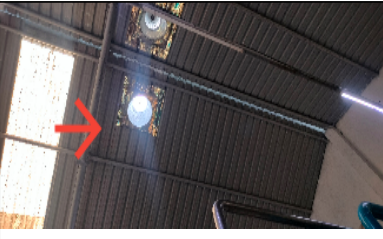
Location	Processing Hall					
		Cleaning / sanitation & Housekeeping Issues	Nil					
		Structural Issue (Pest harbourages)	Roof exhaust fan not available					
		Access Issues	Nil					
		Description of Pest Infestation	It is Serious Threat for Beetles, lizard					
		Any other observations	Nil					
		Preventive Action suggested to customer	Exhaust fan should be placed					
		Curative action from	We are instructed to Technician for Regular Monitoring.					
External Premises				REVIEW DATE	COMPLETION DATE

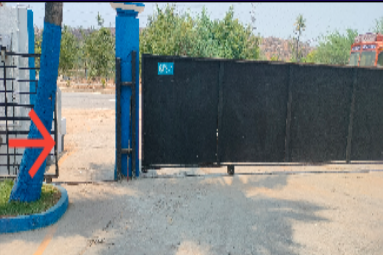
8

Location	Main Gate					
		Cleaning / sanitation & Housekeeping Issues	Nil					
		Structural Issue (Pest harbourages)	Main and back side gate bottom gaps observed					
		Access Issues	Nil					
		Description of Pest Infestation	It is Serious Threat for Ants, Snakes, Rodent					
		Any other observations	Nil					
		Preventive Action suggested to customer	Bottom of the gate should be closed with rubber beading					
		Curative action from	We are instructed to Technician for Regular Monitoring.					
Note:								
For Pest Control Experts Authorized Signature. Name: SURESH KUMAR.V Designation: MANAGER Emp.Code: 002 Phone Number: 8248672110
