PEST CONTROL EXPERTS

Facility Name & Address: LCN Industries , Chittoor	Audited On: 09-09-2025
Audited By: SURESH KUMAR.V	
Client Contact Person Name: Mr. Chanukya Naidu	PC Experts Contact Person Name: SURESH KUMAR.V
Client Contact Person No: 9440274003	PC Experts Contact Person No: 8248672110

FACILITY SURROUNDING

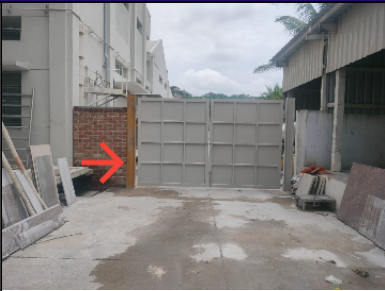
1

Location	Factory backside gate		
	Cleaning / sanitation & Housekeeping Issues	Nil		
	Structural Issue (Pest harbourages)	Gate bottom and gate sides gaps observed		
	Access Issues	Nil		
	Description of Pest Infestation	It is Serious Threat for Ants, Rodents, lizards, snakes and other crawling insects		
	Any other observations	Nil		
	Preventive Action suggested to customer	Gap should be closed with metal sheets or mesh or rubber beading.		
	Curative action from	We are instructed to Technician for Regular Monitoring.

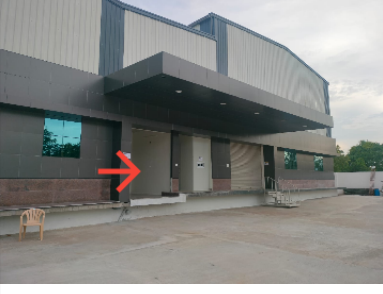
Location	Main building all hygiene and materials receiving area.		
		Cleaning / sanitation & Housekeeping Issues	Nil		
		Structural Issue (Pest harbourages)	All entry points PVC strips and Aircutains not fixed		
		Access Issues	Nil		
		Description of Pest Infestation	It is Serious Threat for Ants, lizards, cockroaches, Rodents, flying insects and other crawling insects

Any other observations	Nil		
		Preventive Action suggested to customer	All entry points should be placed PVC strips and Aircutains without any gaps.		
		Curative action from	We are instructed to Technician for Regular Monitoring.		
3

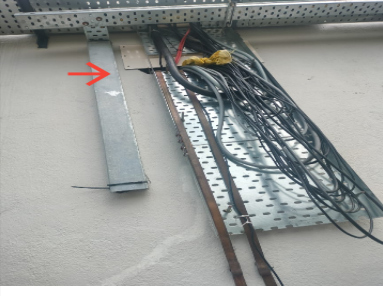
4

Location	Main building cable trench area (Salt and sugar).		
		Cleaning / sanitation & Housekeeping Issues	Nil		
		Structural Issue (Pest harbourages)	Wall to Cable trench surroundings Gap observed		
		Access Issues	Nil		
		Description of Pest Infestation	It is Serious Threat for Ants, beetles, lizards, flying insects and other crawling insects		
		Any other observations	Nil		
		Preventive Action suggested to customer	Gap should be closed with form sealent without any gaps		
		Curative action from	We are instructed to Technician for Regular Monitoring.

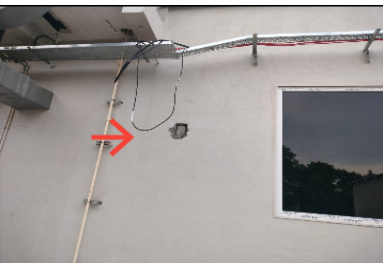
7

Location	Main building backside area		
		Cleaning / sanitation & Housekeeping Issues	Nil		
		Structural Issue (Pest harbourages)	Gap noticed between the wall to wall brick		
		Access Issues	Nil		
		Description of Pest Infestation	It is Serious Threat for Ants, lizards, other crawling insects		
		Any other observations	Nil		
		Preventive Action suggested to customer	Gap should be closed with cement.		
		Curative action from	We are instructed to Technician for Regular Monitoring.

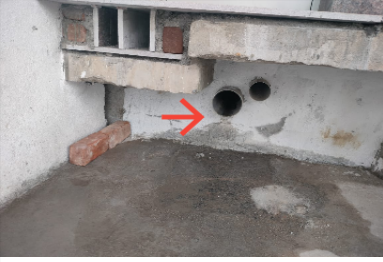
Location	Main building (water outlet pipe line)		
		Cleaning / sanitation & Housekeeping Issues	Nil		
		Structural Issue (Pest harbourages)	Pipe lid not placed		
		Access Issues	Nil		
		Description of Pest Infestation	It is Serious Threat for Ants, mosquito, beetles lizards flying insects and other crawling insects.		
		Any other observations	Nil		
		Preventive Action suggested to customer	Mesh type lid should be placed

Curative action from	We are instructed to Technician for Regular Monitoring.		
12

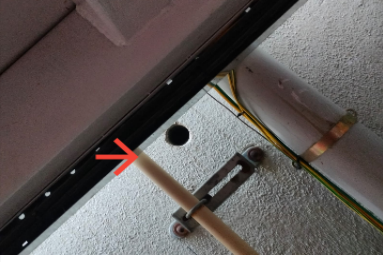
13

Location	Main building outer area (vessels back side)		
		Cleaning / sanitation & Housekeeping Issues	Nil		
		Structural Issue (Pest harbourages)	Hole observed on the Wall		
		Access Issues	Nil		
		Description of Pest Infestation	It is Serious Threat for Ants, lizards and other crawling insects.		
		Any other observations	Nil		
		Preventive Action suggested to customer	Hole should be closed with cement		
		Curative action from	Nil

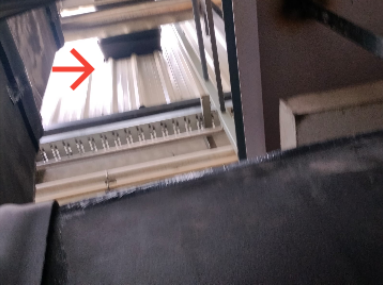
17

Location	Main building outer area (AHU line area)		
		Cleaning / sanitation & Housekeeping Issues	Nil		
		Structural Issue (Pest harbourages)	AHU line surroundings gaps noticed		
		Access Issues	Nil		
		Description of Pest Infestation	It is Serious Threat for Beetles,ants, lizards, flying insects and other crawling insects

Any other observations	Nil		
		Preventive Action suggested to customer	Gap should be closed with form sealent without any gaps		
		Curative action from	We are instructed to Technician for Regular Monitoring.

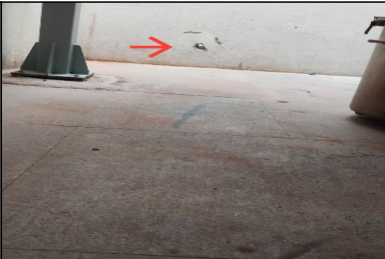
Location	Main building backside area (vessels area backside)		
		Cleaning / sanitation & Housekeeping Issues	Nil		
		Structural Issue (Pest harbourages)	Hole observed in Wall		
		Access Issues	Nil		
		Description of Pest Infestation	It is Serious Threat for Ants., lizards, Rodents, snakes and other crawling insects		
		Any other observations	Nil		
		Preventive Action suggested to customer	Hole should be closed with cement		
		Curative action from	We are instructed to Technician for Regular Monitoring.		
18

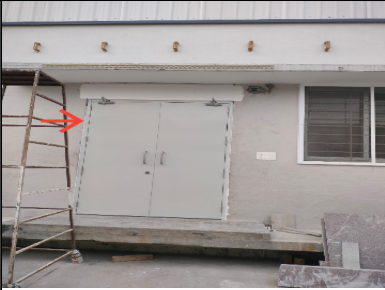
Location	Main building backside (FG outer area)		
		Cleaning / sanitation & Housekeeping Issues	Nil		
		Structural Issue (Pest harbourages)	PVC strips and Aircutains not fixed.		
		Access Issues	Nil		
		Description of Pest Infestation	It is Serious Threat for Beetles, lizards, ant, flying insects cockroaches and other crawling insects		
		Any other observations	Nil		
		Preventive Action suggested to customer	All entry points should be placed PVC strips and Aircutains without any gaps

Curative action from	We are instructed to Technician for Regular Monitoring.
