Facility Name & Address: LCN INDUSTRIES , Chittoor	Audited On: 09-09-2025
Audited By: SURESH KUMAR.V	
Client Contact Person Name: mr.chanukya Naidu	PC Experts Contact Person Name: SURESH KUMAR.V
Client Contact Person No: 9440274003	PC Experts Contact Person No: 8248672110

FACILITY SURROUNDING

Internal Premises				REVIEW DATE	COMPLETION DATE
1

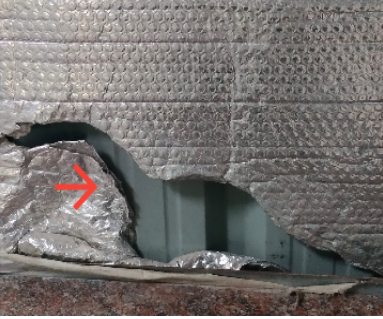
Location	Allergens packing material store 1st floor		
		Cleaning / sanitation & Housekeeping Issues	Nil		
		Structural Issue (Pest harbourages)	Wall to wall metal sheet gap observed & cooling sheets was damaged condition		
		Access Issues	Nil		
		Description of Pest Infestation	It is Serious Threat for Ants, beetles, spider, lizards flying insects and other crawling insects		
		Any other observations	Nil		
		Preventive Action suggested to customer	Gap should be closed with form sealent and replace the cooling sheets or sealed		
		Curative action from	We are instructed to Technician for Regular Monitoring.

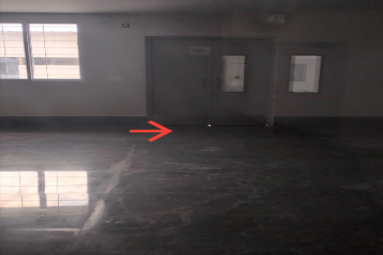
2

Location	FG store area		
		Cleaning / sanitation & Housekeeping Issues	Nil		
		Structural Issue (Pest harbourages)	Bottom of the gaps observed		
		Access Issues	Nil		
		Description of Pest Infestation	It is Serious Threat for Ants, beetles, lizards, flying insects and other crawling insects		
		Any other observations	Nil		
		Preventive Action suggested to customer	Gap should be closed with rubber beading		
		Curative action from	We are instructed to Technician for Regular Monitoring.		
3

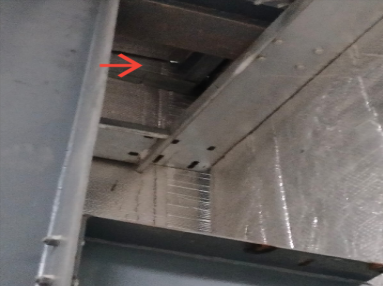
Location	Packing material store 1st floor		
		Cleaning / sanitation & Housekeeping Issues	Nil		
		Structural Issue (Pest harbourages)	Roof sheet joint corner we observed the gaps (both sides).		
		Access Issues	Nil		
		Description of Pest Infestation	It is Serious Threat for Ants, lizards, spiders, beetles, flying insects and other crawling insects		
		Any other observations	Nil		
		Preventive Action suggested to customer	Gaps should be closed with form sealent.

Curative action from	We are instructed to Technician for Regular Monitoring.		
4

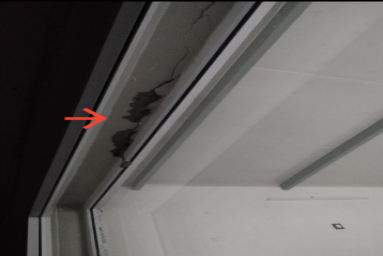
Location	FG and allergens store		
		Cleaning / sanitation & Housekeeping Issues	Nil		
		Structural Issue (Pest harbourages)	FG and allergens store between window frame near wall was damaged condition		
		Access Issues	Nil		
		Description of Pest Infestation	It is Serious Threat for Ants, cockroaches		
		Any other observations	Nil		
		Preventive Action suggested to customer	Damaged area will be plastered.		
		Curative action from	We are instructed to Technician for Regular Monitoring.

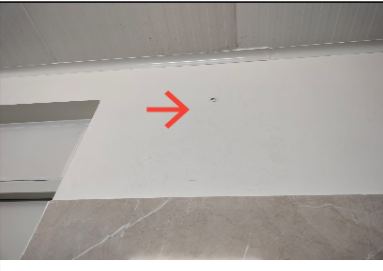
5

Location	Allergens area		
		Cleaning / sanitation & Housekeeping Issues	Nil		
		Structural Issue (Pest harbourages)	Holes was observed on wall		
		Access Issues	Nil		
		Description of Pest Infestation	It is Serious Threat for Ants, lizards, beetles and other crawling insects		
		Any other observations	Nil		
		Preventive Action suggested to customer	Holes should be closed with white cement		
		Curative action from	We are instructed to Technician for Regular Monitoring.		
6

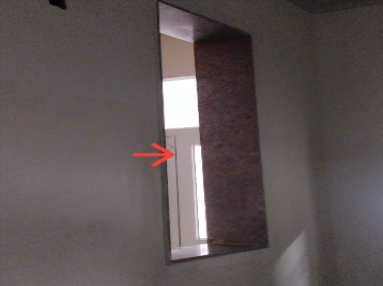
Location	Middle wall of the window from allergen to salt and sugar area.		
		Cleaning / sanitation & Housekeeping Issues	Nil		
		Structural Issue (Pest harbourages)	Opened condition (mesh not fixed).		
		Access Issues	Nil		
		Description of Pest Infestation	It is Serious Threat for Ants, beetles, lizards flying insects and other crawling insects		
		Any other observations	Nil		
		Preventive Action suggested to customer	Mesh window should be placed

Curative action from	We are instructed to Technician for Regular Monitoring.		
7

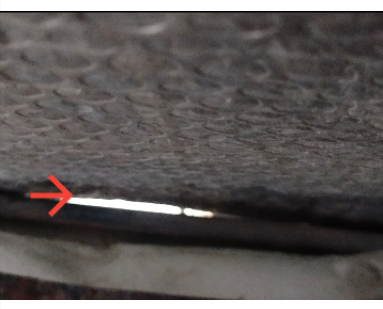
Location	Packing material store (1st floor)		
		Cleaning / sanitation & Housekeeping Issues	Nil		
		Structural Issue (Pest harbourages)	Wall sheet to wall between gap observed		
		Access Issues	Nil		
		Description of Pest Infestation	It is Serious Threat for Ants, lizards, flying insects, beetles and other crawling insects		
		Any other observations	Nil		
		Preventive Action suggested to customer	Gap should be closed with form sealent or cement without any gaps		
		Curative action from	We are instructed to Technician for Regular Monitoring.

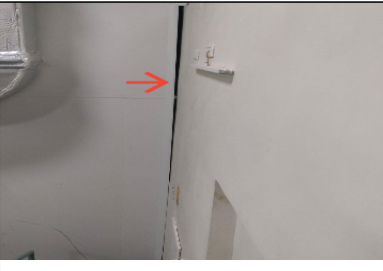
8

Location	Blender to 2nd packing are (steps area)		
		Cleaning / sanitation & Housekeeping Issues	Nil		
		Structural Issue (Pest harbourages)	Wall to from sheet between gaps observed		
		Access Issues	Nil		
		Description of Pest Infestation	It is Serious Threat for Ants, beetles, lizards, and other crawling insects		
		Any other observations	Nil		
		Preventive Action suggested to customer	Gap should be closed with form sealent		
		Curative action from	We are instructed to Technician for Regular Monitoring.		
9

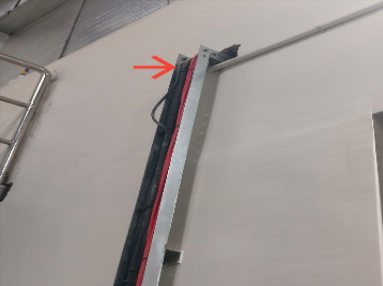
Location	Blender area		
		Cleaning / sanitation & Housekeeping Issues	Nil		
		Structural Issue (Pest harbourages)	Cable trench to wall between gaps observed		
		Access Issues	Nil		
		Description of Pest Infestation	It is Serious Threat for Ants, Rodents, lizards, other crawling insects		
		Any other observations	Nil		
		Preventive Action suggested to customer	Gap should be closed with form sealent or cement without any gaps

Curative action from	We are instructed to Technician for Regular Monitoring.		
10

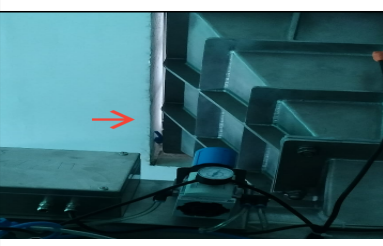
Location	Sugar grinding area		
		Cleaning / sanitation & Housekeeping Issues	Cobweb observed between the machine to 1st slap		
		Structural Issue (Pest harbourages)	Nil		
		Access Issues	Nil		
		Description of Pest Infestation	It is Serious Threat for Ants, spider		
		Any other observations	Nil		
		Preventive Action suggested to customer	Web should be clean on regular basis		
		Curative action from	We are instructed to Technician for Regular Monitoring.

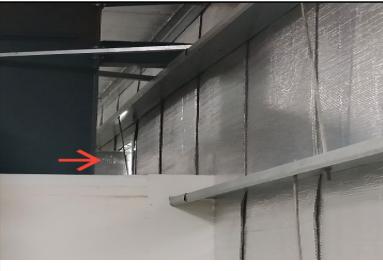
11

Location	Blender area (AHU line)		
		Cleaning / sanitation & Housekeeping Issues	Dust accumulated		
		Structural Issue (Pest harbourages)	AHU line to wall sheet between gaps observed		
		Access Issues	Nil		
		Description of Pest Infestation	It is Serious Threat for Beetles, flying insects, lizards and spider		
		Any other observations	Nil		
		Preventive Action suggested to customer	Gap should be closed with form sealent		
		Curative action from	We are instructed to Technician for Regular Monitoring.		
12

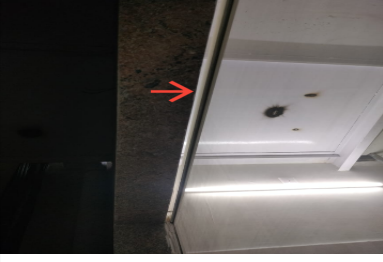
Location	Vessels washing area		
		Cleaning / sanitation & Housekeeping Issues	Nil		
		Structural Issue (Pest harbourages)	Window frame to wall between gap observed		
		Access Issues	Nil		
		Description of Pest Infestation	It is Serious Threat for Beetles, flying insects, lizards, ants and other crawling insects		
		Any other observations	Nil		
		Preventive Action suggested to customer	Gap should be closed with form sealent

Curative action from	We are instructed to Technician for Regular Monitoring.		
13

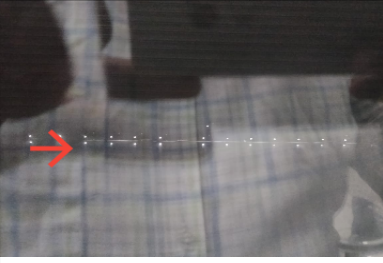
Location	Salt and sugar receiving area (shutter bottom)		
		Cleaning / sanitation & Housekeeping Issues	Nil		
		Structural Issue (Pest harbourages)	Shutter bottom gap noticed		
		Access Issues	NIL		
		Description of Pest Infestation	It is Serious Threat for Ants, beetles, lizards, flying insects and other crawling insects		
		Any other observations	Nil		
		Preventive Action suggested to customer	Shutter bottom rubber beading should be placed		
		Curative action from	We are instructed to Technician for Regular Monitoring.

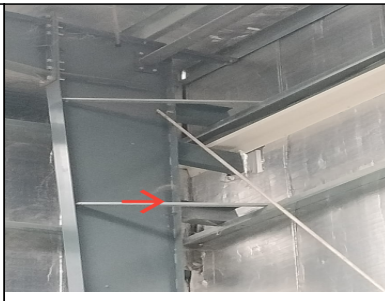
14

Location	Salt and sugar unloading area		
		Cleaning / sanitation & Housekeeping Issues	Spider Web observed		
		Structural Issue (Pest harbourages)	Roof corner we observed the gaps		
		Access Issues	Nil		
		Description of Pest Infestation	It is Serious Threat for Ants, beetles, spider, lizards flying insects and other crawling insects		
		Any other observations	Nil		
		Preventive Action suggested to customer	Spider Web should be clean on regular basis. Gap should be closed with form sealent		
		Curative action from	We are instructed to Technician for Regular Monitoring.		
15

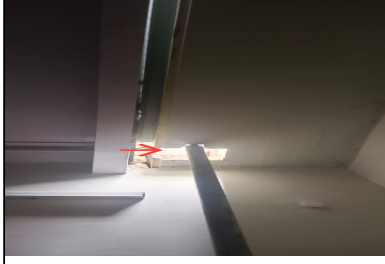
Location	Vessels washing area		
		Cleaning / sanitation & Housekeeping Issues	Nil		
		Structural Issue (Pest harbourages)	Roof top gap noticed		
		Access Issues	Nil		
		Description of Pest Infestation	It is Serious Threat for Ants, flying insects lizards, spider beetles and other crawling insects		
		Any other observations	Nil

Preventive Action suggested to customer	Gap should be closed		
		Curative action from	We are instructed to Technician for Regular Monitoring.		
16

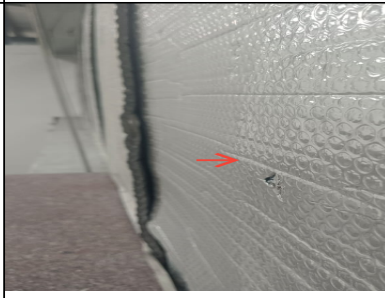
Location	Blender packing material store area		
		Cleaning / sanitation & Housekeeping Issues	Nil		
		Structural Issue (Pest harbourages)	Cooling sheets damaged and cooling sheets not sealed		
		Access Issues	Nil		
		Description of Pest Infestation	It is Serious Threat for Ants, beetles, spider, lizards, flying insects and other crawling insects		
		Any other observations	Nil		
		Preventive Action suggested to customer	Cooling sheets should be seal it, damaged palced should be paste it.		
		Curative action from	We are instructed to Technician for Regular Monitoring.		
Note: fly catcher machines 13 nos required.
