Facility Name & Address: Frozen Tropical Pvt Ltd , Chittoor	Audited On: 11-09-2023
Audited By: SURESH KUMAR.V	
Client Contact Person Name: Mr. Surendra QA	PC Experts Contact Person Name: SURESH KUMAR.V
Client Contact Person No: 7702187499	PC Experts Contact Person No: 9087200011

FACILITY SURROUNDING

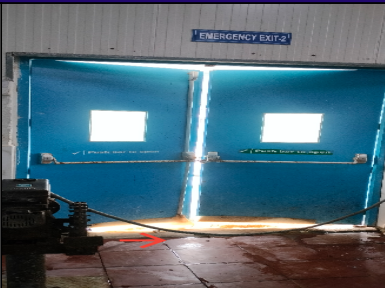
Location	Emergency exit door -2 area	
		Cleaning / sanitation & Housekeeping Issues	Nil	
		Structural Issue (Pest harbourages)	Bottom of doors gap observed.	
		Access Issues	Nil	
		Description of Pest Infestation	It is Serious Threat for Ants rodent, snakes, lizard, frog, flying insects and other crawling insects	
		Any other observations	Nil	
		Preventive Action suggested to customer	Bottom of door should be closed with cement concrete or rubber breading without any gaps.	
		Curative action from	We are instructed to Technician for Regular Monitoring.	
2

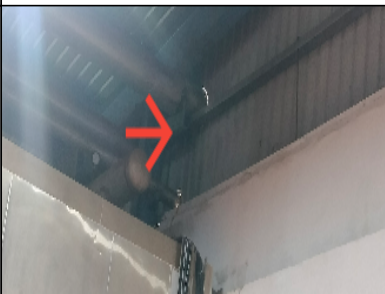
Location	Processing hall area	
		Cleaning / sanitation & Housekeeping Issues	Nil	
		Structural Issue (Pest harbourages)	Gap observed between the pipe to wall sheet	
		Access Issues	Nil	
		Description of Pest Infestation	It is Serious Threat for Ants, beetles, spider lizard and other crawling insects

Any other observations	Nil	
		Preventive Action suggested to customer	Arround the pipe line hole should be closed with rubber beading and silicone sealant.	
		Curative action from	We are instructed to Technician for Regular Monitoring.

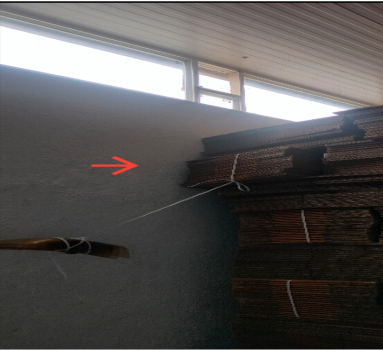
Location	Cotton boxes storage area		
		Cleaning / sanitation & Housekeeping Issues	Spider observed.		
		Structural Issue (Pest harbourages)	Mesh not fixed properly		
		Access Issues	Cotton boxes stored at Wall side without any gaps		
		Description of Pest Infestation	It is Serious Threat for Ants, spider, rodent, lizard, flying insects and other crawling insects		
		Any other observations	Nil		
		Preventive Action suggested to customer	Mesh should be placed without any gaps. Spider should be clean on regular basis. Don't allow the materials at wall side gap should be required wall to materials at least 2 feet distance.		
		Curative action from	We are instructed to Technician for Regular Monitoring.		
4

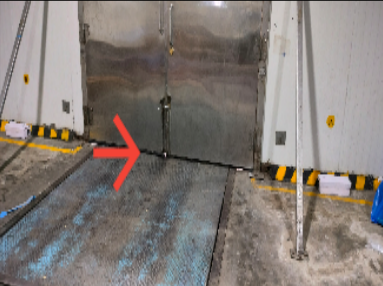
Location	Dispatch area		
		Cleaning / sanitation & Housekeeping Issues	Nil		
		Structural Issue (Pest harbourages)	Dispatch area doors under gap observed		
		Access Issues	Nil		
		Description of Pest Infestation	It is Serious Threat for Ants, lizard and other crawling insects

Any other observations	Nil		
		Preventive Action suggested to customer	Gap should be closed with rubber beading without any gaps.		
		Curative action from	We are instructed to Technician for Regular Monitoring.		
5

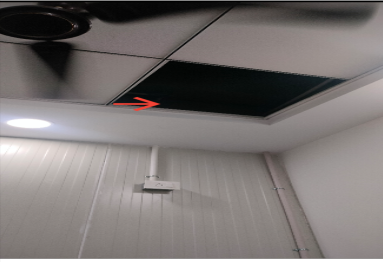
Location	QC room area		
		Cleaning / sanitation & Housekeeping Issues	Nil		
		Structural Issue (Pest harbourages)	False ceiling not closed properly		
		Access Issues	Nil		
		Description of Pest Infestation	It is Serious Threat for Beetles, cockroach, spider, ants, lizard and other crawling insects		
		Any other observations	Nil		
		Preventive Action suggested to customer	False ceiling should be closed with any gaps		
		Curative action from	We are instructed to Technician for Regular Monitoring.

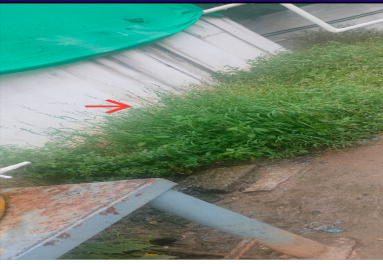
Location	RO plant surrounding		
		Cleaning / sanitation & Housekeeping Issues	Thick vegetation observed		
		Structural Issue (Pest harbourages)	Nil		
		Access Issues	Nil		
		Description of Pest Infestation	It is Serious Threat for Beetles, snakes, rodents, flying insects,, lizards, frogg and other crawling insects		
		Any other observations	Nil		
		Preventive Action suggested to customer	Thick vegetation should be clean on regular basis.		
		Curative action from	We are instructed to Technician for Regular Monitoring.		
2

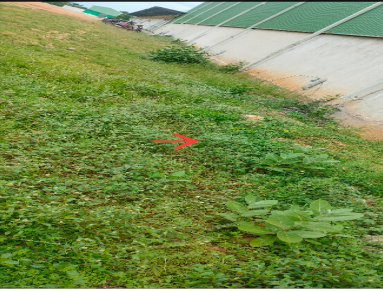
Location	Main building surrounding		
		Cleaning / sanitation & Housekeeping Issues	Thick vegetation observed		
		Structural Issue (Pest harbourages)	Nil		
		Access Issues	Nil		
		Description of Pest Infestation	It is Serious Threat for Ants, beetles, cockroach, lizards, snakes, rodents, flying insects and other crawling insects

Any other observations	Nil		
		Preventive Action suggested to customer	Thick vegetation should be clean on regular basis		
		Curative action from	We are instructed to Technician for Regular Monitoring.		
3

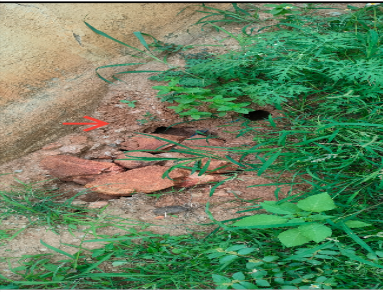
Location	Main building surrounding		
		Cleaning / sanitation & Housekeeping Issues	Thick vegetation observed and Rodent burrows observed.		
		Structural Issue (Pest harbourages)	Nil		
		Access Issues	Nil		
		Description of Pest Infestation	It is Serious Threat for Ants, rodents, snakes, frogg		
		Any other observations	Nil		
		Preventive Action suggested to customer	Thick vegetation should be clean on regular basis. Borrowers treatment to do our technician.		
		Curative action from	We are instructed to Technician for Regular Monitoring.

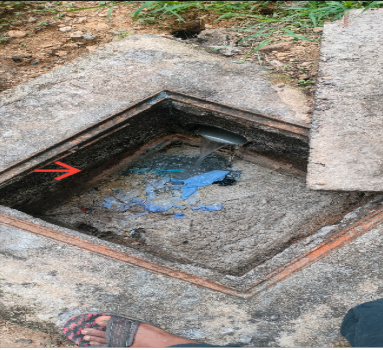
Location	Dispatch area		
		Cleaning / sanitation & Housekeeping Issues	Manhole Not cleaned properly, lid not closed properly. Waste Dumped near by facility		
		Structural Issue (Pest harbourages)	Nil		
		Access Issues	Nil		
		Description of Pest Infestation	It is Serious Threat for Ants, rodents, snakes, lizards, frogg, flying insects and other crawling insects

Any other observations	Nil		
		Preventive Action suggested to customer	Manhole should be closed with lid. Manhole should be clean on regular basis. Don't allow the waste near by facility Surrounding.		
		Curative action from	We are instructed to Technician for Regular Monitoring.		
6

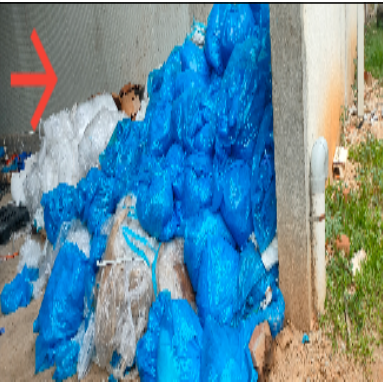
Location	Open godown area		
		Cleaning / sanitation & Housekeeping Issues	Lot of waste Dumped near by facility		
		Structural Issue (Pest harbourages)	Open godown door not available		
		Access Issues	All materials kept at wall side without any gaps		
		Description of Pest Infestation	It is Serious Threat for Ants, beetles, cockroach, rodent, snakes, lizard, frogg, flying insects and other crawling insects		
		Any other observations	Nil		
		Preventive Action suggested to customer	Open godown should be placed doors. Don't allow the materials at wall side gap should be required wall to materials at least one and half feet. Don't allow the waste materials near by facility

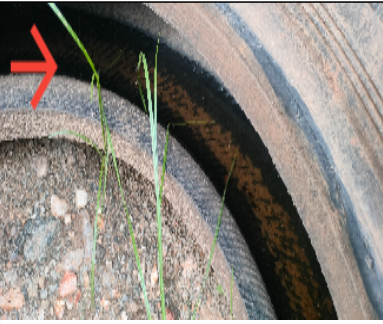
Location	Open godown area outside		
		Cleaning / sanitation & Housekeeping Issues	Rain water stagnated in tyre		
		Structural Issue (Pest harbourages)	Nil		
		Access Issues	Nil		
		Description of Pest Infestation	It is Serious Threat for mosquitoes, ants, rodent, snakes and frog		
		Any other observations	Nil		
		Preventive Action suggested to customer	Don't allow the unused material facility Surrounding. Don't allow the Rain water stagnated facility surrounding. Tyre should be removed.		
8

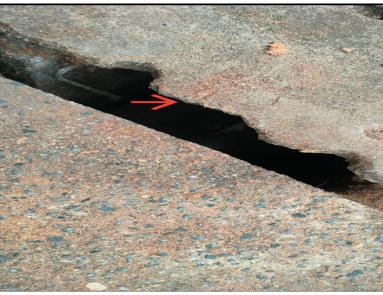
Any other observations	Nil		
		Preventive Action suggested to customer	Don't allow the water stagnated inside facility.		
		Curative action from	We are instructed to Technician for Regular Monitoring.		
		Location	RM area drainage line area		
		Cleaning / sanitation & Housekeeping Issues	Drainage line inside waste water stagnated.		
		Structural Issue (Pest harbourages)	Nil		
		Access Issues	Nil		
10

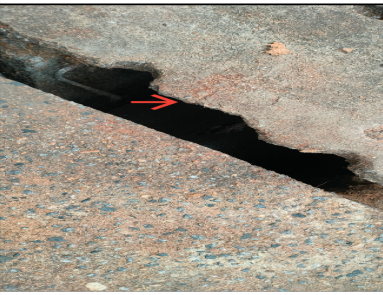
Description of Pest Infestation	It is Serious Threat for Ants, mosquitoes, rodents, snakes, lizard, flying insects and other crawling insects

Any other observations	Nil		
		Preventive Action suggested to customer	Drainage line should be clean on regular basis, don't allow the water stagnated.		
		Curative action from	We are instructed to Technician for Regular Monitoring.

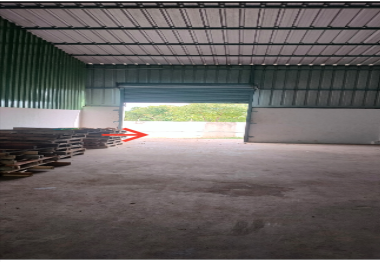
Location	RM area		
		Cleaning / sanitation & Housekeeping Issues	Nil		
		Structural Issue (Pest harbourages)	RM area shutter not closed.		
		Access Issues	Nil		
		Description of Pest Infestation	It is Serious Threat for Ants, flying insects, lizards, Snakes, rodent, spider and other crawling insects		
		Any other observations	Nil		
		Preventive Action suggested to customer	Shutter should be closed		
		Curative action from	We are instructed to Technician for Regular Monitoring.		
12

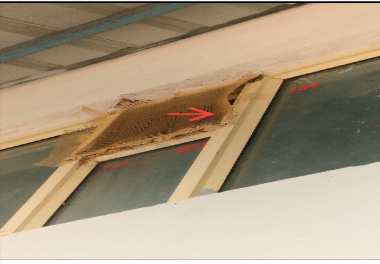
Location	Main building out side area		
		Cleaning / sanitation & Housekeeping Issues	Nil		
		Structural Issue (Pest harbourages)	Exhaust Mesh not fixed properly		
		Access Issues	Nil		
		Description of Pest Infestation	It is Serious Threat for Ants, flying insects, lizard and other crawling insects		
		Any other observations	Nil		
		Preventive Action suggested to customer	Mesh should be placed without any gaps.

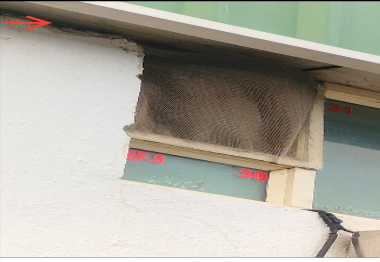
Location	Hygiene entrance area		
		Cleaning / sanitation & Housekeeping Issues	Nil		
		Structural Issue (Pest harbourages)	Gap observed between the wall to wall sheet area		
		Access Issues	Nil		
		Description of Pest Infestation	It is Serious Threat for Beetles, lizard, cockroaches, flying insects and other crawling insects		
		Any other observations	Nil		
		Preventive Action suggested to customer	Gap should be closed with cement concrete.		
		Curative action from	We are instructed to Technician for Regular Monitoring.		
14

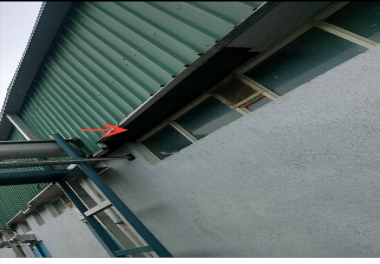
Location	Waste outlet conveyor line area		
		Cleaning / sanitation & Housekeeping Issues	Nil		
		Structural Issue (Pest harbourages)	Gap observed between the wall to wall sheet		
		Access Issues	Nil		
		Description of Pest Infestation	It is Serious Threat for Ants, lizard, spider and other crawling insects

Any other observations	Nil		
		Preventive Action suggested to customer	Gap should be closed with cement without any gaps		
		Curative action from	We are instructed to Technician for Regular Monitoring.		
Note: Nil
