PEST CONTROL EXPERTS

Facility Name & Address: Navya Foods Pvt Ltd , Chittoor	Audited On: 27-05-2024
Audited By: SURESH KUMAR.V	
Client Contact Person Name: Mr. Raghavendra (QH)	PC Experts Contact Person Name: SURESH KUMAR.V
Client Contact Person No: 9441588044	PC Experts Contact Person No: 8248672110

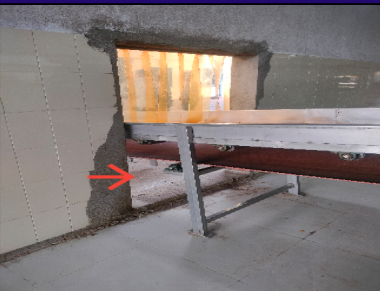
Location	Fruit Washing area		
		Cleaning / sanitation & Housekeeping Issues	Nil		
		Structural Issue (Pest harbourages)	Conveyor line to wall gaps noticed		
		Access Issues	Nil		
		Description of Pest Infestation	It is Serious Threat for Ants, snakes, rodent, lizard and flies		
		Any other observations	Nil		
		Preventive Action suggested to customer	Wall to conveyor line gaps should be closed permanently without any gaps (cement wall or sheet).		
		Curative action from	We are instructed to Technician for Regular Monitoring.

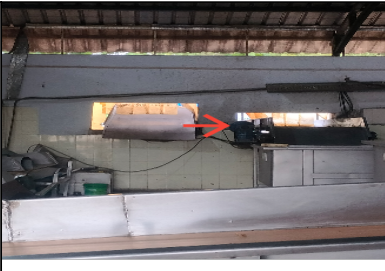
2

Location	Fruit Washing area		
		Cleaning / sanitation & Housekeeping Issues	Nil		
		Structural Issue (Pest harbourages)	Fruit conveyor line to wall gap noticed		
		Access Issues	Nil		
		Description of Pest Infestation	It is Serious Threat for Ants, flies, lizard and other crawling insects		
		Any other observations	Nil		
		Preventive Action suggested to customer	Gap should be closed with sheet without any gaps.		
		Curative action from	We are instructed to Technician for Regular Monitoring.		
3

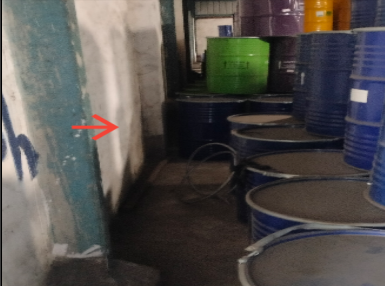
Location	FG area inside		
		Cleaning / sanitation & Housekeeping Issues	Nil		
		Structural Issue (Pest harbourages)	Nil		
		Access Issues	Drums are kept wall side without any gaps		
		Description of Pest Infestation	It is Serious Threat for Ants, rodent, lizard and snakes and other crawling insects		
		Any other observations	Nil		
		Preventive Action suggested to customer	Gap should be required from wall to material atleast 2 feet from wall to material.

Curative action from	We are instructed to Technician for Regular Monitoring.		
4

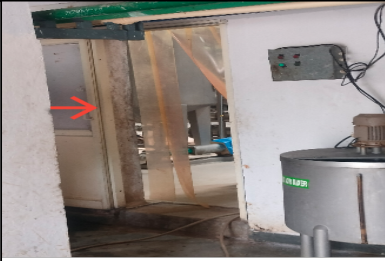
Location	Processing Hall		
		Cleaning / sanitation & Housekeeping Issues	Nil		
		Structural Issue (Pest harbourages)	Doors was opened condition		
		Access Issues	Nil		
		Description of Pest Infestation	It is Serious Threat for Ants, flies,. lizard and Rodent		
		Any other observations	Nil		
		Preventive Action suggested to customer	Processing Hall all window and doors should be closed without any gaps		
		Curative action from	We are instructed to Technician for Regular Monitoring.

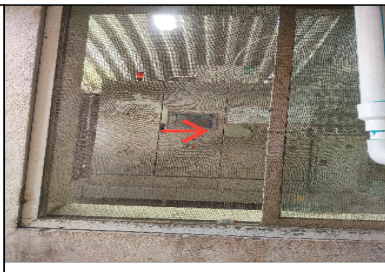
5

Location	Processing Hall		
		Cleaning / sanitation & Housekeeping Issues	Nil		
		Structural Issue (Pest harbourages)	Window mesh was damaged		
		Access Issues	Nil		
		Description of Pest Infestation	It is Serious Threat for Ants, beetle, flies, lizard and other crawling insects		
		Any other observations	Nil		
		Preventive Action suggested to customer	Window mesh should be replaced		
		Curative action from	We are instructed to Technician for Regular Monitoring.		
6

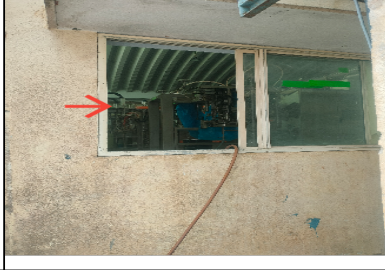
Location	Processing Hall		
		Cleaning / sanitation & Housekeeping Issues	Nil		
		Structural Issue (Pest harbourages)	Window was opened condition		
		Access Issues	Nil		
		Description of Pest Infestation	It is Serious Threat for Ants, beetle, flies, lizard and other crawling insects		
		Any other observations	Nil		
		Preventive Action suggested to customer	Window always closed without any gaps		
		Curative action from	We are instructed to Technician for Regular Monitoring.

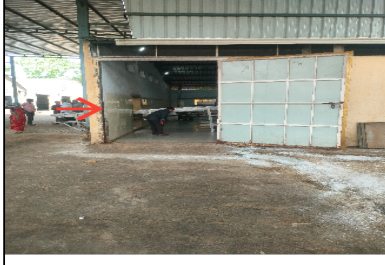
Location	Fruit Washing area		
		Cleaning / sanitation & Housekeeping Issues	Nil		
		Structural Issue (Pest harbourages)	Fruit Washing big door was opened condition		
		Access Issues	Nil		
		Description of Pest Infestation	It is Serious Threat for Ants, flies, rodent, lizard and snakes		
		Any other observations	Nil		
		Preventive Action suggested to customer	Door should be closed permanently without any gaps		
		Curative action from	We are instructed to Technician for Regular Monitoring.

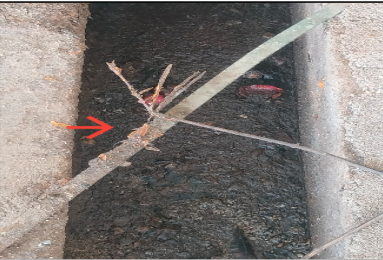
8

Location	Fruit Washing area out side		
		Cleaning / sanitation & Housekeeping Issues	Lot of waste stagnated the water running line		
		Structural Issue (Pest harbourages)	Nil		
		Access Issues	Nil		
		Description of Pest Infestation	It is Serious Threat for bettle, Flies and Ants cockroach other crawling insects		
		Any other observations	Nil		
		Preventive Action suggested to customer	Waste should be clean on regular basis		
		Curative action from	We are instructed to Technician for Regular Monitoring.		
9

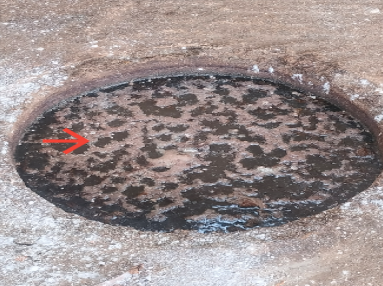
Location	Power plant area out side		
		Cleaning / sanitation & Housekeeping Issues	Waste water stagnated in the manhole		
		Structural Issue (Pest harbourages)	Nil		
		Access Issues	Nil		
		Description of Pest Infestation	It is Serious Threat for Ants, flies,. cockroach and other crawling insects		
		Any other observations	Nil		
10

Preventive Action suggested to customer	Waste water don't allow to stagnate surrounding facility, that should be clean on regular basis

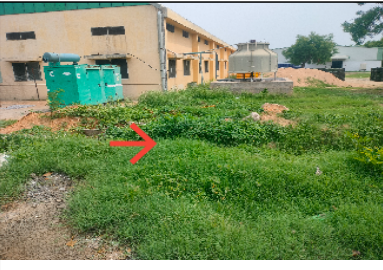
11

Location	Facility in side area		
		Cleaning / sanitation & Housekeeping Issues	Lot of Thick vegetation observed		
		Structural Issue (Pest harbourages)	Nil		
		Access Issues	Nil		
		Description of Pest Infestation	It is Serious Threat for Ants, snakes, rodent, cockroach, flies and other crawling insects		
		Any other observations	Nil		
		Preventive Action suggested to customer	Thick vegetation should be trim on regular basis		
		Curative action from	We are instructed to Technician for Regular Monitoring.		
12

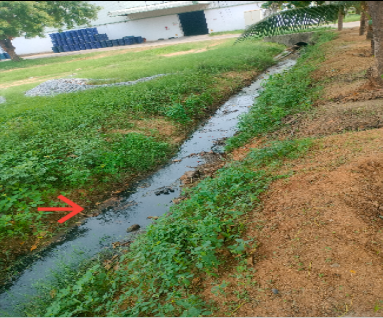
Location	Waste water running line area		
		Cleaning / sanitation & Housekeeping Issues	Lot of waste water stagnated in the water running line area		
		Structural Issue (Pest harbourages)	Nil		
		Access Issues	Nil		
		Description of Pest Infestation	It is Serious Threat for Ants, flies cockroach, and other flying and crawling insects		
		Any other observations	Nil		
		Preventive Action suggested to customer	Don't allow the waste water stagnate surrounding and running line area

Curative action from	We are instructed to Technician for Regular Monitoring.		
13

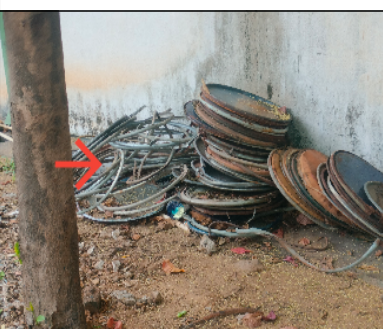
Location	FG area		
		Cleaning / sanitation & Housekeeping Issues	Lot of drums material dumped the building wall side		
		Structural Issue (Pest harbourages)	Shutter also not closed properly		
		Access Issues	Rodent Box also completely closed with cement		
		Description of Pest Infestation	It is Serious Threat for Ants, snakes, lizard, Rodent and other crawling insects		
		Any other observations	Nil		
		Preventive Action suggested to customer	Shutter should be closed godown not used time, don't allow the dumping of the material on wall side. Gap should be required from wall to material atleast 2 feet.		
		Curative action from	We are instructed to Technician for Regular Monitoring.

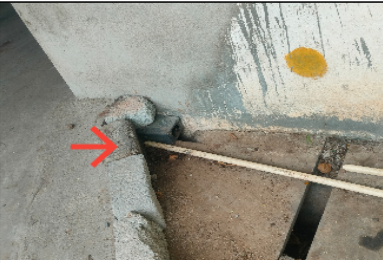
14

Location	FG area		
		Cleaning / sanitation & Housekeeping Issues	Nil		
		Structural Issue (Pest harbourages)	Box was closed with concrete		
		Access Issues	Rodent Box we can't able to access		
		Description of Pest Infestation	It is Serious Threat for Ants, Rodent, snakes, lizard and other crawling insects		
		Any other observations	Nil		
		Preventive Action suggested to customer	Boxes always should be access any time		
		Curative action from	We are instructed to Technician for Regular Monitoring.		
15

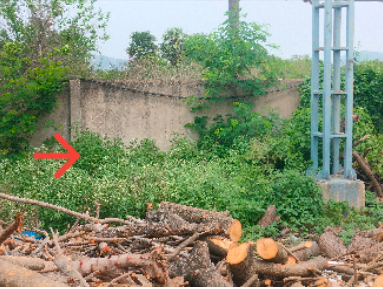
Location	Boiler area		
		Cleaning / sanitation & Housekeeping Issues	Lot of Thick vegetation observed		
		Structural Issue (Pest harbourages)	Nil		
		Access Issues	Nil		
		Description of Pest Infestation	It is Serious Threat for Ants, beetle, snakes, rodent,. crawling insects		
		Any other observations	Nil		
		Preventive Action suggested to customer	Tree branches and vegetation should be trim on regular basis

Curative action from	We are instructed to Technician for Regular Monitoring.		
16

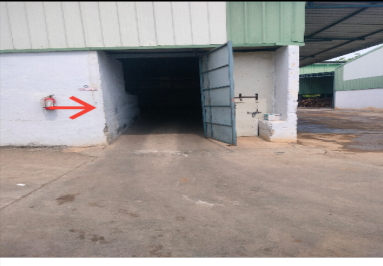
Location	Drums receiving area		
		Cleaning / sanitation & Housekeeping Issues	Nil		
		Structural Issue (Pest harbourages)	Door was opened condition		
		Access Issues	Nil		
		Description of Pest Infestation	It is Serious Threat for Ants, beetle Rodent, Snakes and other crawling insects		
		Any other observations	Nil		
		Preventive Action suggested to customer	Doors should be closed		
		Curative action from	We are instructed to Technician for Regular Monitoring.

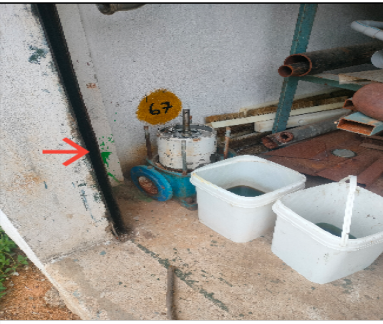
17

Location	Store area		
		Cleaning / sanitation & Housekeeping Issues	Nil		
		Structural Issue (Pest harbourages)	Nil		
		Access Issues	When we observed lot of Rodent boxes missing from the places		
		Description of Pest Infestation	It is Serious Threat for Ants,. lizard, rodent, snakes and other crawling insects		
		Any other observations	Nil		
		Preventive Action suggested to customer	Rodent Boxes should purchase and place it as per diagram		
		Curative action from	We are instructed to Technician for Regular Monitoring.		
18

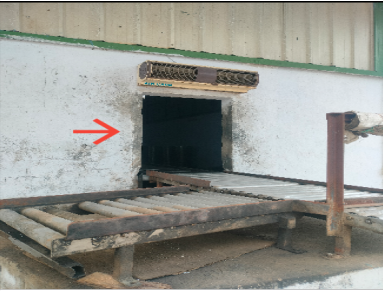
Location	Drums receiving area		
		Cleaning / sanitation & Housekeeping Issues	Nil		
		Structural Issue (Pest harbourages)	Pvc strip not available in this area.and when we observed Air curtain noot running.		
		Access Issues	Nil		
		Description of Pest Infestation	It is Serious Threat for Ants, flies Rodent and other crawling insects		
		Any other observations	Nil		
		Preventive Action suggested to customer	PVC strip should be place without any gaps.

Curative action from	We are instructed to Technician for Regular Monitoring.		
19

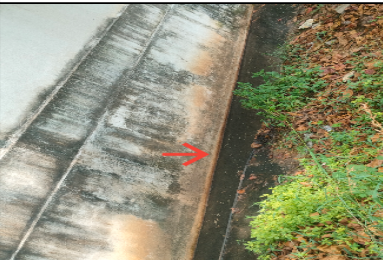
Location	FG area		
		Cleaning / sanitation & Housekeeping Issues	Lot of waste water stagnated		
		Structural Issue (Pest harbourages)	Nil		
		Access Issues	Nil		
		Description of Pest Infestation	It is Serious Threat for Ants, flies, cockroach Rodent, mosquito, snakes and other crawling insects		
		Any other observations	Nil		
		Preventive Action suggested to customer	Don't allow the waste water stagnated		
		Curative action from	We are instructed to Technician for Regular Monitoring.

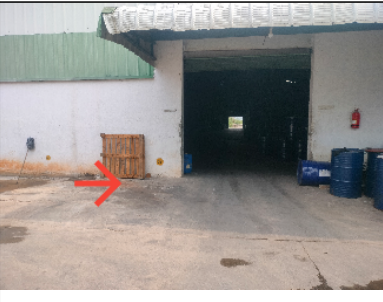
20

Location	FG area					
		Cleaning / sanitation & Housekeeping Issues	Nil					
		Structural Issue (Pest harbourages)	Ni					
		Access Issues	Rodent Boxes was missing from the places					
		Description of Pest Infestation	It is Serious Threat for Ants, Rodent,lizard, Birds snakes and other crawling insects					
		Any other observations	Nil					
		Preventive Action suggested to customer	Boxes should be placed, shutter should be closed when man non working time					
		Curative action from	We are instructed to Technician for Regular Monitoring.					
Note:								
For Pest Control Experts Authorized Signature. Name: SURESH KUMAR.V Designation: MANAGER Emp.Code: 002 Phone Number: 8248672110
