## PEST CONTROL EXPERTS

Facility Name & Address: Frozen Tropicals Pvt Ltd , Chittoor	Audited On: 24-05-2024
Audited By: SURESH KUMAR.V	
Client Contact Person Name: Mr. Surendra (QH)	PC Experts Contact Person Name: SURESH KUMAR.V
Client Contact Person No: 7702187499	PC Experts Contact Person No: 8248672110

Internal Premises			REVIEW DATE	COMPLETION DATE
1

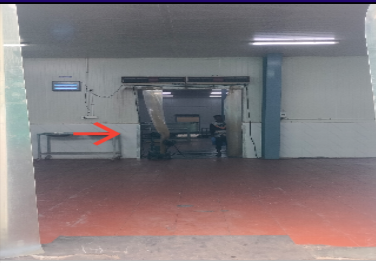
Location	Fruit Washing area	
		Cleaning / sanitation & Housekeeping Issues	Nil	
		Structural Issue (Pest harbourages)	PVC strip	
		Access Issues	Nil	
		Description of Pest Infestation	It is Serious Threat for Ants, beetle, Rodent, snakes and other crawling insects	
		Any other observations	Nil	
		Preventive Action suggested to customer	PVC Strips will be replaced.	
		Curative action from	We are instructed to Technician for Regular Monitoring.

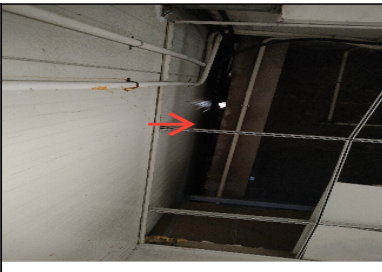
2

Location	QC area		
		Cleaning / sanitation & Housekeeping Issues	Nil		
		Structural Issue (Pest harbourages)	Hole was observed in roof		
		Access Issues	Nil		
		Description of Pest Infestation	It is Serious Threat for Ants, rodent,. lizard, other crawling insects		
		Any other observations	Nil		
		Preventive Action suggested to customer	Hole should be closed with cement		
		Curative action from	We are instructed to Technician for Regular Monitoring.		
External Premises				REVIEW DATE	COMPLETION DATE
3

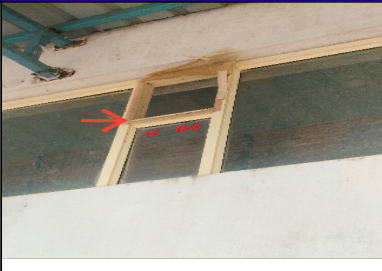
Location	Front office area		
		Cleaning / sanitation & Housekeeping Issues	Nil		
		Structural Issue (Pest harbourages)	Mesh was damaged condition		
		Access Issues	Nil		
		Description of Pest Infestation	It is Serious Threat for Ants, lizard, flies and other crawling insects		
		Any other observations	Nil		
		Preventive Action suggested to customer	Mesh should be replaced without any gaps		
		Curative action from	We are instructed to Technician for Regular Monitoring.

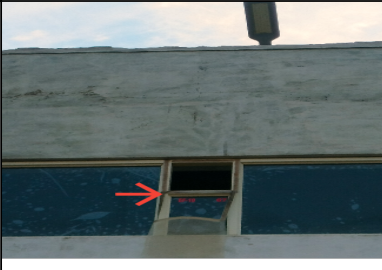
4

Location	Main building ( opp EB yard)		
		Cleaning / sanitation & Housekeeping Issues	Nil		
		Structural Issue (Pest harbourages)	Mesh was damaged condition		
		Access Issues	Nil		
		Description of Pest Infestation	It is Serious Threat for Ants, lizard, flies and other crawling insects		
		Any other observations	Nil		
		Preventive Action suggested to customer	Mesh should be replaced without any gaps		
		Curative action from	We are instructed to Technician for Regular Monitoring.

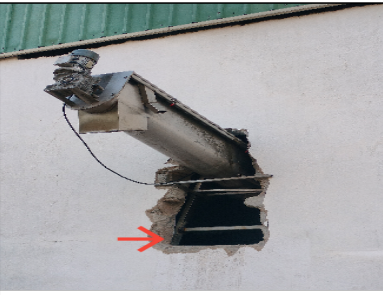
5

Location	Fruit Washing area		
		Cleaning / sanitation & Housekeeping Issues	Nil		
		Structural Issue (Pest harbourages)	Waste fruit conveyor line newly placed but wall surrounding gaps noticed		
		Access Issues	Nil		
		Description of Pest Infestation	It is Serious Threat for Beetles, flies, lizard and crawling insects		
		Any other observations	Nil		
		Preventive Action suggested to customer	Gap should be closed with cement wall		
		Curative action from	We are instructed to Technician for Regular Monitoring.		
6

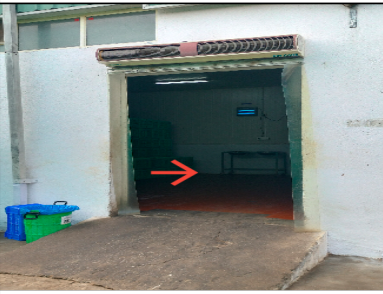
Location	Fruit Washing entrance area		
		Cleaning / sanitation & Housekeeping Issues	Nil		
		Structural Issue (Pest harbourages)	PVC strip not available & door also not closed		
		Access Issues	Nil		
		Description of Pest Infestation	It is Serious Threat for Ants, flies, cockroach Rodent, snakes and other crawling insects		
		Any other observations	Nil		
		Preventive Action suggested to customer	Door should be closed always and PVC strip should be placed without any gaps

Curative action from	We are instructed to Technician for Regular Monitoring.		
7

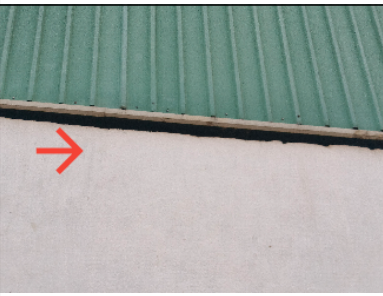
Location	Main building area (opp power plant)		
		Cleaning / sanitation & Housekeeping Issues	Nil		
		Structural Issue (Pest harbourages)	Wall to wall sheet gap noticed		
		Access Issues	Nil		
		Description of Pest Infestation	It is Serious Threat for Ants, lizard, cockroach,. flies,and other crawling insects		
		Any other observations	Nil		
		Preventive Action suggested to customer	Gap should be closed with cement wall without any gaps		
		Curative action from	We are instructed to Technician for Regular Monitoring.

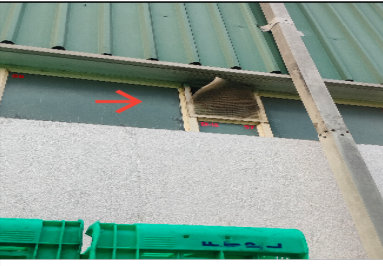
8

Location	Hygienic Entrance area (opp ECRC)		
		Cleaning / sanitation & Housekeeping Issues	Nil		
		Structural Issue (Pest harbourages)	Mesh was Damaged Condition		
		Access Issues	Nil		
		Description of Pest Infestation	It is Serious Threat for Ants, lizard, cockroach, flies and other crawling insects		
		Any other observations	Nil		
		Preventive Action suggested to customer	Mesh should be replaced without any gaps		
		Curative action from	We are instructed to Technician for Regular Monitoring.		
9

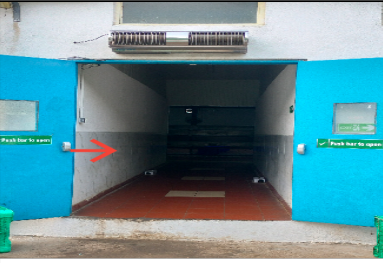
Location	Emergency exit door (opp ECRC)		
		Cleaning / sanitation & Housekeeping Issues	Nil		
		Structural Issue (Pest harbourages)	Door was opened condition		
		Access Issues	Nil		
		Description of Pest Infestation	It is Serious Threat for Ants, snakes, Rodent, lizard, flies and other crawling insects		
		Any other observations	Nil		
		Preventive Action suggested to customer	Emergency doors should be closed condition

Curative action from	We are instructed to Technician for Regular Monitoring.		
10

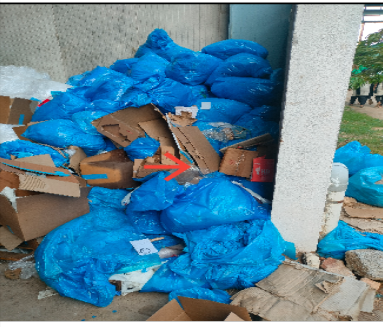
Location	Open cold room area		
		Cleaning / sanitation & Housekeeping Issues	Lot waste material dumped wall side without any gaps		
		Structural Issue (Pest harbourages)	Door also not available		
		Access Issues	Lot of material kept wall side without any gaps		
		Description of Pest Infestation	It is Serious Threat for Ants, beetle, snakes, Rodent, flies and other crawling insects		
		Any other observations	Nil		
		Preventive Action suggested to customer	Waste material should be replaced on regular basis. Door should be placed. Don't kept materials from wall side, give gap 2 feet from Wall to materials		
		Curative action from	We are instructed to Technician for Regular Monitoring.

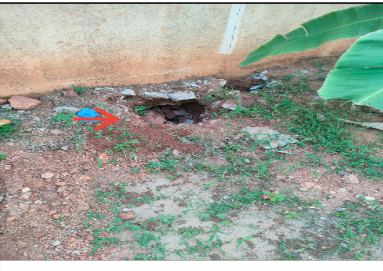
11

Location	Compound wal inside ( ETP area)		
		Cleaning / sanitation & Housekeeping Issues	Nil		
		Structural Issue (Pest harbourages)	Hole observed bottom of the compound wall		
		Access Issues	Nil		
		Description of Pest Infestation	It is Serious Threat for Ants, Rodent, lizard, snakes and other crawling insects		
		Any other observations	Nil		
		Preventive Action suggested to customer	Hole should be closed with cement		
		Curative action from	We are instructed to Technician for Regular Monitoring.		
12	 	Location	Loading area		
		Cleaning / sanitation & Housekeeping Issues	Waste cotton box dumped		
		Structural Issue (Pest harbourages)	Nil		
		Access Issues	Nil		
		Description of Pest Infestation	It is Serious Threat for Beetles, lizard, snakes, Rodent and other crawling insects		
		Any other observations	Nil		
		Preventive Action suggested to customer	Don't allow the waste material surrounding the facility

Curative action from	We are instructed to Technician for Regular Monitoring.		
13

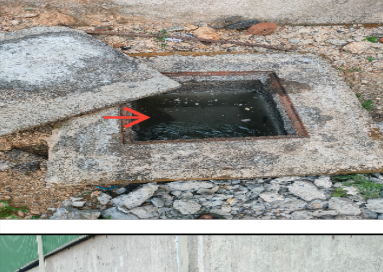
Location	Loading area		
		Cleaning / sanitation & Housekeeping Issues	Nil		
		Structural Issue (Pest harbourages)	Manhole was opened condition		
		Access Issues	Nil		
		Description of Pest Infestation	It is Serious Threat for Ants, cockroach, flies,frog,		
		Any other observations	Nil		
		Preventive Action suggested to customer	Manhole should be closed with lid		
		Curative action from	We are instructed to Technician for Regular Monitoring.		
14	 	Location	Main building out side		
		Cleaning / sanitation & Housekeeping Issues	Granite stone kept on wall side		
		Structural Issue (Pest harbourages)	Nil		
		Access Issues	Thick vegetation observed		
		Description of Pest Infestation	It is Serious Threat for Ants, lizard, Rodent, snakes and other crawling insects		
		Any other observations	Nil		
		Preventive Action suggested to customer	Thick vegetation should be trim on regular basis. Don't allow the material from wall side

Curative action from	We are instructed to Technician for Regular Monitoring.

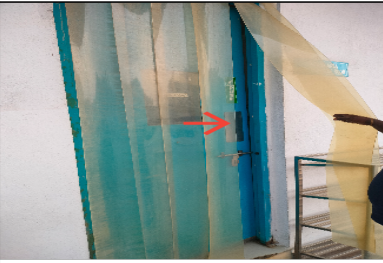
15

Location	Hygiene entry		
		Cleaning / sanitation & Housekeeping Issues	Nil		
		Structural Issue (Pest harbourages)	Door was not closed properly		
		Access Issues	Nil		
		Description of Pest Infestation	It is Serious Threat for Ants, lizard, cockroach, rodent and other crawling insects		
		Any other observations	Nil		
		Preventive Action suggested to customer	Door closed without any gaps		
		Curative action from	We are instructed to Technician for Regular Monitoring.		
16

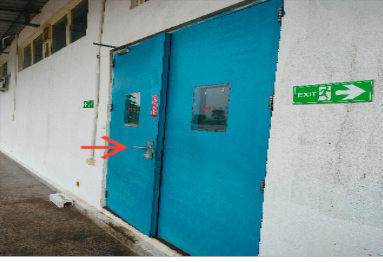
Location	Emergency doors		
		Cleaning / sanitation & Housekeeping Issues	Nil		
		Structural Issue (Pest harbourages)	Doors not closed properly		
		Access Issues	Nil		
		Description of Pest Infestation	It is Serious Threat for Ants, lizard, flies and other crawling insects		
		Any other observations	Nil		
		Preventive Action suggested to customer	Doors should be closed without any gaps		
		Curative action from	We are instructed to Technician for Regular Monitoring.

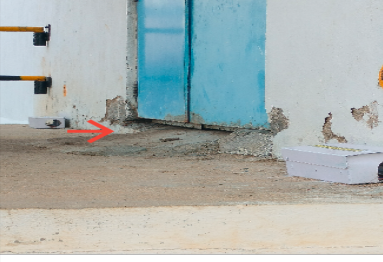
17

Location	Coconut area emergency door		
		Cleaning / sanitation & Housekeeping Issues	Nil		
		Structural Issue (Pest harbourages)	Gap noticed between the door frame to floor		
		Access Issues	Nil		
		Description of Pest Infestation	It is Serious Threat for Ants, lizard, cockroach and other crawling insects		
		Any other observations	Nil		
		Preventive Action suggested to customer	Gap should be closed with cement		
		Curative action from	We are instructed to Technician for Regular Monitoring.

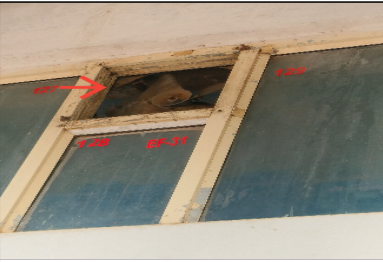
18

Location	Main building out side		
		Cleaning / sanitation & Housekeeping Issues	Nil		
		Structural Issue (Pest harbourages)	Mesh not available		
		Access Issues	Nil		
		Description of Pest Infestation	It is Serious Threat for Ants, lizard, cockroach, flies and other crawling insects		
		Any other observations	Nil		
		Preventive Action suggested to customer	Mesh should be placed		
		Curative action from	We are instructed to Technician for Regular Monitoring.
