PEST CONTROL EXPERTS

Facility Name & Address: TASA - Unit -3, puttur	Audited On: 18-05-2024
Audited By: SURESH KUMAR.V	
Client Contact Person Name: Mr. Murugesh	PC Experts Contact Person Name: SURESH KUMAR.V
Client Contact Person No: 7893430526	PC Experts Contact Person No: 8248672110

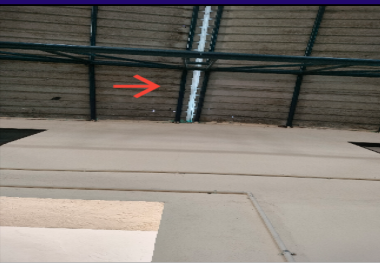
Location	Main processing Hall		
		Cleaning / sanitation & Housekeeping Issues	Nil		
		Structural Issue (Pest harbourages)	Gap observed between Roof sheet to roof sheet		
		Access Issues	Nil		
		Description of Pest Infestation	It is Serious Threat for Ants, flies, lizard and other crawling insects		
		Any other observations	Nil		
		Preventive Action suggested to customer	Gap should be closed with cement tapper,		
		Curative action from	We are instructed to Technician for Regular Monitoring.

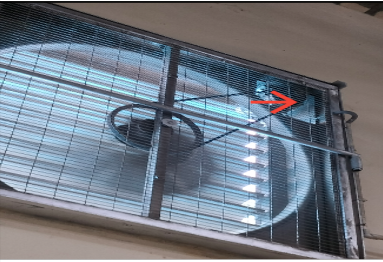
Location	Processing Hall		
		Cleaning / sanitation & Housekeeping Issues	Nil		
		Structural Issue (Pest harbourages)	Exhaust fan inside gap observed		
		Access Issues	Nil		
		Description of Pest Infestation	It is Serious Threat for Ants, lizard, cockroach flying insects and other crawling insects		
		Any other observations	Nil		
		Preventive Action suggested to customer	Exhaust outer should be placed mesh without any gaps		
		Curative action from	We are instructed to Technician for Regular Monitoring.

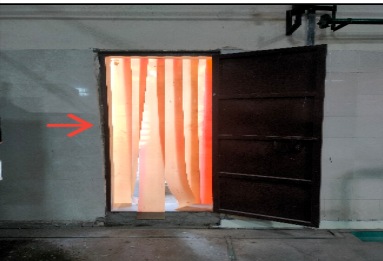
4

Location	Processing Hall		
		Cleaning / sanitation & Housekeeping Issues	Nil		
		Structural Issue (Pest harbourages)	Door was opened condition		
		Access Issues	Nil		
		Description of Pest Infestation	It is Serious Threat for Beetles, flying insects, rodent, lizard and other crawling insects		
		Any other observations	Nil		
		Preventive Action suggested to customer	Door should be closed		
		Curative action from	We are instructed to Technician for Regular Monitoring.		
5

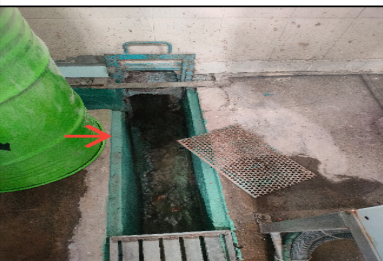
Location	Processing Hall		
		Cleaning / sanitation & Housekeeping Issues	Drain water line lid not closed		
		Structural Issue (Pest harbourages)	Nil		
		Access Issues	Nil		
		Description of Pest Infestation	It is Serious Threat for Ants, lizard, cockroach and Rodent		
		Any other observations	Nil		
		Preventive Action suggested to customer	Lid should be placed		
		Curative action from	We are instructed to Technician for Regular Monitoring.

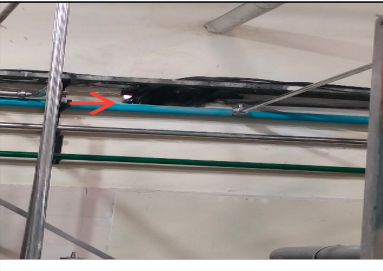
6

Location	Main processing Hall		
		Cleaning / sanitation & Housekeeping Issues	Nil		
		Structural Issue (Pest harbourages)	Power cable line to wall gap noticed		
		Access Issues	Nil		
		Description of Pest Infestation	It is Serious Threat for Ants, lizard, flies and other crawling insects		
		Any other observations	Nil		
		Preventive Action suggested to customer	Cable line should be closed with cement		
		Curative action from	We are instructed to Technician for Regular Monitoring.		
7

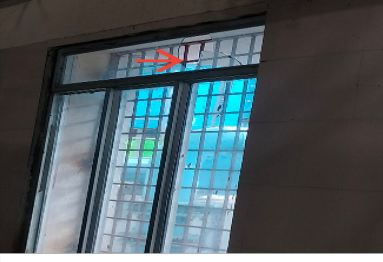
Location	Processing Hall		
		Cleaning / sanitation & Housekeeping Issues	Nil		
		Structural Issue (Pest harbourages)	Window glass damaged condition		
		Access Issues	Nil		
		Description of Pest Infestation	It is Serious Threat for Ants, flying insects, lizard and other crawling insects		
		Any other observations	Nil		
		Preventive Action suggested to customer	Glass should be closed		
		Curative action from	We are instructed to Technician for Regular Monitoring.

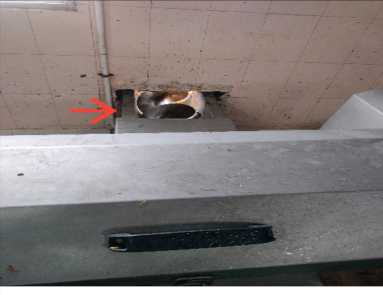
8

Location	Processing Hall		
		Cleaning / sanitation & Housekeeping Issues	Nil		
		Structural Issue (Pest harbourages)	Waste fruit running conveyor line was opened condition		
		Access Issues	Nil		
		Description of Pest Infestation	It is Serious Threat for Ants, flying insects, lizard and other crawling insects		
		Any other observations	Nil		
		Preventive Action suggested to customer	Conveyor lid should be placed without any gaps		
		Curative action from	We are instructed to Technician for Regular Monitoring.

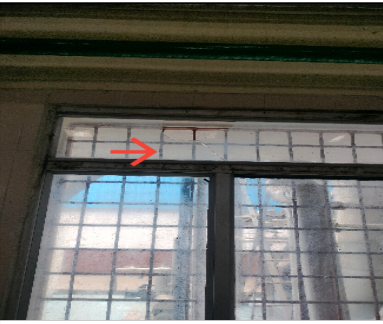
9

Location	Processing Hall		
		Cleaning / sanitation & Housekeeping Issues	Nil		
		Structural Issue (Pest harbourages)	Window glass was damaged condition. Window frame to wall gap noticed		
		Access Issues	Nil		
		Description of Pest Infestation	It is Serious Threat for Ants, lizard, flying insects and other crawling insects		
		Any other observations	Nil		
		Preventive Action suggested to customer	Glass should be replaced. Window frame to Wall gaps should be closed with cement		
		Curative action from	We are instructed to Technician for Regular Monitoring.		
10

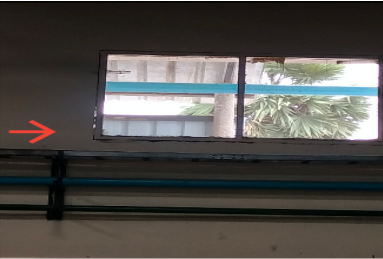
Location	Processing Hall		
		Cleaning / sanitation & Housekeeping Issues	Nil		
		Structural Issue (Pest harbourages)	Ventilation frame to wall gap noticed		
		Access Issues	Nil		
		Description of Pest Infestation	It is Serious Threat for Beetles, Ants, lizard and flying insects		
		Any other observations	Nil		
		Preventive Action suggested to customer	Gap should be closed with cement

Curative action from	We are instructed to Technician for Regular Monitoring.		
11

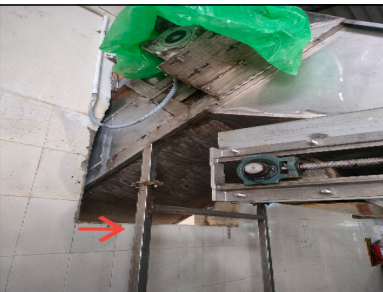
Location	Processing Hall		
		Cleaning / sanitation & Housekeeping Issues	Nil		
		Structural Issue (Pest harbourages)	Gaps Observed between Fruit washing Conveyor Line and Wall		
		Access Issues	Nil		
		Description of Pest Infestation	It is Serious Threat for Ants, flying insects, lizard, rodent and other crawling insects		
		Any other observations	Nil		
		Preventive Action suggested to customer	Gap should be closed with cement wall or sheet		
		Curative action from	We are instructed to Technician for Regular Monitoring.

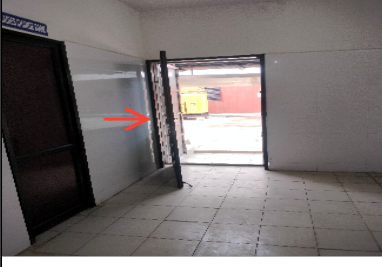
12

Location	Hygiene entry		
		Cleaning / sanitation & Housekeeping Issues	Nil		
		Structural Issue (Pest harbourages)	Hygiene entry door was opened condition		
		Access Issues	Nil		
		Description of Pest Infestation	It is Serious Threat for Ants, lizard, Rodent, flying insects and other crawling insects		
		Any other observations	Nil		
		Preventive Action suggested to customer	PVC strip should be placed and door should be closed		
		Curative action from	We are instructed to Technician for Regular Monitoring.		
External Premises				REVIEW DATE	COMPLETION DATE
13

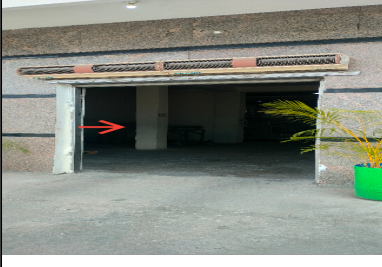
Location	Processing Hall		
		Cleaning / sanitation & Housekeeping Issues	Nil		
		Structural Issue (Pest harbourages)	Main door was opened condition		
		Access Issues	Nil		
		Description of Pest Infestation	It is Serious Threat for Ants, lizard, rodent, snakes, flies and other crawling insects		
		Any other observations	Nil		
		Preventive Action suggested to customer	Door should be closed and PVC strip should be placed

Curative action from	We are instructed to Technician for Regular Monitoring.		
14

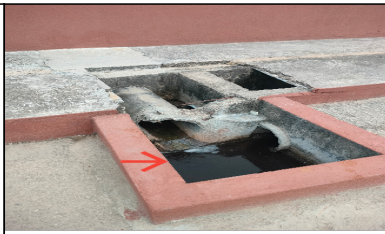
15

Location	Main building outer		
		Cleaning / sanitation & Housekeeping Issues	Nil		
		Structural Issue (Pest harbourages)	Manhole was opened condition		
		Access Issues	Nil		
		Description of Pest Infestation	It is Serious Threat for Beetles, Ants, lizard, cockroach		
		Any other observations	Nil		
		Preventive Action suggested to customer	Manhole lid should be placed without any gaps		
		Curative action from	We are instructed to Technician for Regular Monitoring.		
16

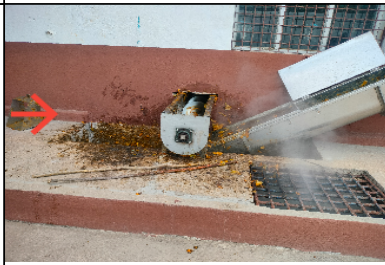
Location	Main building outer		
		Cleaning / sanitation & Housekeeping Issues	Waste fruit receiving please fruit was accumulated		
		Structural Issue (Pest harbourages)	Nil		
		Access Issues	Nil		
		Description of Pest Infestation	It is Serious Threat for Ants, flying insects other crawling insects		
		Any other observations	Nil		
		Preventive Action suggested to customer	That area should be clean on regular basis		
		Curative action from	We are instructed to Technician for Regular Monitoring.

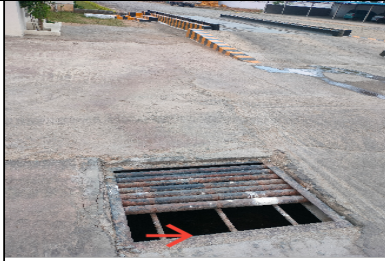
17

Location	Weighing machine area		
		Cleaning / sanitation & Housekeeping Issues	Nil		
		Structural Issue (Pest harbourages)	Manhole lid pipe was not closed properly		
		Access Issues	Nil		
		Description of Pest Infestation	It is Serious Threat for Ants, rodent, lizard, snakes and other crawling insects		
		Any other observations	Nil		
		Preventive Action suggested to customer	Manhole top pipes should be placed		
		Curative action from	We are instructed to Technician for Regular Monitoring.		
18

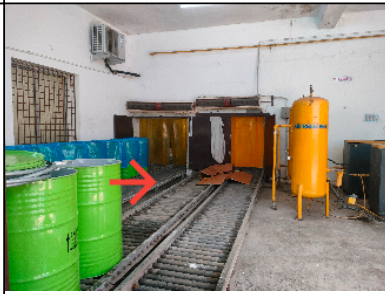
Location	Drums receiving area		
		Cleaning / sanitation & Housekeeping Issues	Nil		
		Structural Issue (Pest harbourages)	Drums receiving area was opened condition		
		Access Issues	Nil		
		Description of Pest Infestation	It is Serious Threat for Ants, lizard, rodent, snakes, flying insects and other crawling insects		
		Any other observations	Nil		
		Preventive Action suggested to customer	PVC strip should be placed and when not used that area that time should be closed

Curative action from	We are instructed to Technician for Regular Monitoring.		
Note:
