PEST CONTROL EXPERTS

Facility Name & Address: RMM FOOD PRODUCTS PRIVATE LIMITED , Chittoor	Audited On: 06-05-2024
Audited By: SURESH KUMAR.V	
Client Contact Person Name: Mr. Chengal Reddy (Plant Manager)	PC Experts Contact Person Name: SURESH KUMAR.V
Client Contact Person No: 9441911123	PC Experts Contact Person No: 8248672110

Internal Premises			REVIEW DATE	COMPLETION DATE
1

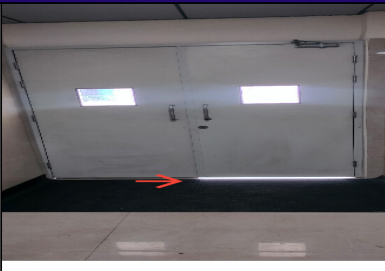
Location	Hygiene entry	
		Cleaning / sanitation & Housekeeping Issues	Nil	
		Structural Issue (Pest harbourages)	Door bottom gaps observed	
		Access Issues	Nil	
		Description of Pest Infestation	It is Serious Threat for Ants, beetle, lizard, flying insects and other crawling insects	
		Any other observations	Nil	
		Preventive Action suggested to customer	Gap should be closed with rubber beading	
		Curative action from	We are instructed to Technician for Regular Monitoring.

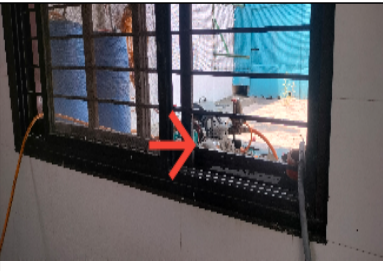
2

Location	Processing Hall		
		Cleaning / sanitation & Housekeeping Issues	Nil		
		Structural Issue (Pest harbourages)	Window mesh was damaged condition		
		Access Issues	Nil		
		Description of Pest Infestation	It is Serious Threat for Ants, lizard and other flying insects		
		Any other observations	Nil		
		Preventive Action suggested to customer	Mesh should be replaced		
		Curative action from	We are instructed to Technician for Regular Monitoring.		
3

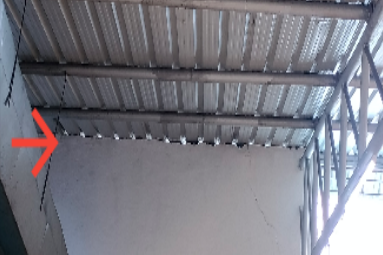
Location	Processing Hall		
		Cleaning / sanitation & Housekeeping Issues	Nil		
		Structural Issue (Pest harbourages)	Wall to roof sheet gap noticed		
		Access Issues	Nil		
		Description of Pest Infestation	It is Serious Threat for Ants,. lizard, flying insects and other crawling insects		
		Any other observations	Nil		
		Preventive Action suggested to customer	Gap should be closed with cement		
		Curative action from	We are instructed to Technician for Regular Monitoring.

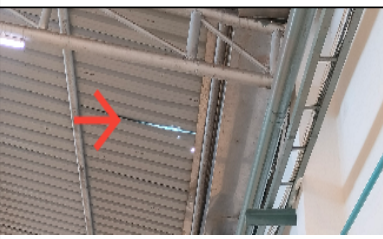
4

Location	Processing Hall		
		Cleaning / sanitation & Housekeeping Issues	Nil		
		Structural Issue (Pest harbourages)	Roof sheet not fixed properly gap observed		
		Access Issues	Nil		
		Description of Pest Infestation	It is Serious Threat for Ants, lizard and flying insects		
		Any other observations	Nil		
		Preventive Action suggested to customer	Sheet should be placed without any gaps		
		Curative action from	We are instructed to Technician for Regular Monitoring.		
5

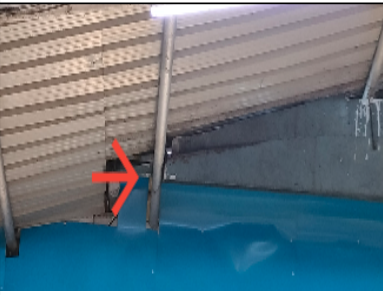
Location	Processing Hall		
		Cleaning / sanitation & Housekeeping Issues	Nil		
		Structural Issue (Pest harbourages)	Roof sheet to sheet gap noticed		
		Access Issues	Nil		
		Description of Pest Infestation	It is Serious Threat for Ants, Flying insects, lizard and other crawling insects		
		Any other observations	Nil		
		Preventive Action suggested to customer	Roof sheet to sheet gap should be closed permanently without any gaps

Curative action from	We are instructed to Technician for Regular Monitoring.

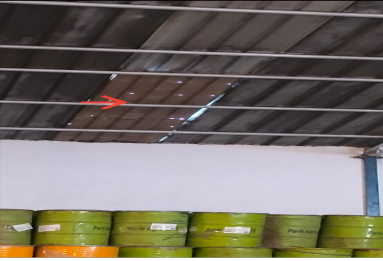
8

Location	FG area		
		Cleaning / sanitation & Housekeeping Issues	Nil		
		Structural Issue (Pest harbourages)	Roof sheet fixed properly		
		Access Issues	Nil		
		Description of Pest Infestation	It is Serious Threat for Beetles, lizard, other flying insects		
		Any other observations	Nil		
		Preventive Action suggested to customer	Sheet should be placed without any gaps		
		Curative action from	We are instructed to Technician for Regular Monitoring.		
9

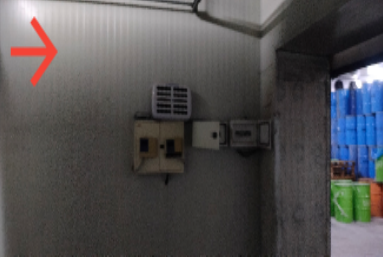
Location	Frozen area		
		Cleaning / sanitation & Housekeeping Issues	Nil		
		Structural Issue (Pest harbourages)	Fly catcher machine switch off condition		
		Access Issues	Nil		
		Description of Pest Infestation	It is Serious Threat for Ants, lizard and other flying insects		
		Any other observations	Nil		
		Preventive Action suggested to customer	Fly catcher machine should be working condition		
		Curative action from	We are instructed to Technician for Regular Monitoring.

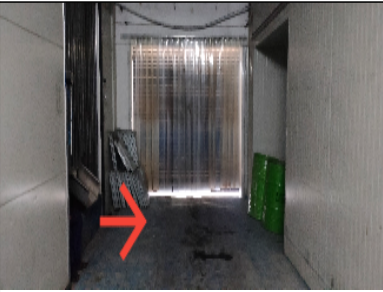
10

Location	Frozen shutter area		
		Cleaning / sanitation & Housekeeping Issues	Nil		
		Structural Issue (Pest harbourages)	Bottom gaps observed between the shutter to floor		
		Access Issues	Nil		
		Description of Pest Infestation	It is Serious Threat for Beetles,Ants, lizard,. cockroach, rodent and other crawling insects		
		Any other observations	Nil		
		Preventive Action suggested to customer	Shuttle should be closed with rubber beading without any gaps		
		Curative action from	We are instructed to Technician for Regular Monitoring.		
11

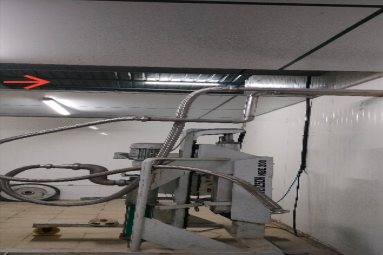
Location	Frozen area		
		Cleaning / sanitation & Housekeeping Issues	Nil		
		Structural Issue (Pest harbourages)	Flase ceiling was opened condition		
		Access Issues	Nil		
		Description of Pest Infestation	It is Serious Threat for Ants, spider, lizard, bird, flying insects and other crawling insects		
		Any other observations	Nil		
		Preventive Action suggested to customer	False ceiling should be placed

Curative action from	We are instructed to Technician for Regular Monitoring.		
12

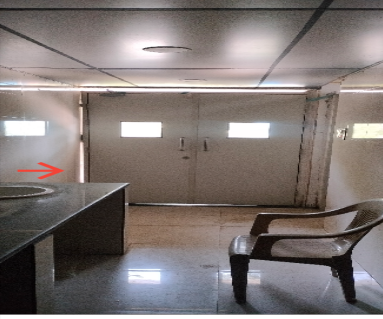
13

Location	Frozen hygiene entry		
		Cleaning / sanitation & Housekeeping Issues	Nil		
		Structural Issue (Pest harbourages)	Gap observed between the door frame to wall and door to door		
		Access Issues	Nil		
		Description of Pest Infestation	It is Serious Threat for Ants, lizard, flying insects and other crawling insects and		
		Any other observations	Nil		
		Preventive Action suggested to customer	Gap should be closed with rubber beading or silicone sealant		
		Curative action from	We are instructed to Technician for Regular Monitoring.		
14

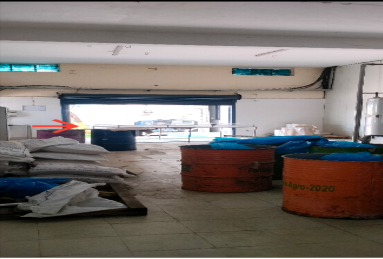
Location	Store area		
		Cleaning / sanitation & Housekeeping Issues	Nil		
		Structural Issue (Pest harbourages)	Shutter was opened condition		
		Access Issues	Nil		
		Description of Pest Infestation	It is Serious Threat for Beetles, flying insects, lizard and other crawling insects		
		Any other observations	Nil		
		Preventive Action suggested to customer	Shutter should be closed non working time

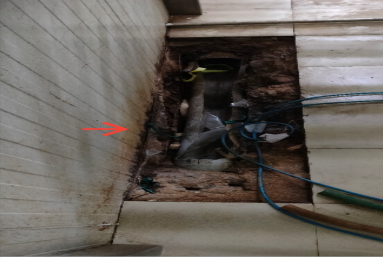
15

Location	Frozen area		
		Cleaning / sanitation & Housekeeping Issues	Nil		
		Structural Issue (Pest harbourages)	Cable line was opened condition		
		Access Issues	Nil		
		Description of Pest Infestation	It is Serious Threat for Beetles, rodent,. Ants and other crawling insects		
		Any other observations	Nil		
		Preventive Action suggested to customer	Gap should be closed		
		Curative action from	Cable line gaps should be closed with cement

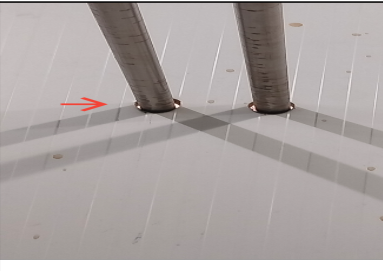
16

Location	Frozen area		
		Cleaning / sanitation & Housekeeping Issues	Nil		
		Structural Issue (Pest harbourages)	Evaporator line to wall sheet gaps observed		
		Access Issues	Nil		
		Description of Pest Infestation	It is Serious Threat for Ants, lizard, spider, flying insects and other crawling insects		
		Any other observations	Nil		
		Preventive Action suggested to customer	Gap should be closed with fume sealant		
		Curative action from	We are instructed to Technician for Regular Monitoring.		
17

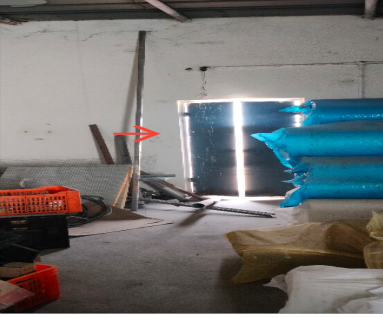
Location	1st floor Store area		
		Cleaning / sanitation & Housekeeping Issues	Spider and cobweb observed		
		Structural Issue (Pest harbourages)	Door to door gap observed and door to frame gap observed		
		Access Issues	Nil		
		Description of Pest Infestation	It is Serious Threat for Ants, spider, lizard		
		Any other observations	Nil		
		Preventive Action suggested to customer	Spider and cobweb should be clean on regular basis. Door to door and door to door frame gap should be closed with rubber beading

Curative action from	We are instructed to Technician for Regular Monitoring.		
18

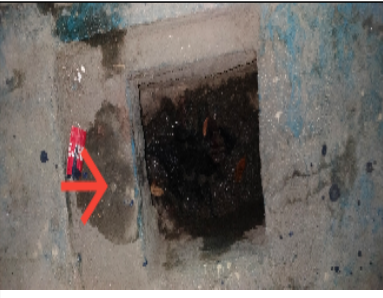
19

Location	Empty drums to st floor area		
		Cleaning / sanitation & Housekeeping Issues	Manhole was unclean condition and lid also not available		
		Structural Issue (Pest harbourages)	Nil		
		Access Issues	Nil		
		Description of Pest Infestation	It is Serious Threat for Beetles, Ants, lizard, rodent and other crawling insects		
		Any other observations	Nil		
		Preventive Action suggested to customer	Lid should be placed and regular cleaning required		
		Curative action from	We are instructed to Technician for Regular Monitoring.		
20

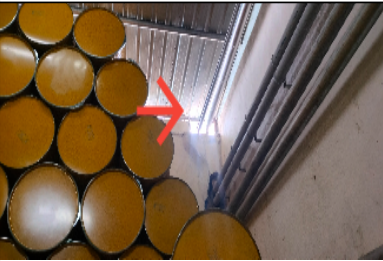
Location	Empty drums store area		
		Cleaning / sanitation & Housekeeping Issues	Nil		
		Structural Issue (Pest harbourages)	Wall to roof sheet gap observed		
		Access Issues	Nil		
		Description of Pest Infestation	It is Serious Threat for Ants, lizard, spider, other crawling insects		
		Any other observations	Nil		
		Preventive Action suggested to customer	Gap should be closed permanently without any gaps

Curative action from	We are instructed to Technician for Regular Monitoring.		
21

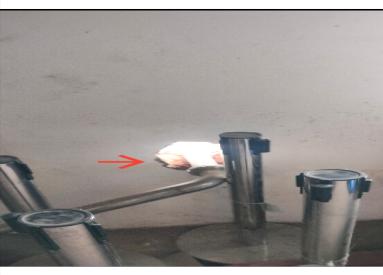
Location	Store area		
		Cleaning / sanitation & Housekeeping Issues	Nil		
		Structural Issue (Pest harbourages)	Hole observed		
		Access Issues	Nil		
		Description of Pest Infestation	It is Serious Threat for Ants, beetle, lizard, flying insects and other crawling insects		
		Any other observations	Nil		
		Preventive Action suggested to customer	Gap should be closed with cement		
		Curative action from	We are instructed to Technician for Regular Monitoring.

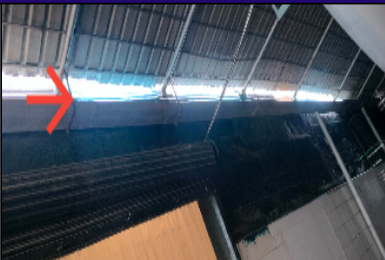
Location	Processing Hall to FG area middle		
		Cleaning / sanitation & Housekeeping Issues	Nil		
		Structural Issue (Pest harbourages)	Roof sheet not fixed properly, lot of gaps observed		
		Access Issues	Nil		
		Description of Pest Infestation	It is Serious Threat for Ants, beetle, flying insects and birds		
		Any other observations	Nil		
		Preventive Action suggested to customer	Sheet should be closed permanently without any gaps		
		Curative action from	We are instructed to Technician for Regular Monitoring.		
23

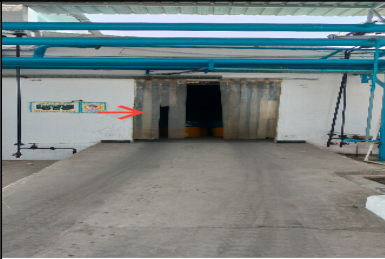
Location	Empty drums section		
		Cleaning / sanitation & Housekeeping Issues	Nil		
		Structural Issue (Pest harbourages)	PVC strip damaged condition		
		Access Issues	Nil		
		Description of Pest Infestation	It is Serious Threat for Ants, lizard, rodent, snakes and other crawling insects		
		Any other observations	Nil		
		Preventive Action suggested to customer	PVC strip should be placed

Curative action from	We are instructed to Technician for Regular Monitoring.		
24

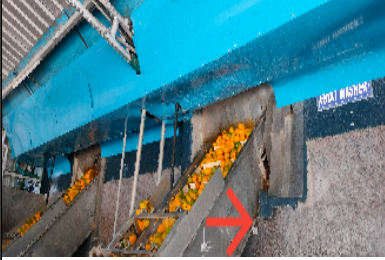
Location	Fruit Washing area		
		Cleaning / sanitation & Housekeeping Issues	Nil		
		Structural Issue (Pest harbourages)	Fruit conveyor line to wall gap noticed		
		Access Issues	Nil		
		Description of Pest Infestation	It is Serious Threat for Beetles, ants, lizard, flying insects and other crawling insects		
		Any other observations	Nil		
		Preventive Action suggested to customer	Conveyor line should be closed with rubber beading		
		Curative action from	We are instructed to Technician for Regular Monitoring.

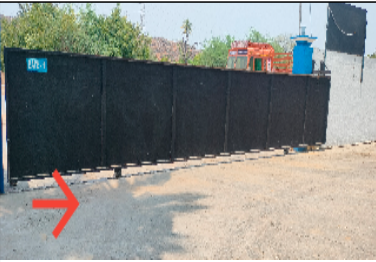
25

Location	Main gate		
		Cleaning / sanitation & Housekeeping Issues	Nil		
		Structural Issue (Pest harbourages)	Main gate bottom gaps observed		
		Access Issues	Nil		
		Description of Pest Infestation	It is Serious Threat for rodent, lizard, snakes, flying insects and other crawling insects		
		Any other observations	Nil		
		Preventive Action suggested to customer	Main gate should be closed with rubber beading		
		Curative action from	We are instructed to Technician for Regular Monitoring.
