PEST CONTROL EXPERTS

Facility Name & Address: Innovative Foods Ltd , Chittoor	Audited On: 28-10-2024
Audited By: SURESH KUMAR.V	
Client Contact Person Name: Mr. Naresh (QC)	PC Experts Contact Person Name: SURESH KUMAR.V
Client Contact Person No: 7994833665	PC Experts Contact Person No: 8248672110

FACILITY SURROUNDING

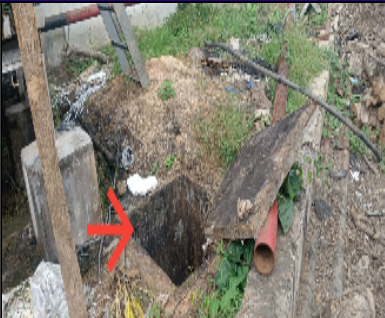
1

Location	Back side compound wall near manhole		
	Cleaning / sanitation & Housekeeping Issues	Not cleaned properly		
	Structural Issue (Pest harbourages)	Lid not closed properly		
	Access Issues	Vegetation observed		
	Description of Pest Infestation	It is Serious Threat for Cockroaches, rodent, fly, snake, ants and other crawling insects		
	Any other observations	Nil		
	Preventive Action suggested to customer	Vegetation should be removed on regular basis. Lid should be closed, and don't kept waste near by building area.		
	Curative action from	We are instructed to Technician for Regular Monitoring.

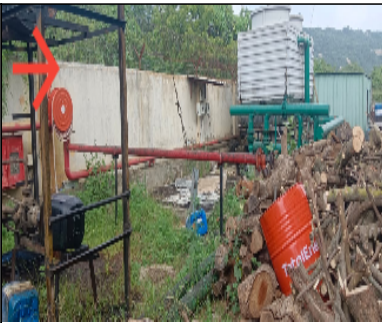
Location	Back side of the building area		
		Cleaning / sanitation & Housekeeping Issues	Fire wood dumped on inside road area un even condition		
		Structural Issue (Pest harbourages)	Nil		
		Access Issues	We can't able to go and do the service		
		Description of Pest Infestation	It is Serious Threat for Cockroaches, termites, rodent, snake, frog,ants and other crawling insects		
		Any other observations	Nil		
		Preventive Action suggested to customer	Area should be clean always, fire wood dumped to fire wood yard		
		Curative action from	We are instructed to Technician for Regular Monitoring.		
2

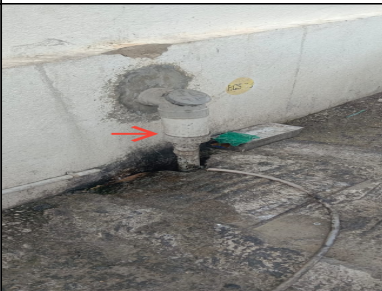
Location	Back side of the building		
		Cleaning / sanitation & Housekeeping Issues	Nil		
		Structural Issue (Pest harbourages)	Waste water out let pipe and manhole lid gap between noticed		
		Access Issues	Nil		
		Description of Pest Infestation	It is Serious Threat for Cockroaches, rodent, mosquito, lizard, snake

Any other observations	Nil		
		Preventive Action suggested to customer	Gap should be closed with cement		
		Curative action from	We are instructed to Technician for Regular Monitoring.		
3

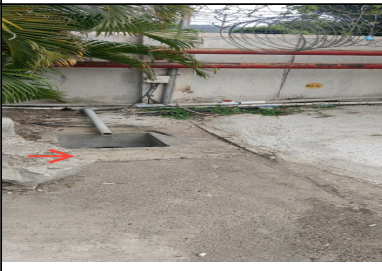
Location	Back side compound wall		
		Cleaning / sanitation & Housekeeping Issues	Nil		
		Structural Issue (Pest harbourages)	Manhole lid not their		
		Access Issues	Nil		
		Description of Pest Infestation	It is Serious Threat for Cockroaches, mosquito, rodent, snake, lizard, ants and other crawling insects		
		Any other observations	Nil		
		Preventive Action suggested to customer	Manhole lid will be placed		
		Curative action from	We are instructed to Technician for Regular Monitoring.		
Note: Nil
