Facility Name & Address: Saroj Agro industries , Tumkur	Audited On: 25-11-2023
Audited By: SURESH KUMAR.V	
Client Contact Person Name: Mr. Naveen Kumar	PC Experts Contact Person Name: SURESH KUMAR.V
Client Contact Person No: 9164761942	PC Experts Contact Person No: 9087200011

FACILITY SURROUNDING

Internal Premises			REVIEW DATE	COMPLETION DATE	
1

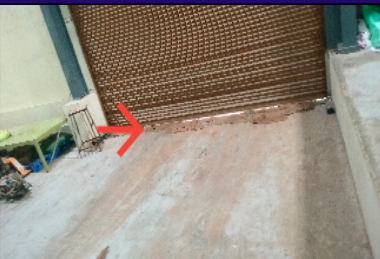
Location	Back side shutter area		
		Cleaning / sanitation & Housekeeping Issues	Nil		
		Structural Issue (Pest harbourages)	Bottom of the shutter gap observed		
		Access Issues	Nil		
		Description of Pest Infestation	It is Serious Threat for Ants, snakes, rodent, cockroach, lizard, flying insects and other crawling insects		
		Any other observations	Nil		
		Preventive Action suggested to customer	Shutter gap should be closed with rubber breading		
		Curative action from	We are instructed to Technician for Regular Monitoring.		
2

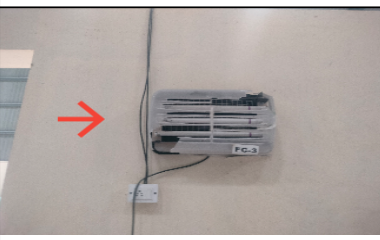
Location	Waste material dumping area		
		Cleaning / sanitation & Housekeeping Issues	Nil		
		Structural Issue (Pest harbourages)	Nil		
		Access Issues	Fly catcher machine fasia was damaged		
		Description of Pest Infestation	It is Serious Threat for Ants, beetles and flying insects		
		Any other observations	Nil		
		Preventive Action suggested to customer	Fasia should be replaced

Curative action from	We are instructed to Technician for Regular Monitoring.

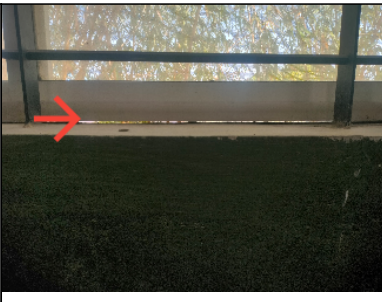
Location	Window frame area		
		Cleaning / sanitation & Housekeeping Issues	Nil		
		Structural Issue (Pest harbourages)	Gap observed window frame to Wall		
		Access Issues	Nil		
		Description of Pest Infestation	It is Serious Threat for Beetles, Ants, lizard, flying insects and other crawling insects		
		Any other observations	Nil		
		Preventive Action suggested to customer	Gap should be closed with cement concrete or rubber breading		
		Curative action from	We are instructed to Technician for Regular Monitoring.		
External Premises				REVIEW DATE	COMPLETION DATE
1		Location	Main building surrounding		
		Cleaning / sanitation & Housekeeping Issues	Tree branches touch into the Wall		
		Structural Issue (Pest harbourages)	Nil		
		Access Issues	Nil		
		Description of Pest Infestation	It is Serious Threat for Ants, lizard, flying insects		
		Any other observations	Nil		
		Preventive Action suggested to customer	Tree branches should be trim on regular basis

We are instructed to Technician for Regular Monitoring.

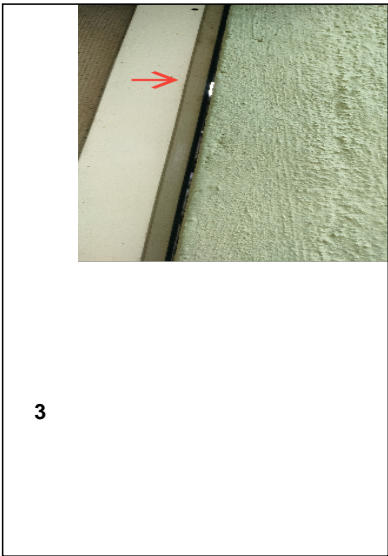
Location	All window frame
Cleaning / sanitation & Housekeeping Issues	Nil
Structural Issue (Pest harbourages)	Gaps Observed between Window Frame and Wall
Access Issues	Nil
Description of Pest Infestation	It is Serious Threat for Ants, lizard, flying insects
Any other observations	Nil
Preventive Action suggested to customer	Gaps should be closed with cement concrete or silicone sealant
	We are instructed to Technician for Regular Monitoring.

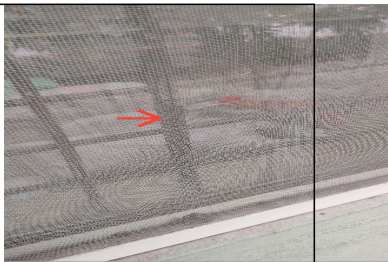
Location	Window mesh
Cleaning / sanitation & Housekeeping Issues	Nil
Structural Issue (Pest harbourages)	Window mesh was damaged
Access Issues	Nil
Description of Pest Infestation	It is Serious Threat for Beetles, ants, lizard, flying insects and other crawling insects
Any other observations	Nil
Preventive Action suggested to customer	Mesh should be replaced
	We are instructed to Technician for Regular Monitoring.

Note: In General your all window mesh will be replaced all windows. Also in Processing area. Fly Killer Machine will be placed to Fly Catcher Machines
