PEST CONTROL EXPERTS

Facility Name & Address: Garudapolyflex Foods Pvt Ltd , Electronic City, Bangalore	Audited On: 30-11-2023
Audited By: SURESH KUMAR.V	
Client Contact Person Name: Mr. Saravan (QC)	PC Experts Contact Person Name: SURESH KUMAR.V
Client Contact Person No: 8973047541	PC Experts Contact Person No: 9087200011

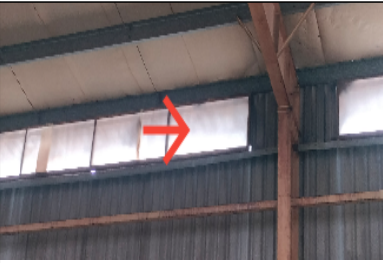
2

Location	Packing material storage area		
		Cleaning / sanitation & Housekeeping Issues	Nil		
		Structural Issue (Pest harbourages)	Roof sheet to transparent sheet gap observed		
		Access Issues	Nil		
		Description of Pest Infestation	It is Serious Threat for lizards		
		Any other observations	Nil		
		Preventive Action suggested to customer	Gaps should be closed with rubber breading or silicone sealant		
		Curative action from	We are instructed to Technician for Regular Monitoring.		
3

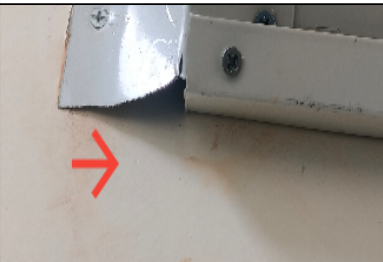
Location	R&D Store Area		
		Cleaning / sanitation & Housekeeping Issues	Nil		
		Structural Issue (Pest harbourages)	Gap observed between the cable line finishing Area.		
		Access Issues	Nil		
		Description of Pest Infestation	It is Serious Threat for Ants and lizard		
		Any other observations	Nil		
		Preventive Action suggested to customer	Gap should be closed with rubber breading or silicone sealant		
		Curative action from	We are instructed to Technician for Regular Monitoring.

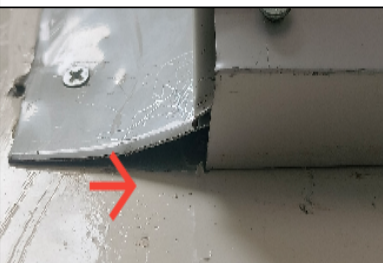
4

Location	R&D area		
		Cleaning / sanitation & Housekeeping Issues	Nil		
		Structural Issue (Pest harbourages)	Gap observed between the finishing metal Area		
		Access Issues	Nil		
		Description of Pest Infestation	It is Serious Threat for Ants, lizard		
		Any other observations	Nil		
		Preventive Action suggested to customer	Gap should be closed with rubber breading or silicone sealant		
		Curative action from	We are instructed to Technician for Regular Monitoring.

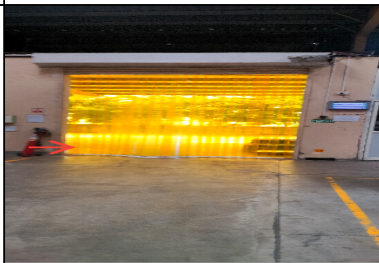
Location	Loading Area		
		Cleaning / sanitation & Housekeeping Issues	Nil		
		Structural Issue (Pest harbourages)	Not working time shutter was opened condition		
		Access Issues	Nil		
		Description of Pest Infestation	It is Serious Threat for Ants, lizard, and other crawling insects		
		Any other observations	Nil		
		Preventive Action suggested to customer	Not working time shutter should be closed.		
		Curative action from	We are instructed to Technician for Regular Monitoring.

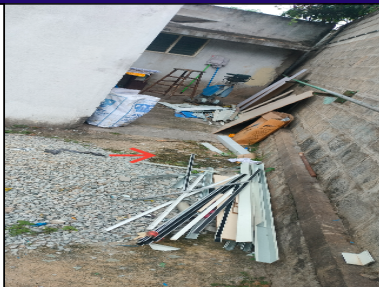
Location	Canteen back side area		
		Cleaning / sanitation & Housekeeping Issues	Unused materials stored in this area		
		Structural Issue (Pest harbourages)	Nil		
		Access Issues	Nil		
		Description of Pest Infestation	It is pest hiding place, like snakes, rodent, lizard, cockroach and Ants		
		Any other observations	Nil		
		Preventive Action suggested to customer	Don't allow the materials near by building Area. Keep the materials separate Area.		
		Curative action from	We are instructed to Technician for Regular Monitoring.

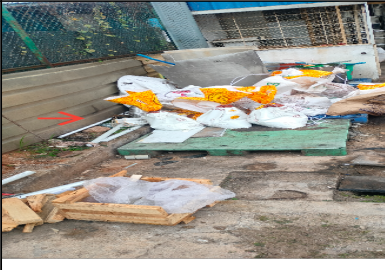
2

Location	Waste dumping area		
		Cleaning / sanitation & Housekeeping Issues	At the time of inspection we observed the waste observed the waste yard		
		Structural Issue (Pest harbourages)	Nil		
		Access Issues	Nil		
		Description of Pest Infestation	It is Serious Threat for Ants, flying insects and Rodent		
		Any other observations	Nil		
		Preventive Action suggested to customer	Waste to be remove on regular basis		
		Curative action from	We are instructed to Technician for Regular Monitoring.		
3

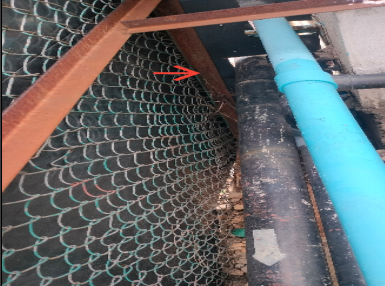
Location	ETP Area (fencing line)		
		Cleaning / sanitation & Housekeeping Issues	Nil		
		Structural Issue (Pest harbourages)	Fencing we observed the gaps		
		Access Issues	Nil		
		Description of Pest Infestation	It is Serious Threat for snakes, lizard, Rodent, Ants and other crawling insects		
		Any other observations	Nil		
		Preventive Action suggested to customer	Fencing gaps should be closed with mental sheet or proper material without gaps

Curative action from	We are instructed to Technician for Regular Monitoring.		
4

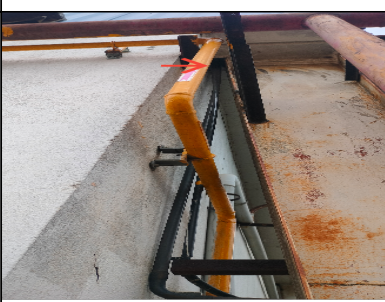
Location	Main building back outer side area		
		Cleaning / sanitation & Housekeeping Issues	Nil		
		Structural Issue (Pest harbourages)	Gaps Observed Around the Pipe and Wall		
		Access Issues	Nil		
		Description of Pest Infestation	It is Serious Threat for Ants, lizard, squirrel, Rodent and other crawling insects		
		Any other observations	Nil		
		Preventive Action suggested to customer	Gaps should be closed with silicone sealant or cement concrete.		
		Curative action from	We are instructed to Technician for Regular Monitoring.

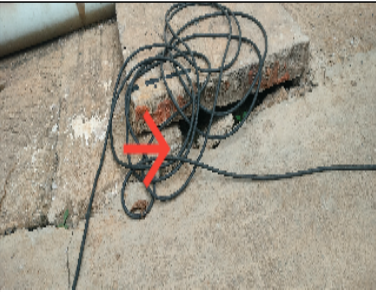
5

Location	Main building back side (Man hole area)		
		Cleaning / sanitation & Housekeeping Issues	Nil		
		Structural Issue (Pest harbourages)	Manhole lid not closed properly		
		Access Issues	Nil		
		Description of Pest Infestation	It is Serious Threat for Ants, beetles, flies, cockroach and other crawling insects		
		Any other observations	Nil		
		Preventive Action suggested to customer	Manholes lid should be closed properly without any gaps		
		Curative action from	We are instructed to Technician for Regular Monitoring.		
6

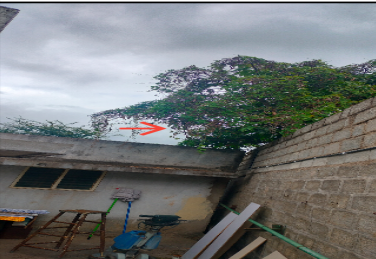
Location	Compound wall area		
		Cleaning / sanitation & Housekeeping Issues	Tree branches fall down on the compound wall		
		Structural Issue (Pest harbourages)	Nil		
		Access Issues	Nil		
		Description of Pest Infestation	It is Serious Threat for Ants, lizard, snakes, squirrel and Rats		
		Any other observations	Nil		
		Preventive Action suggested to customer	Tree branches should be trim on regular basis

Curative action from	We are instructed to Technician for Regular Monitoring.		
7

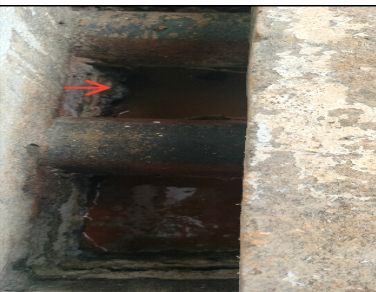
Location	Main building back side (waste water outlet manhole)		
		Cleaning / sanitation & Housekeeping Issues	Waste water outlet manhole not cleaned properly.		
		Structural Issue (Pest harbourages)	Manhole lid not closed properly		
		Access Issues	Nil		
		Description of Pest Infestation	It is Serious Threat for Ants, flies, mosquitoes, crawling insects		
		Any other observations	Nil		
		Preventive Action suggested to customer	Manholes should be clean on regular basis and manhole lid should be closed without any gaps		
		Curative action from	We are instructed to Technician for Regular Monitoring.

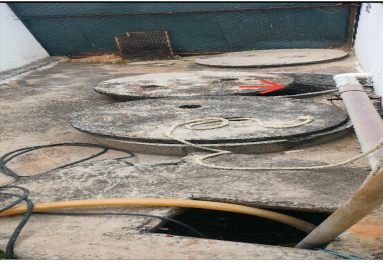
8

Location	ETP Area		
		Cleaning / sanitation & Housekeeping Issues	Nil		
		Structural Issue (Pest harbourages)	ETP manholes not closed properly		
		Access Issues	Nil		
		Description of Pest Infestation	It is Serious Threat for Cockroaches, flies, Ants and other crawling insects		
		Any other observations	Nil		
		Preventive Action suggested to customer	Manholes lid should be closed without any gaps		
		Curative action from	We are instructed to Technician for Regular Monitoring.		
9

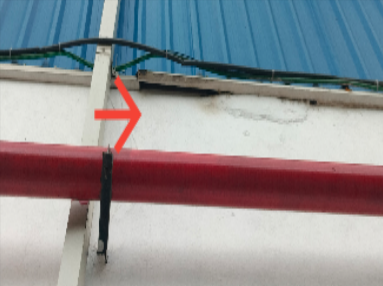
Location	Main building are (loading area)		
		Cleaning / sanitation & Housekeeping Issues	Nil		
		Structural Issue (Pest harbourages)	Gaps Observed between wall to wall metal sheet		
		Access Issues	Nil		
		Description of Pest Infestation	It is Serious Threat for Ants, lizard, flying insects and other crawling insects		
		Any other observations	Nil		
		Preventive Action suggested to customer	Gap should be closed with cement concrete or silicone sealant

Curative action from	We are instructed to Technician for Regular Monitoring.		
10

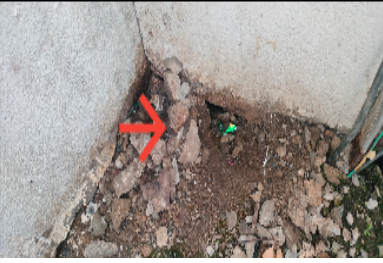
Location	Gas cylinder area		
		Cleaning / sanitation & Housekeeping Issues	Nil		
		Structural Issue (Pest harbourages)	Rodent borrow observed		
		Access Issues	Nil		
		Description of Pest Infestation	It is Serious Threat for Ants, rodent, snakes and other crawling insects		
		Any other observations	Nil		
		Preventive Action suggested to customer	Borrow should be closed with cement concrete.		
		Curative action from	We are instructed to Technician for Regular Monitoring.

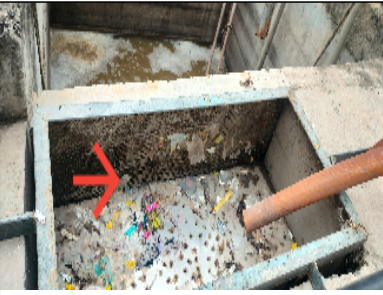
11

Location	Waste filtering area		
		Cleaning / sanitation & Housekeeping Issues	At the time of inspection we observed the waste observed.		
		Structural Issue (Pest harbourages)	Nil		
		Access Issues	Nil		
		Description of Pest Infestation	It is Serious Threat for Ants, flies, cockroach and other crawling insects		
		Any other observations	Nil		
		Preventive Action suggested to customer	Waste should be clean on regular basis		
		Curative action from	We are instructed to Technician for Regular Monitoring.		
12

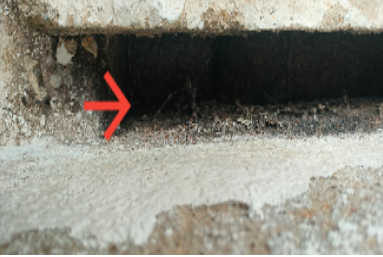
Location	Main building back side (manholes)		
		Cleaning / sanitation & Housekeeping Issues	Manholes not cleaned properly, lot of waste stagnated.		
		Structural Issue (Pest harbourages)	Nil		
		Access Issues	Nil		
		Description of Pest Infestation	It is Serious Threat for Ants, flies, cockroach, rodent		
		Any other observations	Nil		
		Preventive Action suggested to customer	Manholes should be clean on regular basis. Lid should be closed properly without any gaps.

Curative action from	We are instructed to Technician for Regular Monitoring.		
13

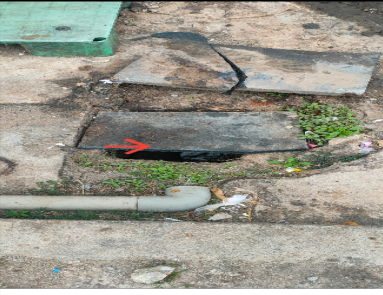
Location	Waste dumping area		
		Cleaning / sanitation & Housekeeping Issues	NIL		
		Structural Issue (Pest harbourages)	Lid was damaged condition		
		Access Issues	Nil		
		Description of Pest Infestation	It is Serious Threat for Ants, cockroach, Rodent, snakes and other crawling insects		
		Any other observations	Nil		
		Preventive Action suggested to customer	Manholes lid should changed. Lid should be closed without any gaps		
		Curative action from	We are instructed to Technician for Regular Monitoring.

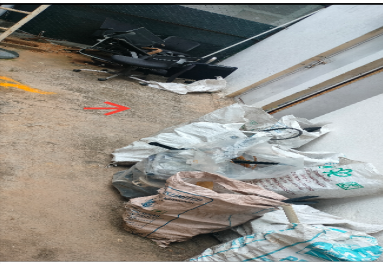
Location	Waste material dumping area		
		Cleaning / sanitation & Housekeeping Issues	Nil		
		Structural Issue (Pest harbourages)	Nil		
		Access Issues	Unused materials dumped out side of the waste yard		
		Description of Pest Infestation	It is Serious Threat for snakes, Rodent and other crawling insects		
		Any other observations	Nil		
		Preventive Action suggested to customer	Unused materials should be removed.

Curative action from	We are instructed to Technician for Regular Monitoring.		
16

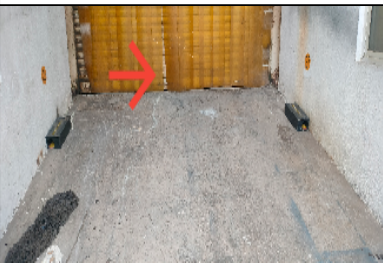
Location	R&D outer shutter area		
		Cleaning / sanitation & Housekeeping Issues	Nil		
		Structural Issue (Pest harbourages)	Gap observed between the bottom of the shutter		
		Access Issues	Nil		
		Description of Pest Infestation	It is Serious Threat for Ants, cockroach, lizard		
		Any other observations	Nil		
		Preventive Action suggested to customer	Bottom of the shutter gap should be closed with rubber breading		
		Curative action from	We are instructed to Technician for Regular Monitoring.
