PEST CONTROL EXPERTS
No.6, 1st Floor, Balaji Lodge Complex,
NH 46 Service Road(Chennai to Bangalore Highway),
Vellore - 632 004.Tamilnadu. Email:care@pestcontrolexpert.in
Cell: 9087200011 ; 90872000022

Facility Name & Address: LCN Industries , Chittoor	**Audited On: 09-09-2025**
Audited By: SURESH KUMAR.V	
Client Contact Person Name: Mr. Chanukya Naidu	**PC Experts Contact Person Name: SURESH KUMAR.V**
Client Contact Person No: 9440274003	**PC Experts Contact Person No: 8248672110**

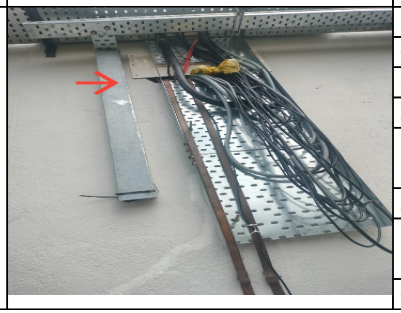
Location	Main building cable trench area (Salt and sugar).		
		Cleaning / sanitation & Housekeeping Issues	Nil		
		Structural Issue (Pest harbourages)	Wall to Cable trench surroundings Gap observed		
		Access Issues	Nil		
		Description of Pest Infestation	It is Serious Threat for Ants, beetles, lizards, flying insects and other crawling insects		
		Any other observations	Nil		
		Preventive Action suggested to customer	Gap should be closed with form sealent without any gaps		
		Curative action from	We are instructed to Technician for Regular Monitoring.

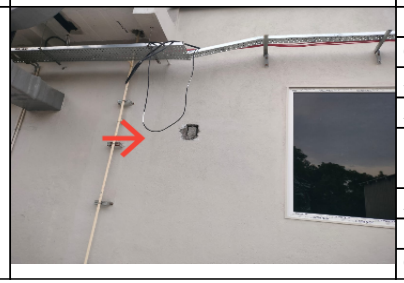
Location	Main building backside area		
		Cleaning / sanitation & Housekeeping Issues	Nil		
		Structural Issue (Pest harbourages)	Gap noticed between the wall to wall brick		
		Access Issues	Nil		
		Description of Pest Infestation	It is Serious Threat for Ants, lizards, other crawling insects		
		Any other observations	Nil		
		Preventive Action suggested to customer	Gap should be closed with cement.		
		Curative action from	We are instructed to Technician for Regular Monitoring.

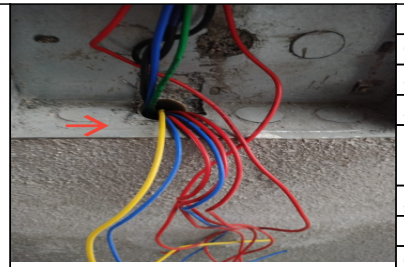
Location	Emergency door backside (cable switch box area)		
		Cleaning / sanitation & Housekeeping Issues	Nil		
		Structural Issue (Pest harbourages)	Switch box wire line pipe gaps noticed		
		Access Issues	Nil		
		Description of Pest Infestation	It is Serious Threat for Ants, lizards, other crawling insects		
		Any other observations	Nil		
		Preventive Action suggested to customer	Switch box should be placed with top switch box frame		
		Curative action from	We are instructed to Technician for Regular Monitoring.		
11		Location	Main building (water outlet pipe line)		
		Cleaning / sanitation & Housekeeping Issues	Nil		
		Structural Issue (Pest harbourages)	Pipe lid not placed		
		Access Issues	Nil		
		Description of Pest Infestation	It is Serious Threat for Ants, mosquito, beetles lizards flying insects and other crawling insects.		
		Any other observations	Nil		
		Preventive Action suggested to customer	Mesh type lid should be placed

Curative action from	We are instructed to Technician for Regular Monitoring.		
12

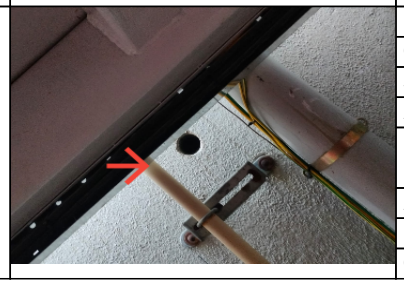
Location	Main building outer area (vessels back side)		
		Cleaning / sanitation & Housekeeping Issues	Nil		
		Structural Issue (Pest harbourages)	Hole observed on the Wall		
		Access Issues	Nil		
		Description of Pest Infestation	It is Serious Threat for Ants, lizards and other crawling insects.		
		Any other observations	Nil		
		Preventive Action suggested to customer	Hole should be closed with cement		
		Curative action from	Nil
