| Facility Name & Address: CG Foods India Pvt Ltd , Chittoor | Audited On: 28-09-2023 |

## FACILITY SURROUNDING

| External Premises | | | | REVIEW DATE | COMPLETION DATE |

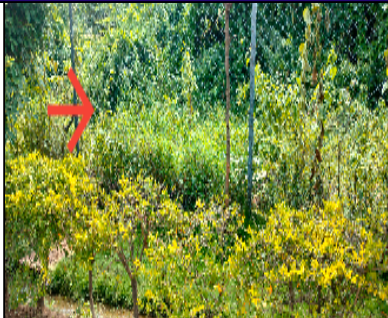
| External Premises | | | | REVIEW DATE | COMPLETION DATE |
|---|---|---|---|---|---|
| 1 | | Location | Fencing area | | |

| External Premises | | | | REVIEW DATE | COMPLETION DATE |
|---|---|---|---|---|---|
| | | Cleaning / sanitation & Housekeeping Issues | Lot of thick vegetation observed. | | |
| | | Structural Issue (Pest harbourages) | No compound wall | | |
| | | Description of Pest Infestation | It is Serious Threat for snakes, Rodents, lizards, monkeys, spiders, Ants flying insects and other crawling insects. | | |

| External Premises | | | | REVIEW DATE | COMPLETION DATE |
|---|---|---|---|---|---|
| | | Preventive Action suggested to customer | Facility Surrounding compound wall required. Thick vegetation should be clean on regular basis. | | |

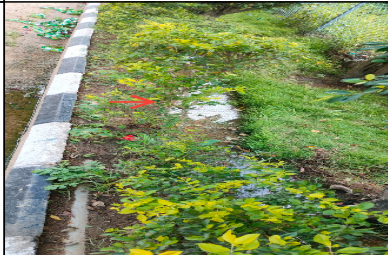
| External Premises | | | | REVIEW DATE | COMPLETION DATE |
|---|---|---|---|---|---|
| 2 | | Location | Fencing area | | |

| External Premises | | | | REVIEW DATE | COMPLETION DATE |
|---|---|---|---|---|---|
| | | Cleaning / sanitation & Housekeeping Issues | Lot of water stagnated | | |
| | | Description of Pest Infestation | It is Serious Threat for mosquitoes, beetles, Ants, flying insects and other crawling insects. | | |

| External Premises | | | | REVIEW DATE | COMPLETION DATE |
|---|---|---|---|---|---|
| | | Preventive Action suggested to customer | Don't allow the water stagnated facility Surrounding. | | |

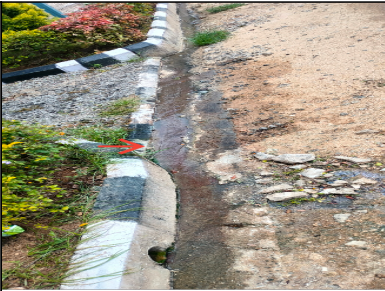
| 3 | | Location | Main building back side | | |

| | | Cleaning / sanitation & Housekeeping Issues | Water stagnated | | |
| | | Description of Pest Infestation | It is Serious Threat for Beetles, mosquitoes, flying insects and other crawling insects. | | |

| | | Preventive Action suggested to customer | Don't allow the water stagnated inside the facility Surrounding. | | |

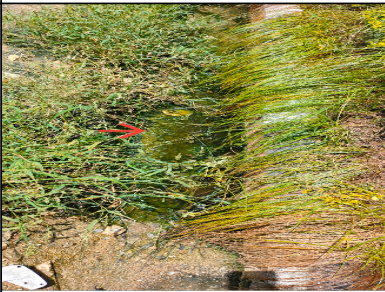
| 4 | | Location | Main building back side. | | |

| | | Cleaning / sanitation & Housekeeping Issues | Lot water stagnated | | |
| | | Description of Pest Infestation | It is Serious Threat for Beetles, flying insects, mosquitoes and other crawling insects. | | |

| | | Preventive Action suggested to customer | Don't allow the water stagnated inside of facility Surrounding. | | |

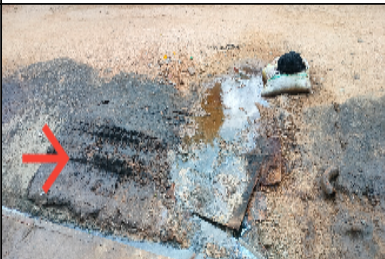
| 5 | | Location | Main building back side | | |

| | | Cleaning / sanitation & Housekeeping Issues | Waste oil spillage observed and not cleaned properly. | | |
| | | Description of Pest Infestation | It is Serious Threat for Beetles. | | |
| | | Any other observations | Employee May be fall down | | |

| | | Preventive Action suggested to customer | Don't allow oil spillage and always keep dry conditions. Make a danger barricades | | |

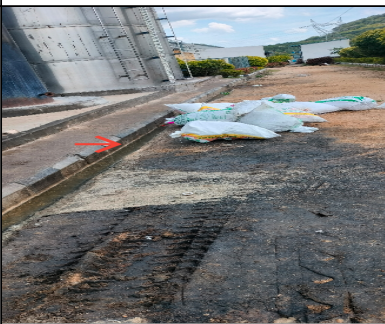
| 6 | | Location | Main building back side area | | |

| | | Cleaning / sanitation & Housekeeping Issues | Waste Dumped near by facility Surrounding | | |
| | | Description of Pest Infestation | It is Serious Threat for Ants, cockroach, rodent, lizard, monkeys, flying insects and other crawling insects. | | |

| | | Preventive Action suggested to customer | Don't allow the waste materials near by facility Surrounding. Waste material dumping purpose Separate area to be allotted. | | |

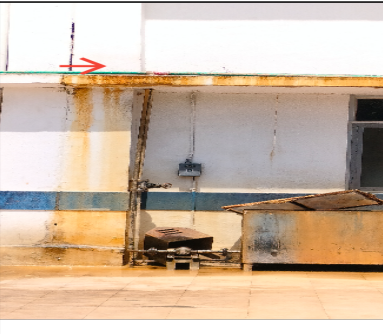
| 7 | | Location | Main building back side. | | |

| | | Cleaning / sanitation & Housekeeping Issues | Lot of hot water stagnated. | | |
| | | Structural Issue (Pest harbourages) | Hot water pipe line was damaged, so that hot water fall down. | | |
| | | Description of Pest Infestation | It is Serious Threat for Beetles, flying insects and other crawling insects. | | |

| | | Preventive Action suggested to customer | Pipe should be replaced. Pipe should be replaced. Don't allow the fall down the hot water. | | |

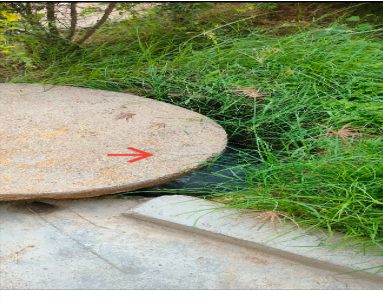
| 8 | | Location | Hygiene entrance area | | |

| | | Cleaning / sanitation & Housekeeping Issues | Manhole not cleaned properly. | | |
| | | Structural Issue (Pest harbourages) | Manhole was opened condition. | | |
| | | Description of Pest Infestation | It is Serious Threat for Cockroaches, mosquitoes, flying insects, Ants, and other crawling insects. | | |

| | | Preventive Action suggested to customer | Manhole should be closed with manhole lid without any gaps. | | |

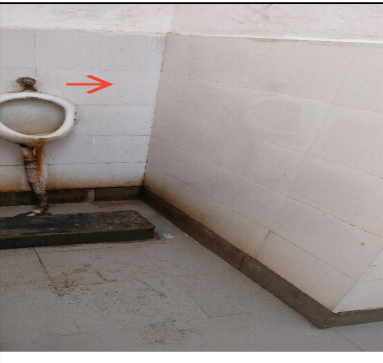
| 9 | | Location | Hygiene entrance toilet area. | | |

| | | Cleaning / sanitation & Housekeeping Issues | Not cleaned regularly. It's worst condition. | | |
| | | Structural Issue (Pest harbourages) | Toilet exhaust gaps observed. Toilet doors not closed properly and gaps observed. | | |
| | | Description of Pest Infestation | It is Serious Threat for Cockroaches, bacteria, fungal, lizard, flying insects and other crawling insects. | | |

| | | Preventive Action suggested to customer | All toilet area must be clean on regular basis. Doors also should be closed. All gaps should be closed with rubber breading, cement and mesh. | | |

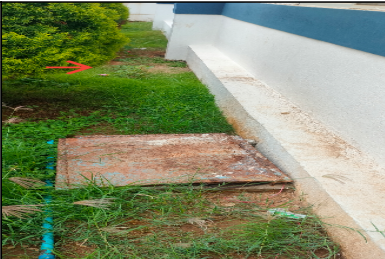
| 10 | | Location | Main building outer surface | | |

| | | Cleaning / sanitation & Housekeeping Issues | Lot of thick vegetation observed | | |
| | | Access Issues | We can't able to monitoring the boxes. | | |
| | | Description of Pest Infestation | It is Serious Threat for Beetles, snakes, rodents, lizards, Ants, frog and other crawling insects | | |

| | | Preventive Action suggested to customer | Thick vegetation should be clean on regular basis. | | |

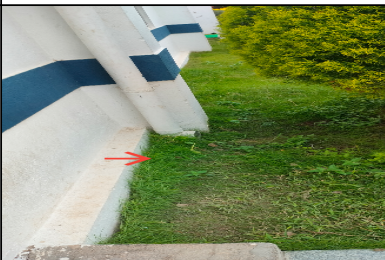
| 11 | | Location | Main building surrounding area | | |

| | | Cleaning / sanitation & Housekeeping Issues | Lot of thick vegetation observed | | |
| | | Description of Pest Infestation | It is Serious Threat for Beetles, Ants, cockroach, snakes, rodents, lizards and other crawling insects. | | |

| | | Preventive Action suggested to customer | Thick vegetation should be clean on regular basis. | | |

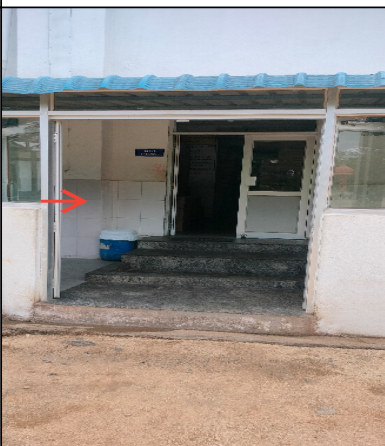
| 12 | | Location | Hygiene entrance area | | |

| | | Cleaning / sanitation & Housekeeping Issues | Floor not cleaned properly | | |
| | | Structural Issue (Pest harbourages) | Hygiene entrance doors always opend condition. Not closed properly. | | |
| | | Description of Pest Infestation | It is Serious Threat for Ants, cockroach, flying insects, rodents, snakes, lizards and other crawling insects. | | |
| | | Any other observations | Doors frame to doors gaps observed. Toilet exhaust fan mesh not fixed properly.in this area gaps observed between the wall to Wall Sheet and Wall Sheet to roof sheet. | | |

| | | Preventive Action suggested to customer | Floor should be clean on regular basis. All gaps should be closed with cement or rubber breading or Mesh without any gaps. | | |

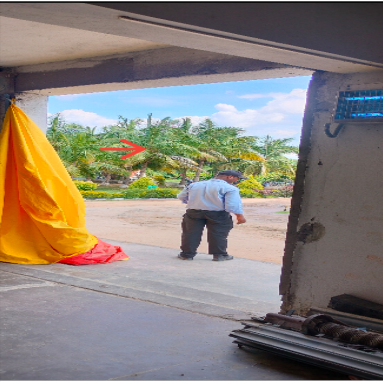
| 13 | | Location | RM area | | |

| | | Structural Issue (Pest harbourages) | RM area shutter was damaged condition | | |
| | | Description of Pest Infestation | It is Serious Threat for Beetles, lizard, spiders, rodents, Ants, snakes, dogs, frogg, flying insects and other crawling insects. | | |
| | | Any other observations | 2nd shutter also gaps observed between the shutter to shutter frame | | |

| | | Preventive Action suggested to customer | Shutter should be placed without any gaps. Bottom of shutter should be placed rubber beading without any gaps. | | |

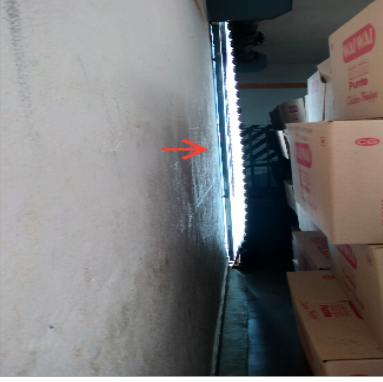
| 14 | | Curative action from | We are instructed to Technician for Regular Monitoring. | | |

| | | Location | FG area | | |
| | | Structural Issue (Pest harbourages) | FG area shutter was damaged condition, lot of gaps observed and shutter was opened condition. | | |
| | | Access Issues | In FG area all FG material kept at wall side without any gaps. | | |
| | | Description of Pest Infestation | It is Serious Threat for Ants, cockroach, lizard, rodent, snake, flying insects and other crawling insects. | | |
| | | Any other observations | In side of FG area all materials kept at wall side without gaps. | | |

| 15 | | Preventive Action suggested to customer | Shutter should be replaced. Shutter gaps closed with rubber breading or mesh or cement without any gaps. | | |

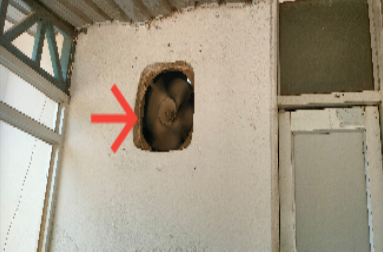
| | | Location | Hygiene entrance toilet area. | | |
| | | Cleaning / sanitation & Housekeeping Issues | Toilets not cleaned properly | | |
| | | Structural Issue (Pest harbourages) | Mesh not fixed on Exhaust fan. | | |
| | | Description of Pest Infestation | It is Serious Threat for Cockroaches, Ants, beetles, lizard, flying insects and other crawling insects. | | |

| | | Preventive Action suggested to customer | Mesh to be placed without any gaps. | | |

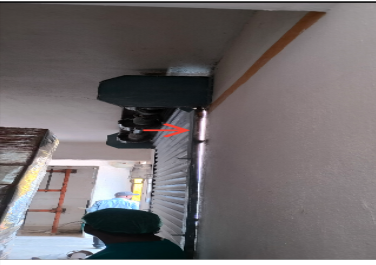
| 16 | | Location | RM shutter area | | |

| | | Structural Issue (Pest harbourages) | Gaps observed between the Shutter frame to Wall | | |
| | | Description of Pest Infestation | It is Serious Threat for Beetles, Ants, cockroach, lizard, flying insects and other crawling insects. | | |

| | | Preventive Action suggested to customer | Gap should be closed with cement concrete | | |

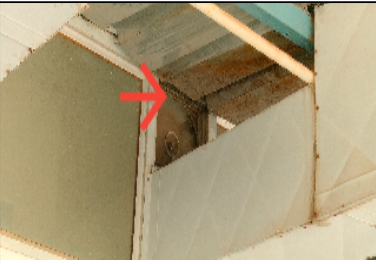
| 17 | | Location | Hygiene entrance area | | |

| | | Structural Issue (Pest harbourages) | Wall sheet opened condition | | |
| | | Description of Pest Infestation | It is Serious Threat for Ants, beetles, flying insects, lizards and other crawling insects. | | |

| | | Preventive Action suggested to customer | Sheet to be placed without any gaps | | |
