Facility Name & Address: Aseptic Quality Foods Pvt Ltd , srinivapur	Audited On: 19-10-2023
Audited By: SURESH KUMAR.V	
Client Contact Person Name: Mr. Ramesh	PC Experts Contact Person Name: SURESH KUMAR.V
Client Contact Person No: 8008804187	PC Experts Contact Person No: 9087200011

FACILITY SURROUNDING

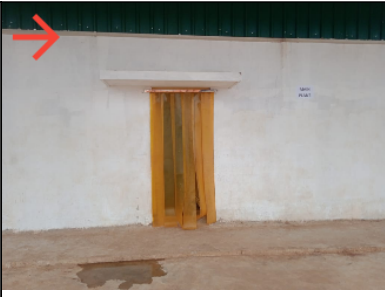
Location	Fruit Washing area.		
		Cleaning / sanitation & Housekeeping Issues	Nil		
		Structural Issue (Pest harbourages)	Gaps Observed between Fruit washing Conveyor Line and Wall		
		Access Issues	Nil		
		Description of Pest Infestation	It is Serious Threat for Beetles, Ants, snake, lizard, frogg, flies, rodent and other crawling insects

Any other observations	Nil		
		Preventive Action suggested to customer	Fruit Washing conveyor surrounding should be closed with wall or form sheet without any gaps.		
		Curative action from	We are instructed to Technician for Regular Monitoring.

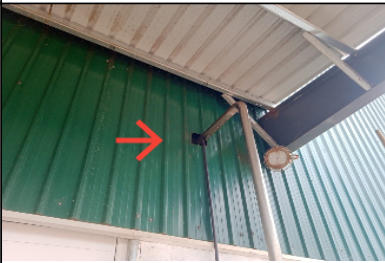
Location	Hygiene entrance area		
		Cleaning / sanitation & Housekeeping Issues	Nil		
		Structural Issue (Pest harbourages)	Nil		
		Access Issues	Air curtains not fixed		
		Description of Pest Infestation	It is Serious Threat for Ants, snakes, lizard, flying insects, rodent and other crawling insects.		
		Any other observations	Nil		
		Preventive Action suggested to customer	Air curtains should be placed, doors should be closed always.		
		Curative action from	We are instructed to Technician for Regular Monitoring.		
4

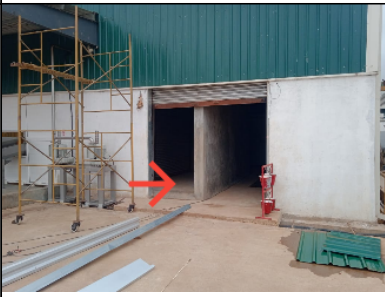
Location	1st line fruit Washing area		
		Cleaning / sanitation & Housekeeping Issues	Nil		
		Structural Issue (Pest harbourages)	We observed gaps between the pipe hole to wall sheet.		
		Access Issues	Nil		
		Description of Pest Infestation	It is Serious Threat for Beetles, flying insects, lizard,		
		Any other observations	Nil		
		Preventive Action suggested to customer	Around the Pipeline Gap will be closed with cement mortar or Foam Sealant.

Curative action from	We are instructed to Technician for Regular Monitoring.		
5
